# 2023 Asbestos Reinspections

**September 2023**

San Diego County Regional Airport Authority

TETRA TECH, INC.

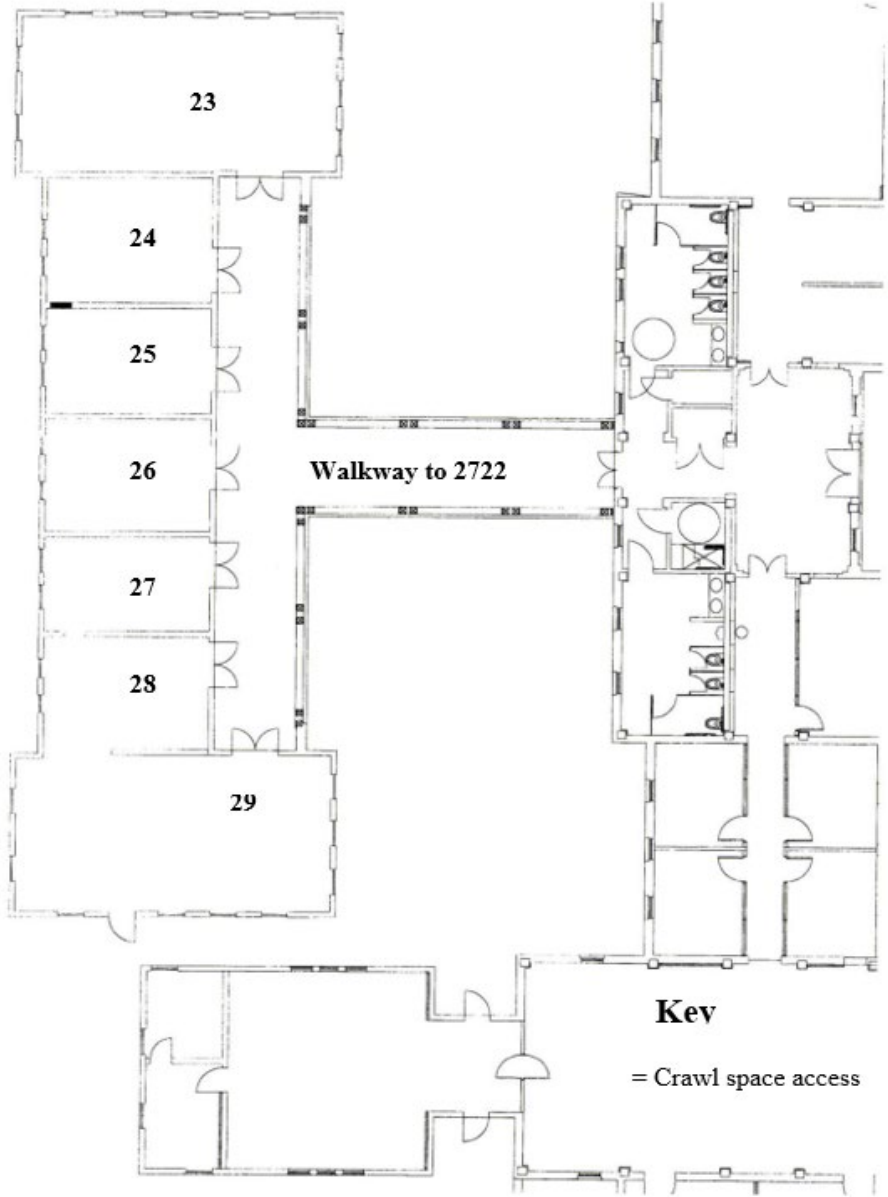
2724 Truxton Road

Room #	Material Description	Material Location	Approximate Quantity	Friable Y/N	Condition	Comments
Exterior	Black/gray roof mastic	On roof of both buildings	110 SF	N	G	Presumed to be asbestos – not sampled. No changes observed.
Exterior	Roll asphalt shingle	On roof of both buildings	9,000 SF	N	G	Presumed to be asbestos – not sampled. No changes observed.
Crawl Space	Transite and TSI	Under both buildings	Unknown	Unknown	Unknown	Material located in a locked and “confined space”. Material was inaccessible for inspection.

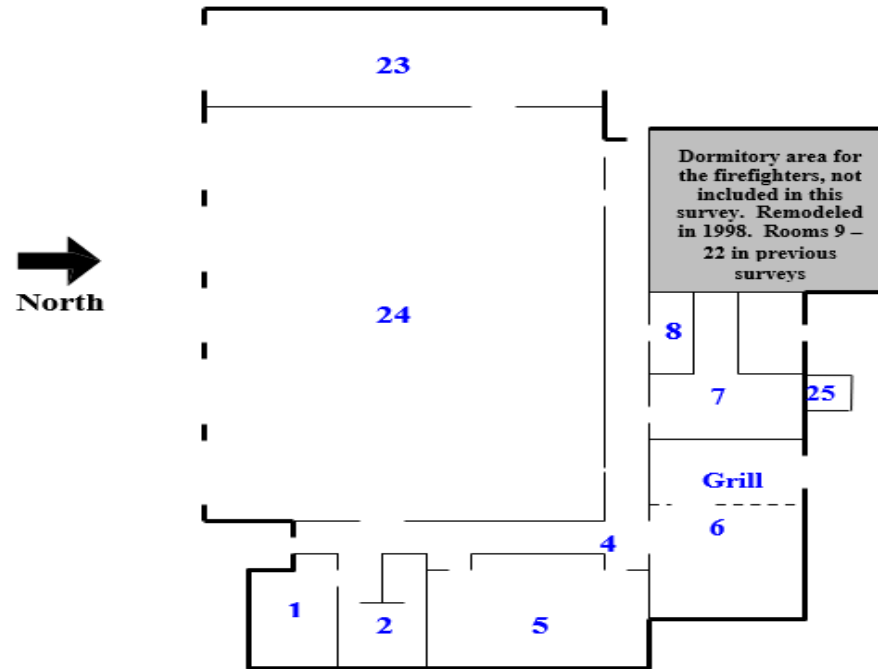
3698 Pacific Highway  
1<sup>st</sup> Floor  
Not to Scale

Room #	Material Description	Material Location	Approximate Quantity <sup>1</sup>	Friable Y/N	Condition	Comments
23	Drywall and Joint Compound	Ceiling and some walls	2,500 SF	N	G	Holes in drywall noted in 2022 have been repaired. No damage present.
24	Drywall and Joint Compound	Ceiling and some walls	5,800 SF	N	G	Damage previously present on ceiling and west wall has been repaired.
25	TSI elbows (PACM)	Boiler room	4 EA	F	G	1 observed in the exterior water heater closet. 3 more were noticed in the spring of 2021. Others are likely hidden in walls.
Roof	HVAC, Roof assembly and penetrations	Roof	5000 ft <sup>2</sup>	N	G	These items are suspected of containing asbestos. Confirm with analysis before disturbance.
