***San Diego County Regional  
Airport Authority***

***Fiscal Year 2010-2011  
Industrial Stormwater Permit  
Annual Report***

2010-2011  
**ANNUAL REPORT**  
FOR  
STORM WATER DISCHARGES ASSOCIATED  
WITH INDUSTRIAL ACTIVITIES

Facility Business Name: San Diego International Airport Contact Person: Richard Gilb  
Physical Address: 3225 North Harbor Drive e-mail: RGilb@san.org  
City: San Diego **CA** Zip: 92101 Phone: (619)400-2790  
Standard Industrial Classification (SIC) Code(s): 4581 – Airports, Flying Fields, and Airport Terminal Services

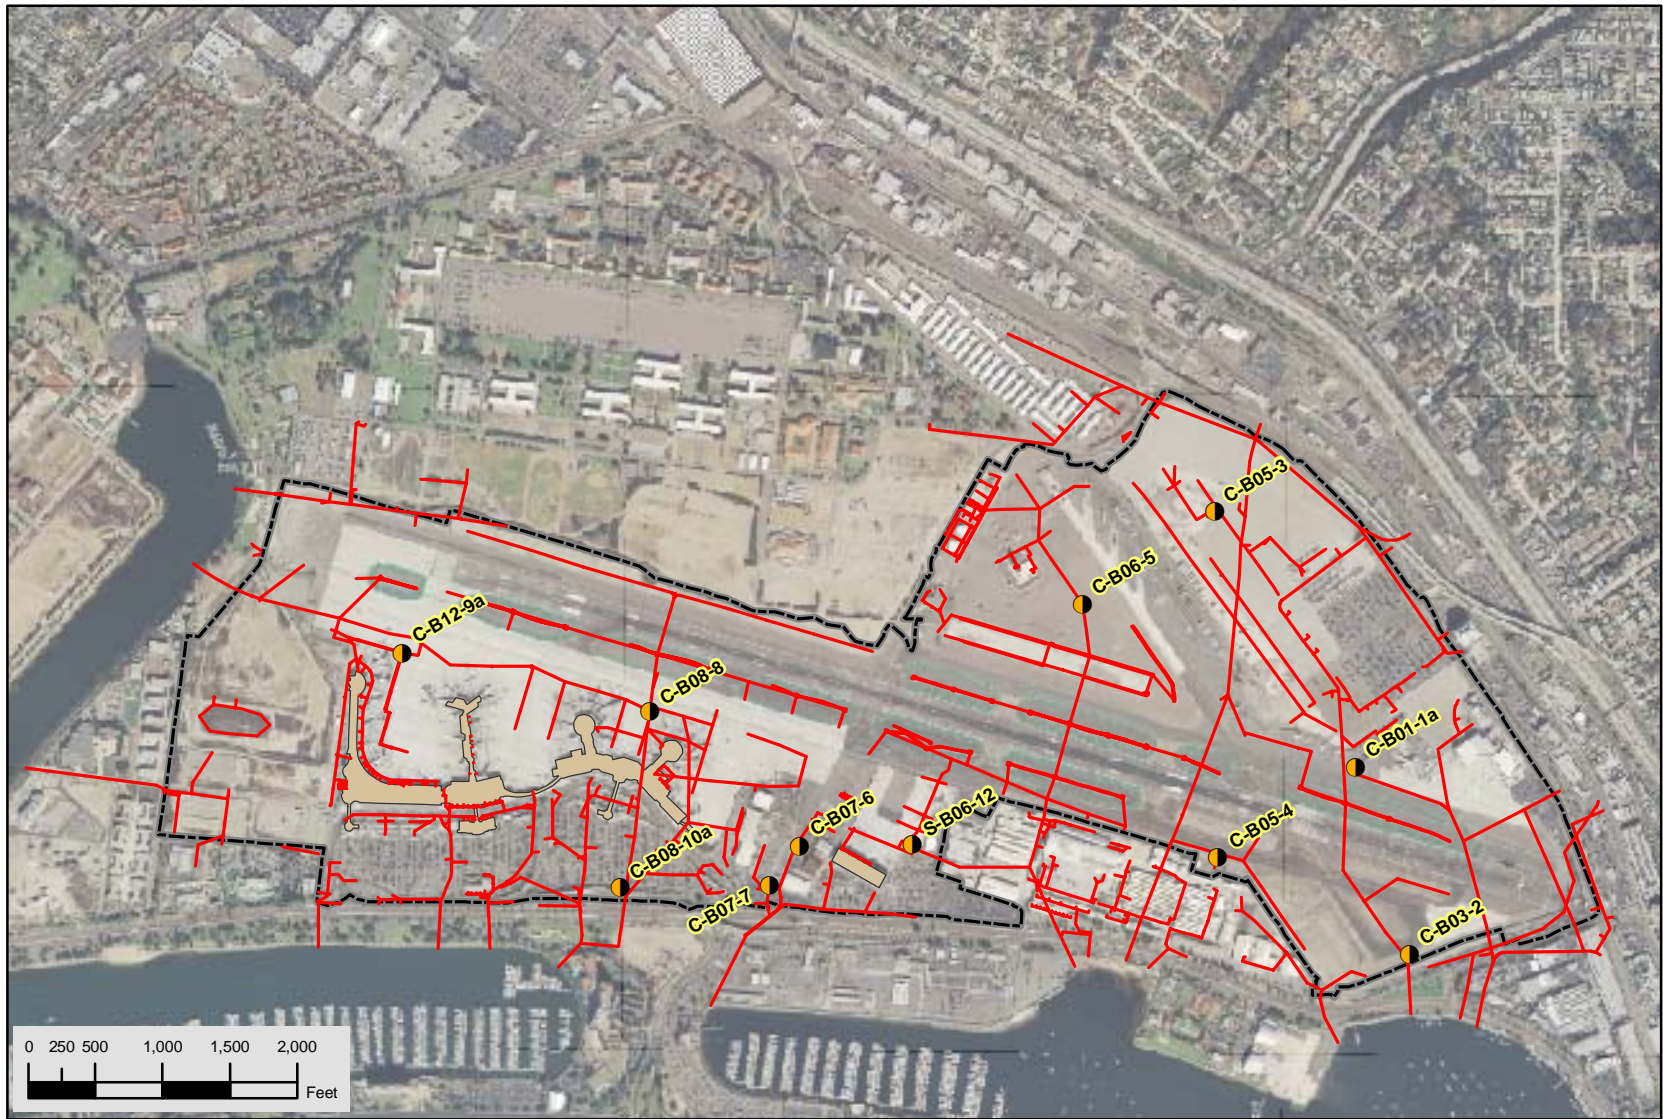
Storm Drain System and Sampling Locations Map

## Storm Drain System and Sampling Locations

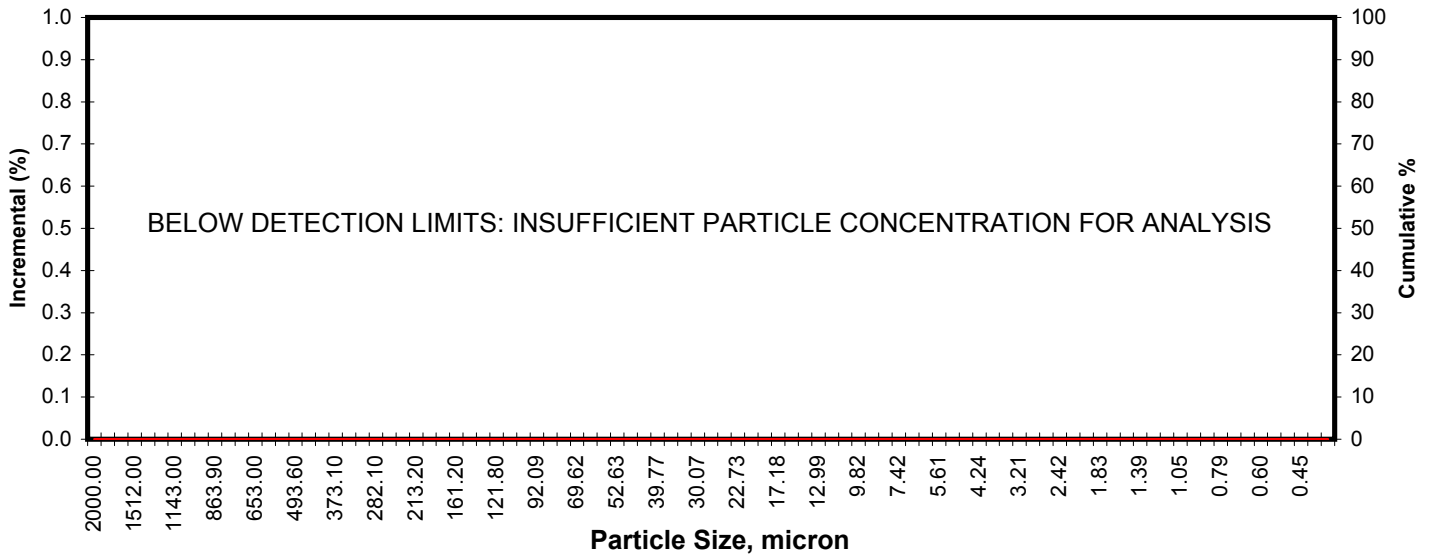
**PTS File No:** 41029  
**Sample ID:** S-B06-12 (1012352-11)  
**Matrix:** N/A

Particle Diameter, micron	Particle Distribution		Particle Diameter, micron	Particle Distribution		Particle Diameter, micron	Particle Distribution	
	Incremental percent	Cumulative percent		Incremental percent	Cumulative percent		Incremental percent	Cumulative percent
2000.00	0.00	0.0	52.63	0.00	0.0	1.385	0.000	0.0
1822.00	0.00	0.0	47.93	0.00	0.0	1.261	0.000	0.0
1660.00	0.00	0.0	43.66	0.00	0.0	1.149	0.000	0.0
1512.00	0.00	0.0	39.77	0.00	0.0	1.047	0.000	0.0
1377.00	0.00	0.0	36.24	0.00	0.0	0.953	0.000	0.0
1255.00	0.00	0.0	33.00	0.00	0.0	0.869	0.000	0.0
1143.00	0.00	0.0	30.07	0.00	0.0	0.791	0.000	0.0
1041.00	0.00	0.0	27.38	0.00	0.0	0.721	0.000	0.0
