**Section 106 Assessment for the San Diego International Airport Airfield  
Improvements and Terminal 1 Replacement Project**

**SECTION 106 ASSESSMENT FOR THE  
SAN DIEGO INTERNATIONAL AIRPORT  
AIRFIELD IMPROVEMENTS AND  
TERMINAL 1 REPLACEMENT PROJECT**

**CITY OF SAN DIEGO, CALIFORNIA**

***November 10, 2020; Revised January 8, 2021; Revised February 19, 2021;  
Revised March 12, 2021; Revised April 27, 2021; Revised May 7, 2021***

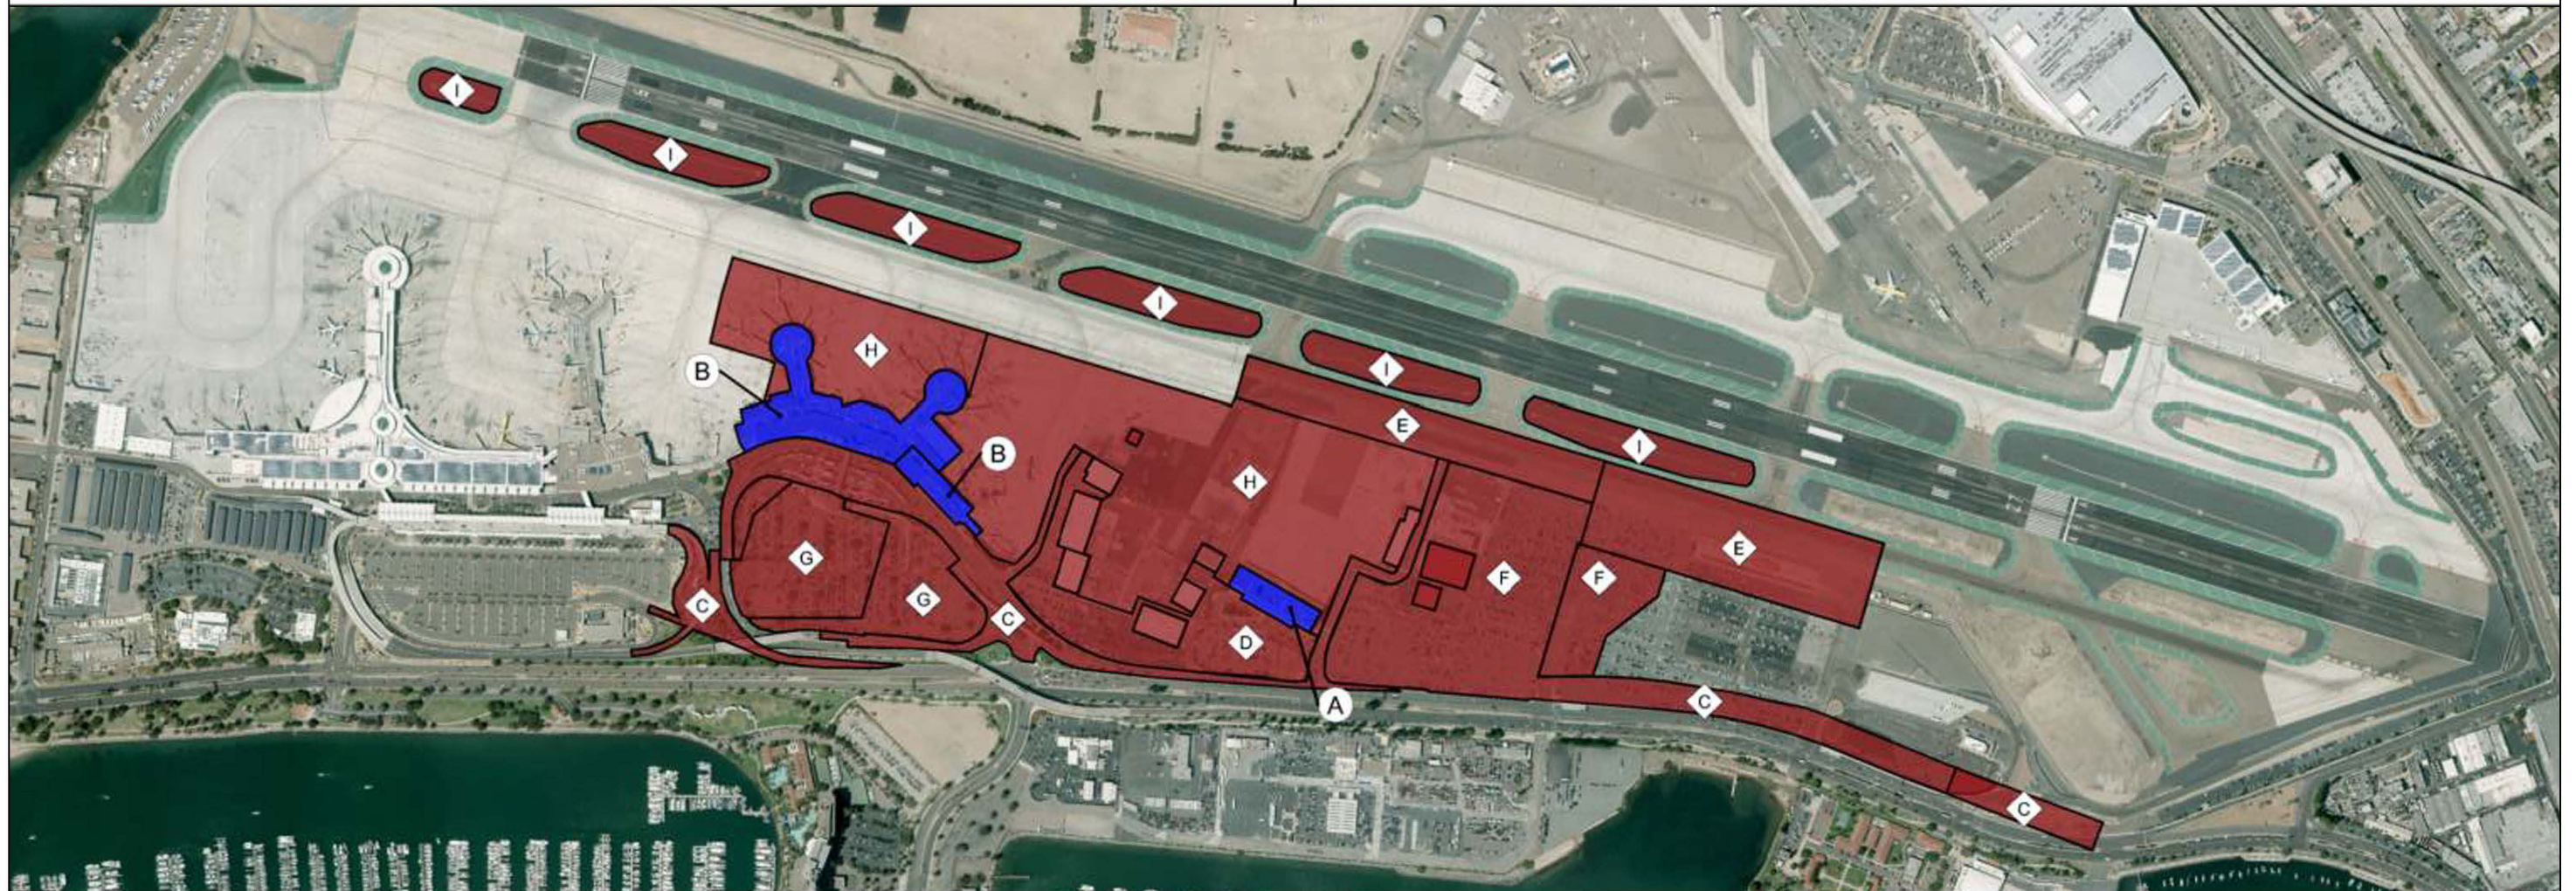
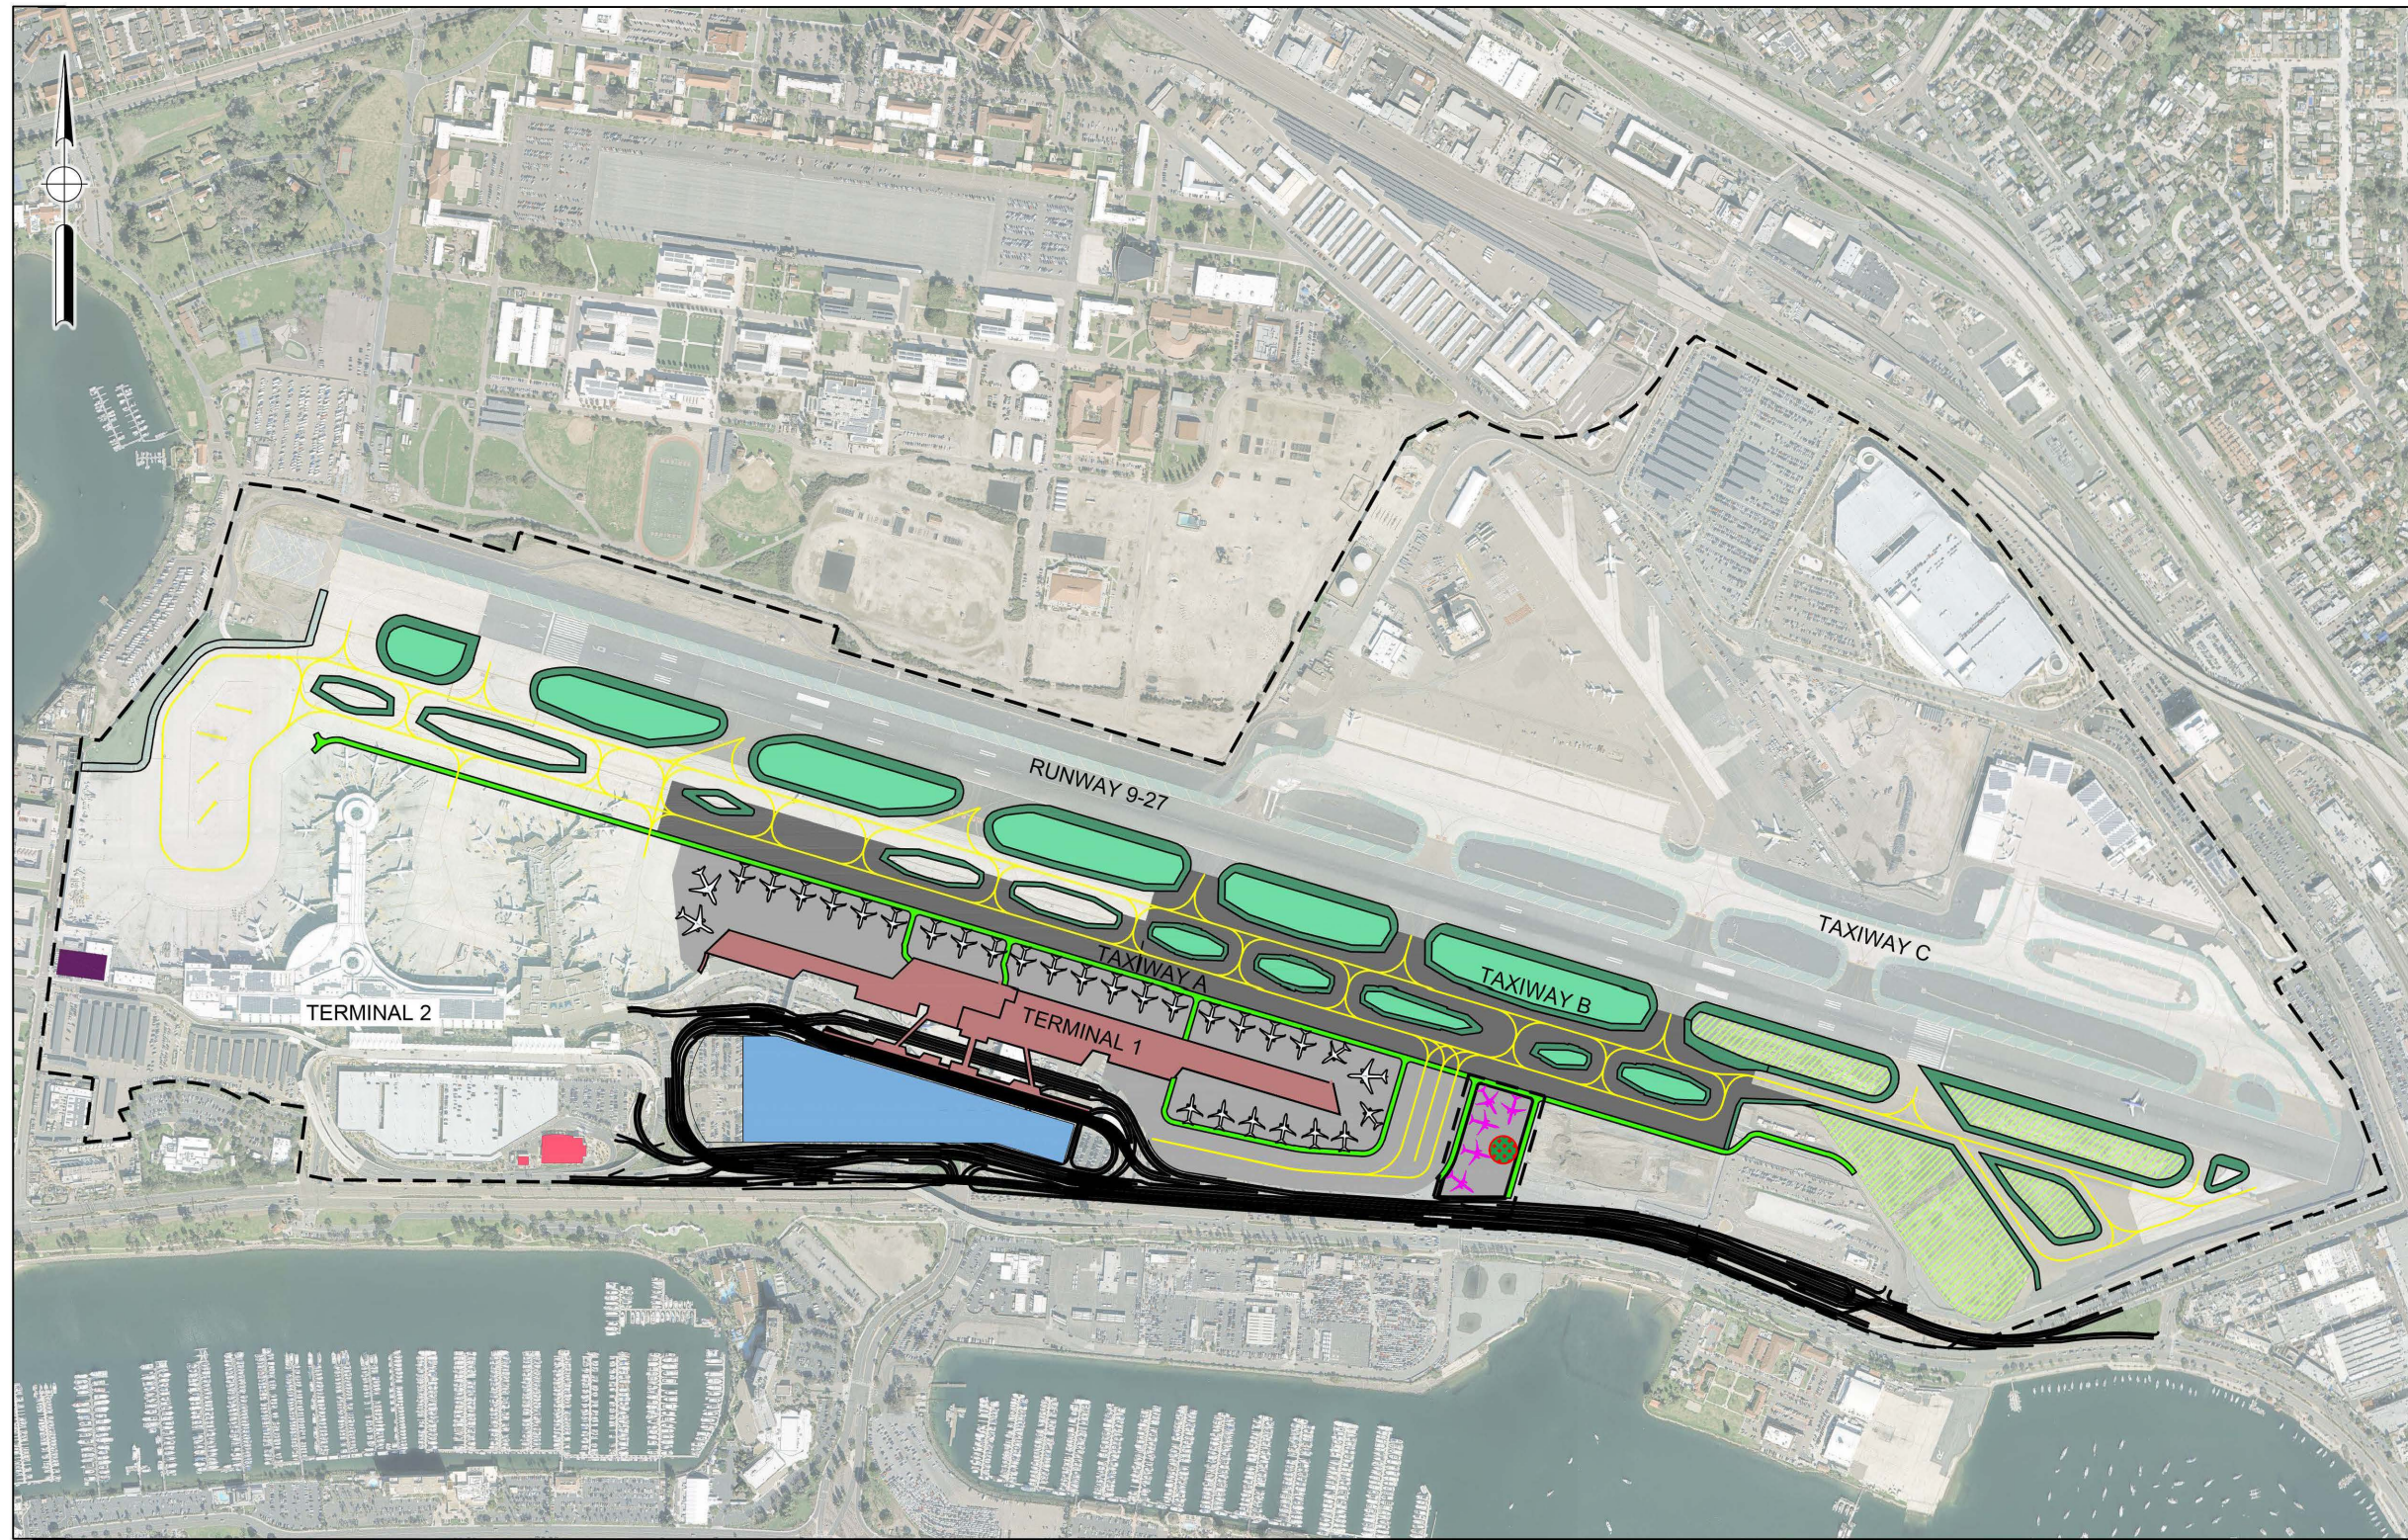
**Figure 2.0-1**  
**Undertaking Demolition Map**  
 The SAN Airfield Improvements and Terminal 1 Replacement Project

The proposed undertaking includes the replacement of the existing 336,000-square-foot Terminal 1 with a new 1,210,000-square-foot terminal, and the replacement of the former 132,000-square-foot commuter terminal (originally the PSA AMF building before being repurposed in 1996; currently the SDCRAA offices) with a new 150,000-square-foot facility near the intersection of McCain and Airport Terminal roads. The new Terminal 1 would replace the existing terminal, both overlapping and extending eastward from its current location, and will add 11 additional aircraft gates. The excavation depth for these new facilities would be a maximum of 25 feet below the surface with the average depth of eight feet and a pile depth of 75 feet. The proposed undertaking also includes relocating part of Taxiway B (from the west end to the Taxiway B4 connection) 37.5 feet south of its present location; constructing Taxiway A from the west end of Runway 9 to the Taxiway B4 connection; constructing a new RON aircraft parking apron east of the new terminal; and relocation of three FAA sensors. These airfield improvements would have excavation depths between four and 22 feet below the surface.

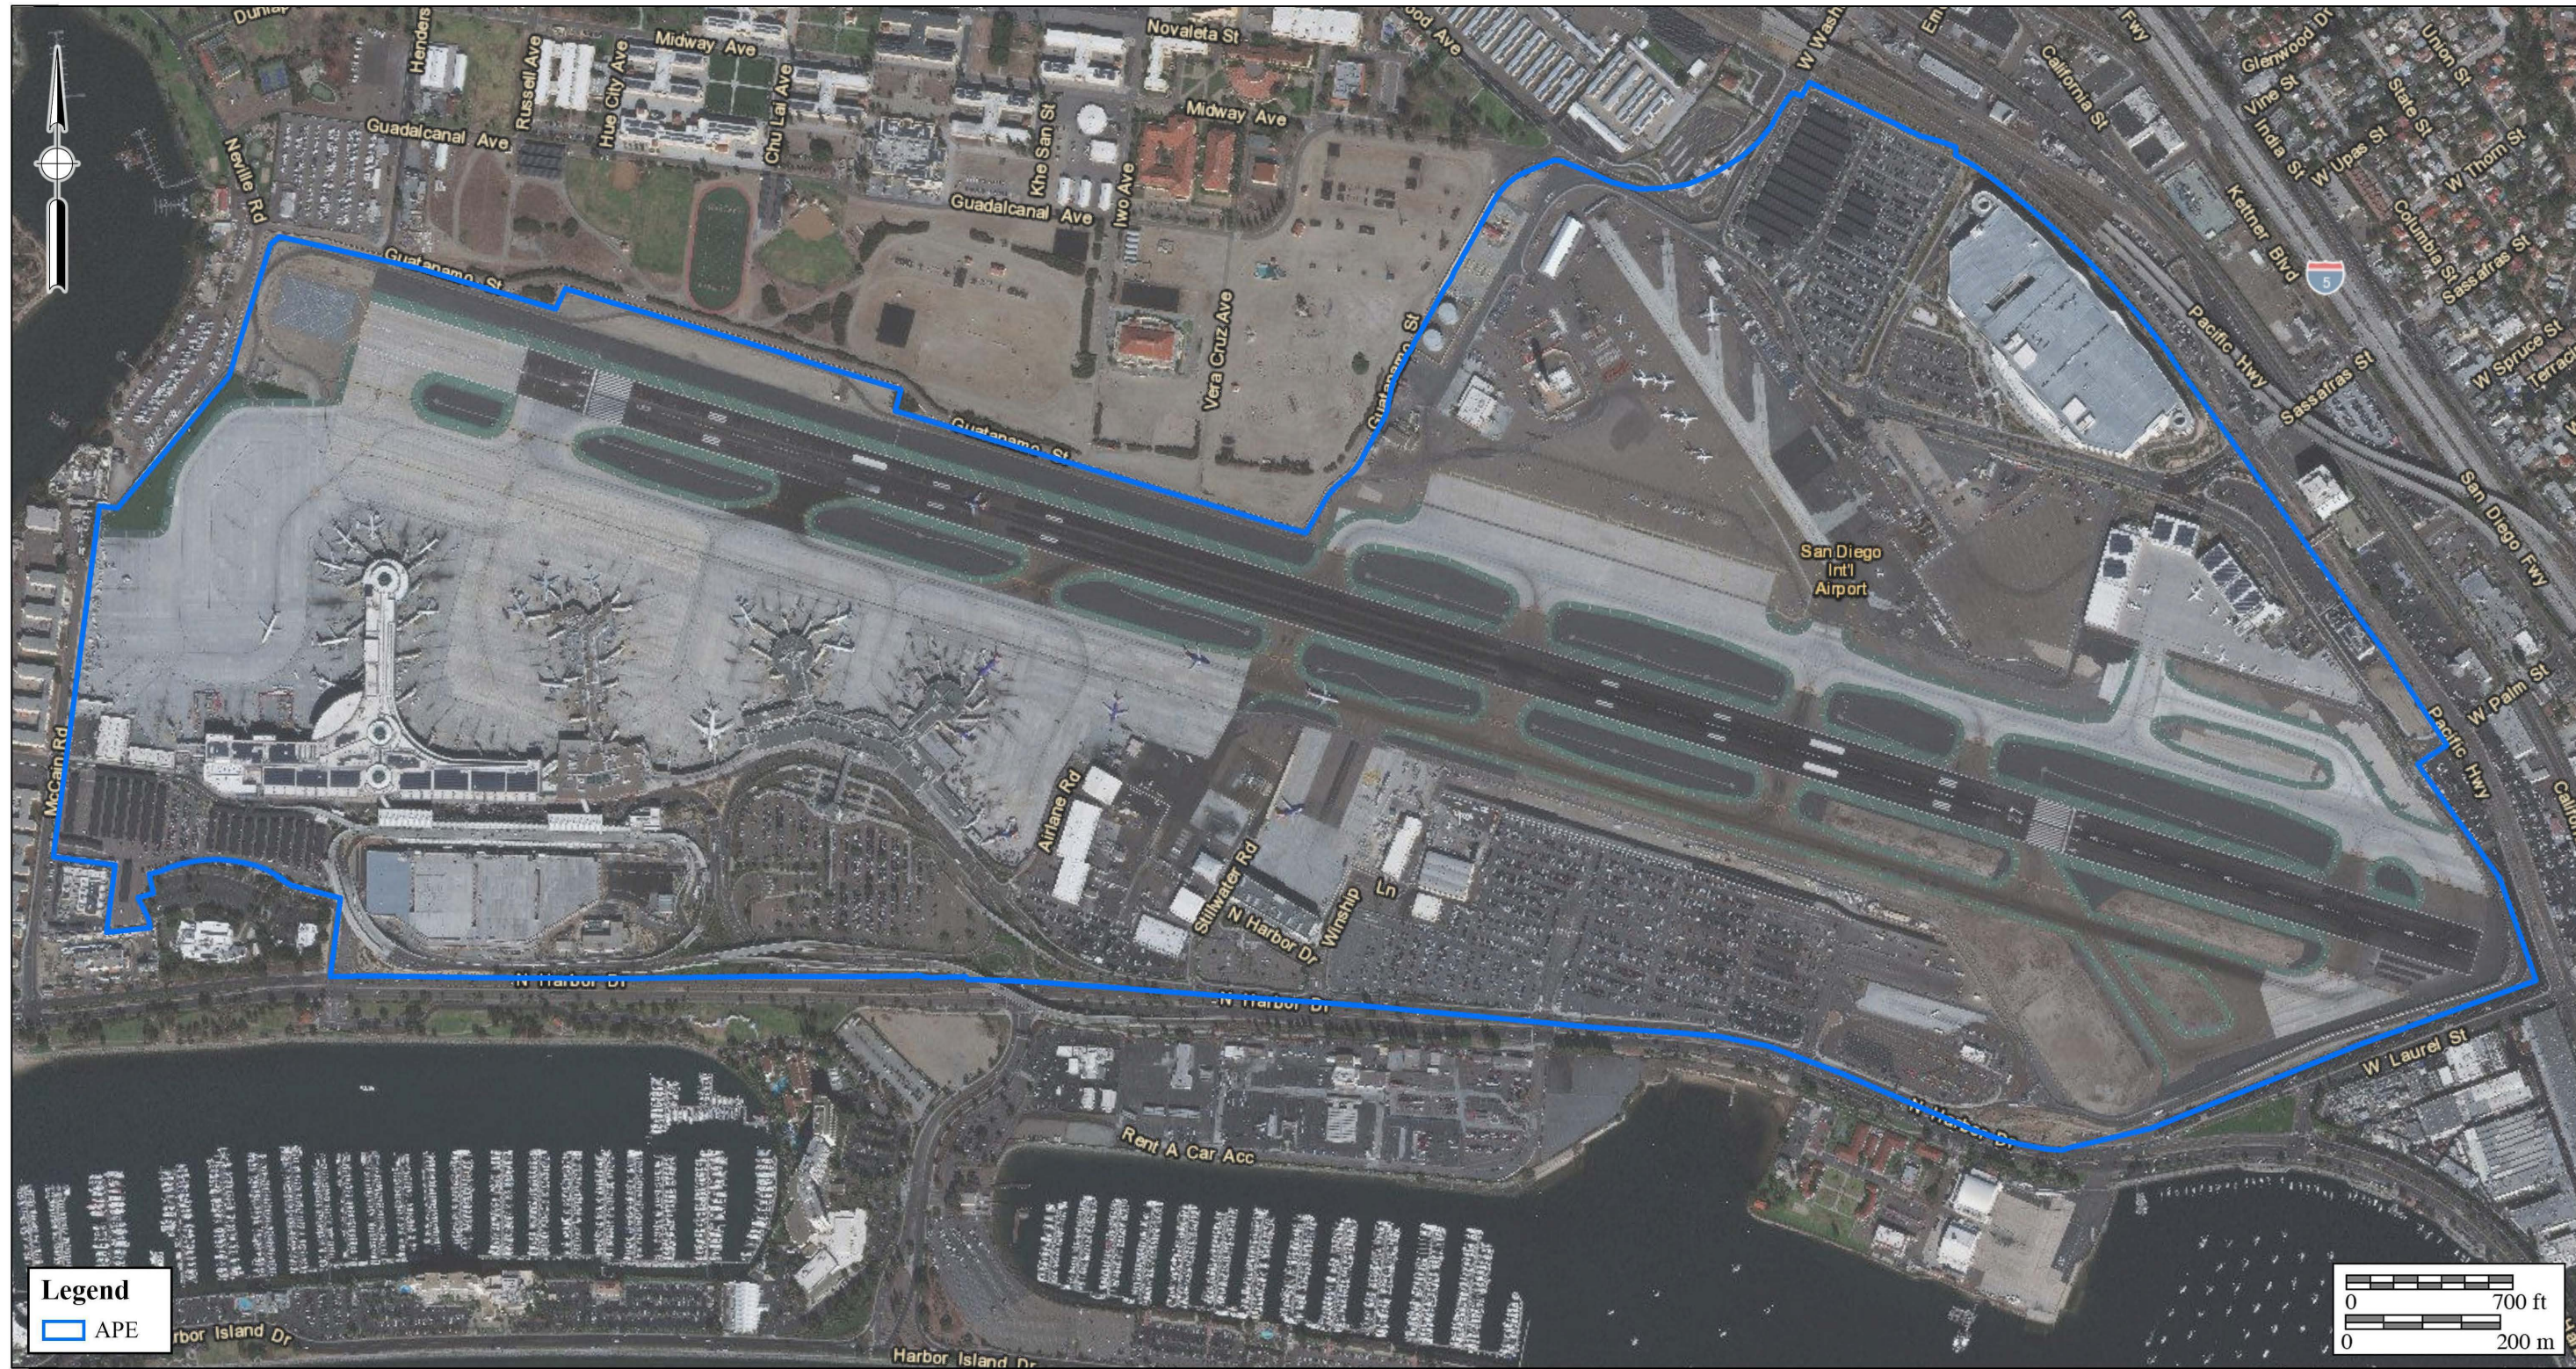
**Figure 3.0-3**  
**Area of Potential Effect**  
 The SAN Airfield Improvements and Terminal 1 Replacement Project

The APE, which corresponds to the SAN property boundary, is situated north of Harbor Drive and is bound by McCain Road to the west, West Laurel Street to the southeast, Pacific Highway to the east and northeast, and Admiral Boland Way and Guantanamo Street to the north in the city of San Diego, San Diego County, California (Figure 3.0-1). The site is located in the former Pueblo Lands of San Diego, as shown on the 7.5-minute USGS *Point Loma, California* topographic quadrangle, Township 17 South, Range 3 West (Figure 3.0-2). The APE, which has been defined as the entire 661-acre airport property, is located on reclaimed tidelands where fill soil was deposited in the 1930s and 1940s during dredging of San Diego Bay (Figure 3.0-3).

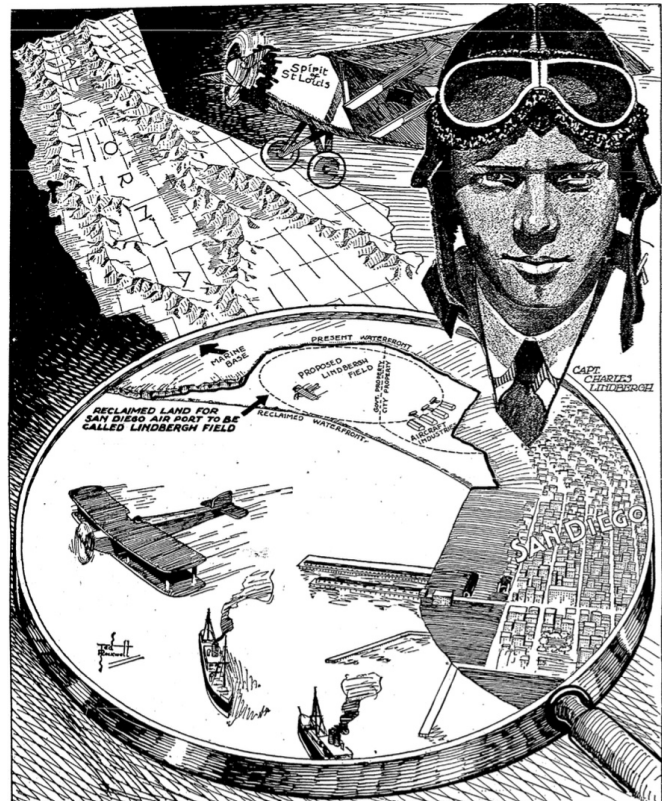
**Plate 5.4–1: A stylized drawing of Lindbergh Field with the Spirit of Saint Louis and Charles Lindbergh prominently featured.**  
(Illustration courtesy of *San Diego Union* 1927)

Prior to construction, much of present-day Lindbergh Field consisted of a mud flat that was covered by water during high tides. The original design for the airport consisted of a 3,000-foot-diameter, circular runway (Plate 5.4–1) (*San Diego Union* 1927). The executed airport design would end up consisting of 287 acres, 105 of which belonged to the City and 182 of which belonged to the United States Marine Corps (URS Corporation 2009a).

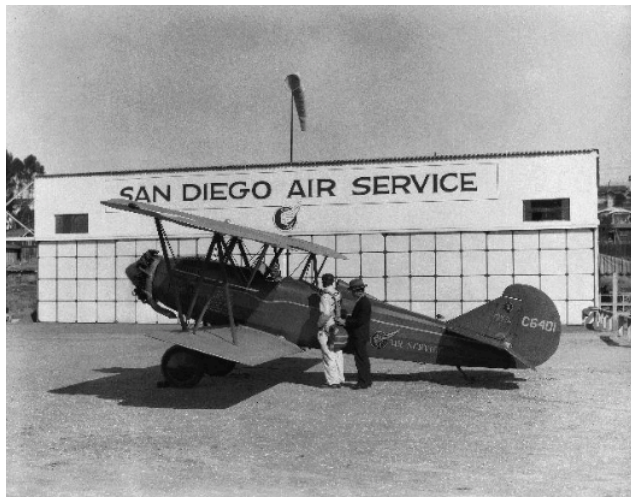
**Plate 5.4–2: The San Diego Air Service hangar in 1930. (Photograph courtesy of the San Diego History Center)**

A building permit was issued on August 21, 1928 for construction of the San Diego Air Service hangar by National Iron Works on the “Municipal Tidelands” (*San Diego Union* 1928d). The hangar was completed in September of 1928 (Pescador et al. 2012) (Plate 5.4–2). In May 1929, the San Diego Air Service began aerial taxi flights to

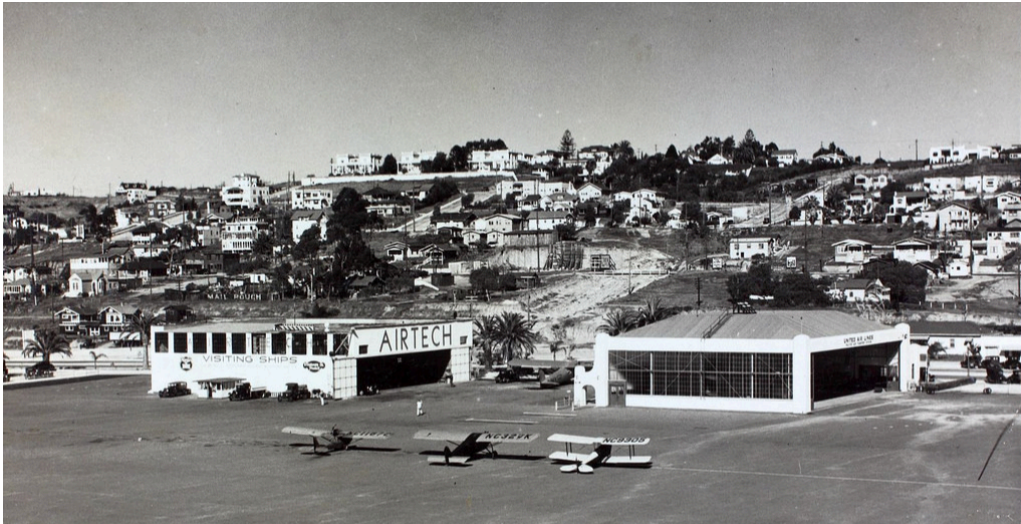
**Plate 5.4–3: Airtech hangar and the Pacific Air Transport/United Airlines Terminal circa 1931 to 1932. (Photograph courtesy of the San Diego Air and Space Museum)**

In March of 1929, San Diego Air Service expanded their flying activities to include the Airtech Training School (Plate 5.4–3) (*San Diego Union* 1929a), which offered a commercial pilot’s course, a private pilot’s course, and a transport pilot’s course. Combined, these three courses would qualify students for their pilot’s license. Between 1928 and 1932, 254 students attended the Airtech Training School (*San Diego Union* 1932a). The hangar was later leased by the Nelson-Kelley Co. in the 1940s.

The second building constructed at Lindbergh Field was the Pacific Air Transport (PAT) hangar and terminal in 1931, which was located just south of the Airtech hangar (see Plate 5.4–3). A dedication ceremony commemorating the completion of the new building was held on May 28, 1931. Starting with a 7:30 a.m. flight, the first of the “Daylight Flyer” service from San Diego to Seattle, the day featured “a full program of events

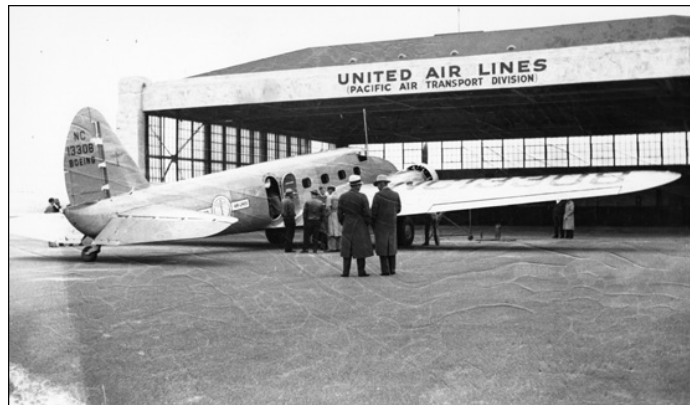
**Plate 5.5–1: United Airlines hangar and terminal in 1934. (Photograph courtesy of the San Diego Air and Space Museum)**

... including a public dance in the new P.A.T. hangar” (*San Diego Union* 1931a). The new building featured a hangar, a passenger corridor on the north side of the hangar, and an attached office with restrooms, ticket offices, and a waiting room. Four days after the ceremony, it was announced that PAT, National Air Transport, Boeing Air Transport, and Varney Airlines would be consolidated and designated as divisions of United Airlines (*San Diego Union* 1931b). The PAT hangar building was thereafter referred to as the United Airlines hangar and terminal (Plate 5.5–1). Prior to the construction of the United Airlines hangar and terminal, the airport did not have a ticket office, as between 1929 and 1931, a square pilot house from a tugboat located to the west of the Airtech hangar served as a ticket booth (Van Wormer and Robbins-Wade 2006).

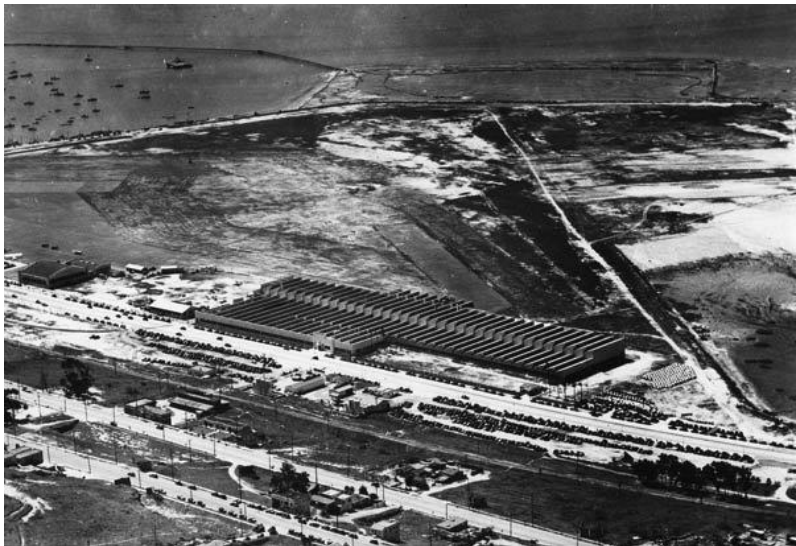
**Plate 5.6–1: Consolidated Aircraft Corporation plant in November of 1935. Note the Ryan School of Aeronautics hangar to the left. (Photograph courtesy of the San Diego Union Tribune)**

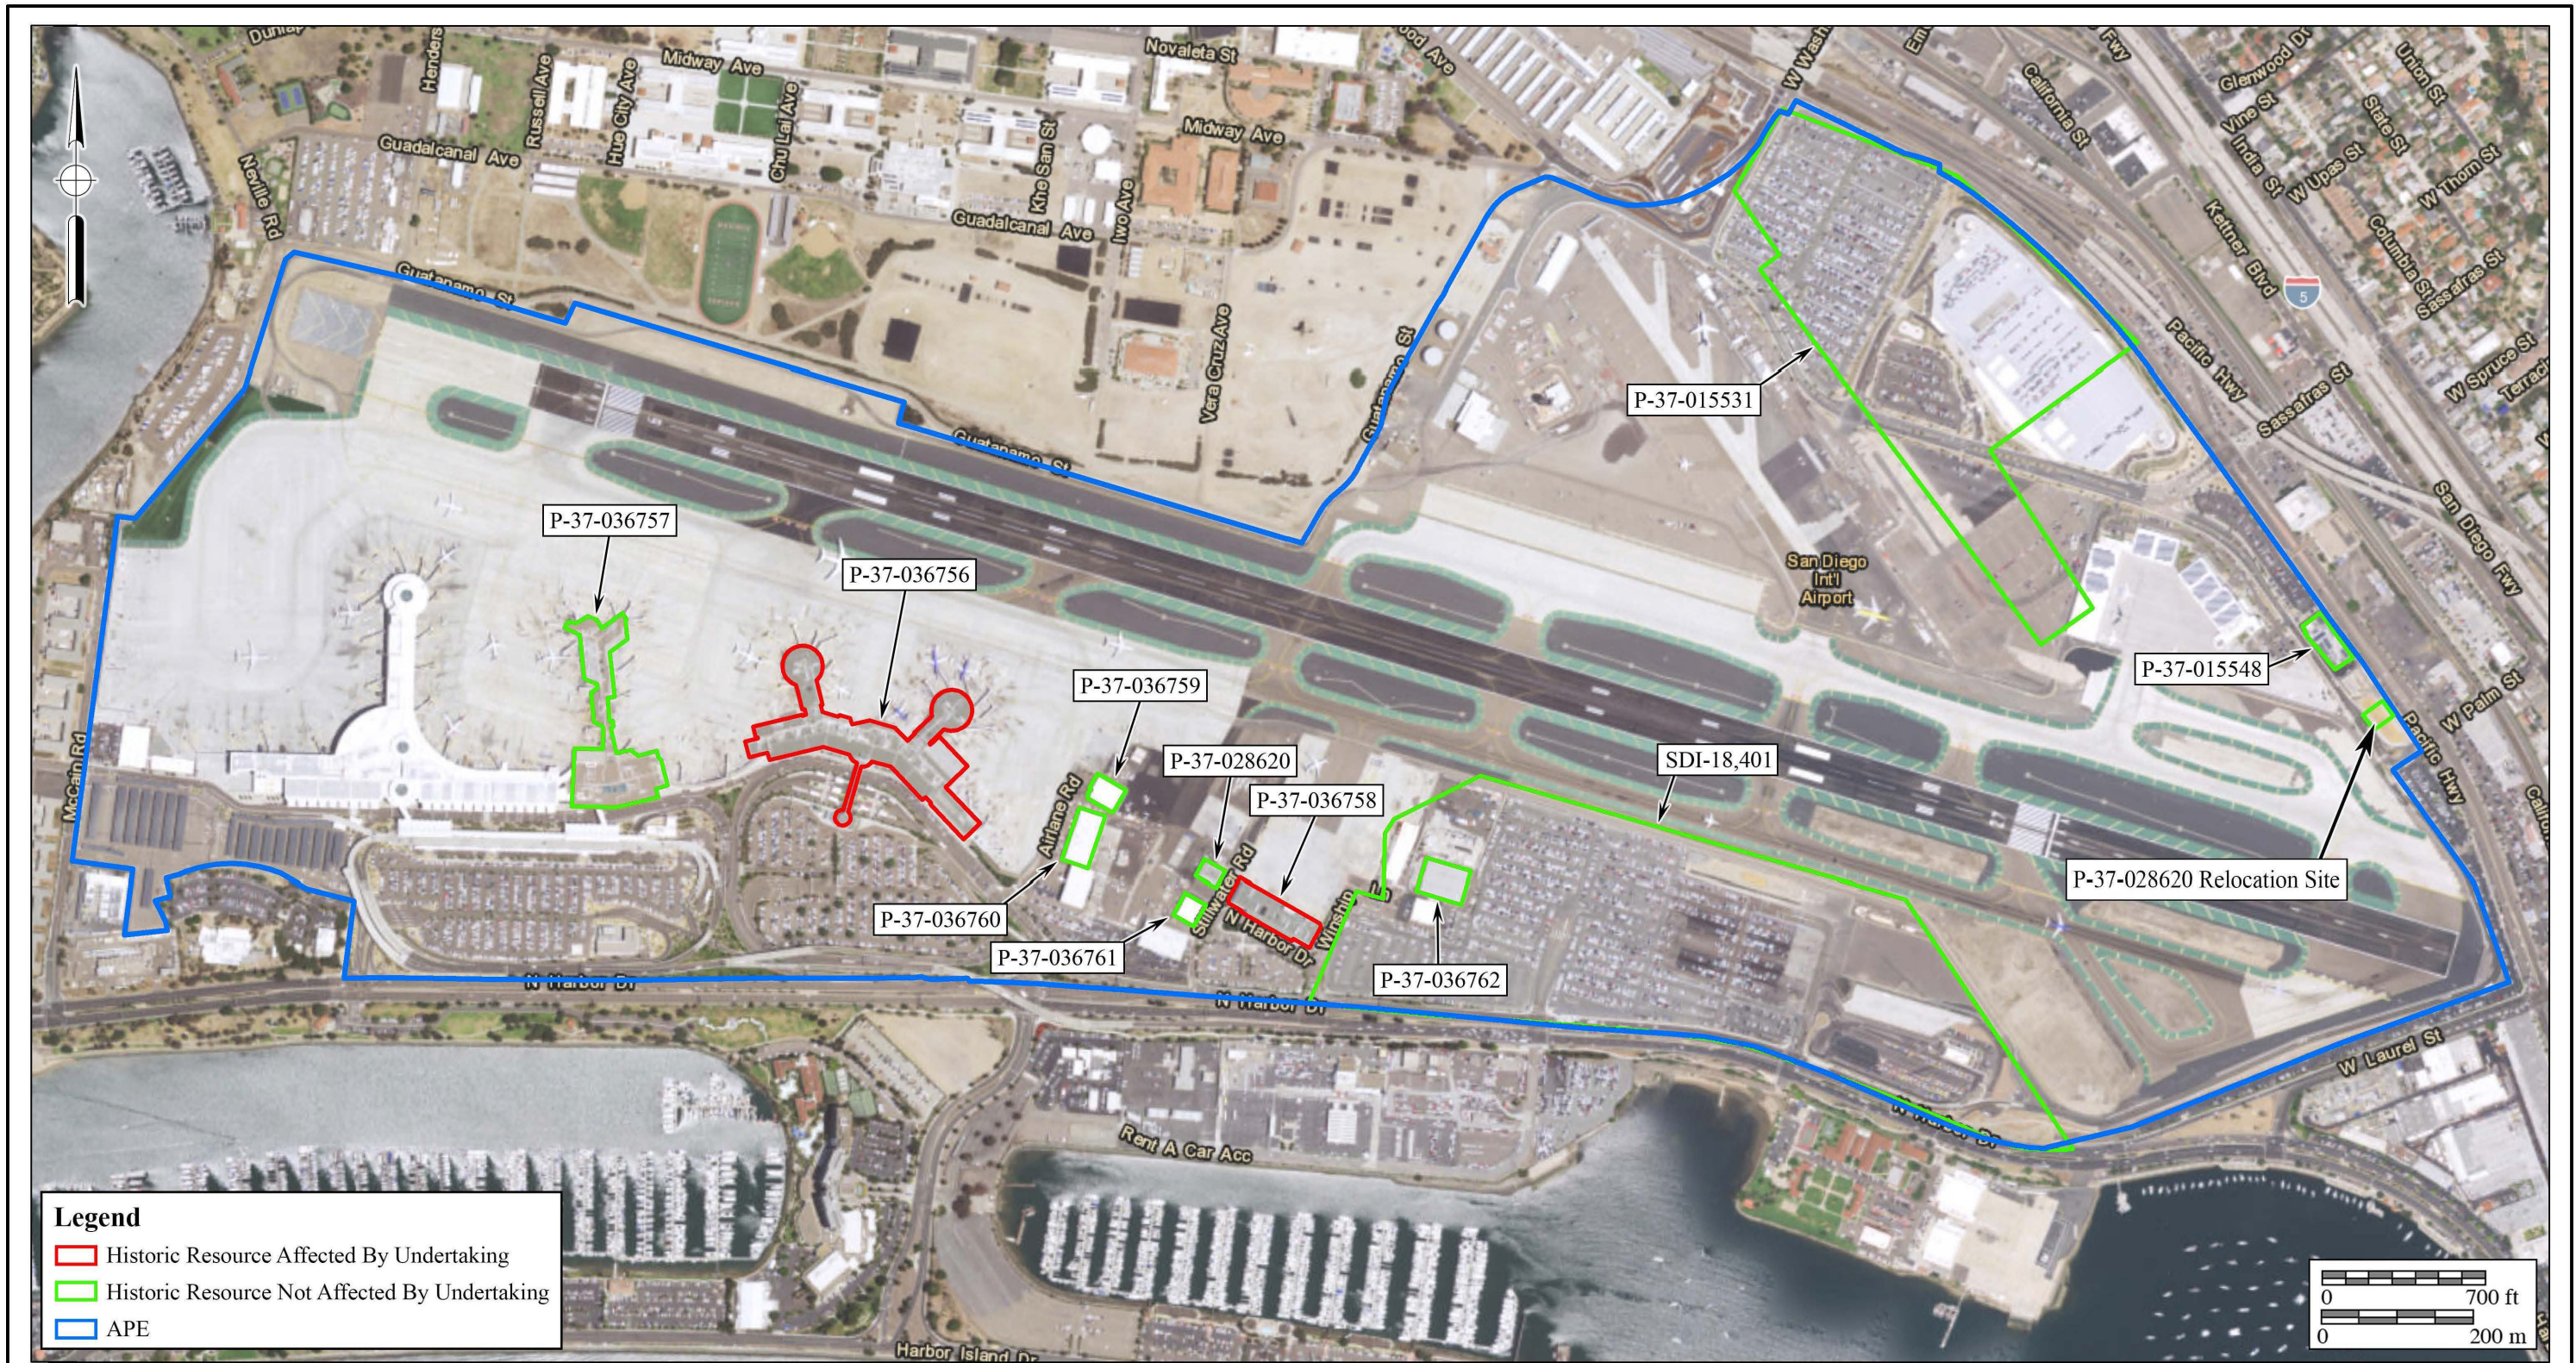
**Figure 6.0-1**  
**Historic Resource Location Map**  
 The SAN Airfield Improvements and Terminal 1 Replacement Project

During the survey, seven unrecorded historic resources (Terminal 1, Terminal 2 East, and the PSA AMF, UAF, ASF, AOH, and JEO buildings) were identified and two previously recorded historic resources (the CWT and UAHT buildings) were confirmed to still be extant within the APE. Consolidated Aircraft Plant No. 1 (historic district) and the Ryan Aeronautical Company Historic District, which are recorded within the APE, have since been demolished. See Figure 6.0–1 for all historic resources identified within the APE. The UAF, ASF, AOH, UAHT, and JEO buildings, however, would be demolished or relocated by the separate and independent SAN ASF improvement program. Any relocated building will be outside of the construction footprint for the proposed undertaking. In addition, the CWT building and Terminal 2 East will not be affected by the proposed undertaking as both are located outside of the development footprint. Therefore, Terminal 2 East and the CWT, UAHT, UAF, ASF, AOH, and JEO buildings will not be physically affected by the undertaking. The four buildings that will be demolished prior to the undertaking (the UAF, ASF, AOH, and JEO buildings) will not be discussed or evaluated as part of this study.

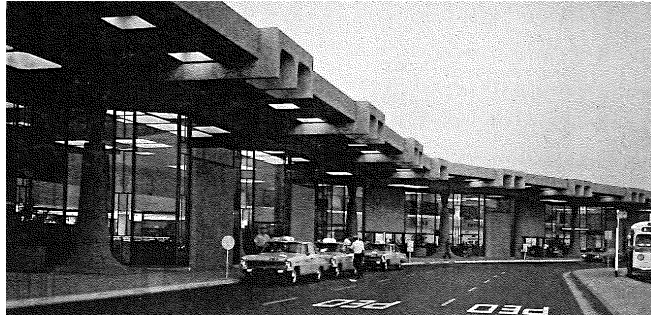
**Plate 6.1–4: View of Terminal 1 (Section A) in 1967. (Photograph courtesy of San Diego Unified Port District 1966-1967)**

The primary (south) façade of Section A remains the same today as when it was built in 1967 (Plates 6.1–4 through 6.1–6). Section A has an irregular-shaped footprint, a flat roof, and is comprised of a main crescent-shaped portion with two concourse wings that project off the eastern and western portions of the north façade. The crescent-shaped portion of Section A is positioned on an east-west axis. The two wings form separate concourses that each terminate at two identical rotundas. The primary (south) façade of Section A provides public access to the terminal under a wide overhang supported by 18 evenly spaced, poured-concrete columns. The columns taper toward the top where they reach their narrowest point and reveal structural steel (Plate 6.1–7). When constructed, the wide overhang was entirely comprised of concrete (Plate 6.1–8); however, it currently features a mixture of vinyl and concrete (Plate 6.1–9).

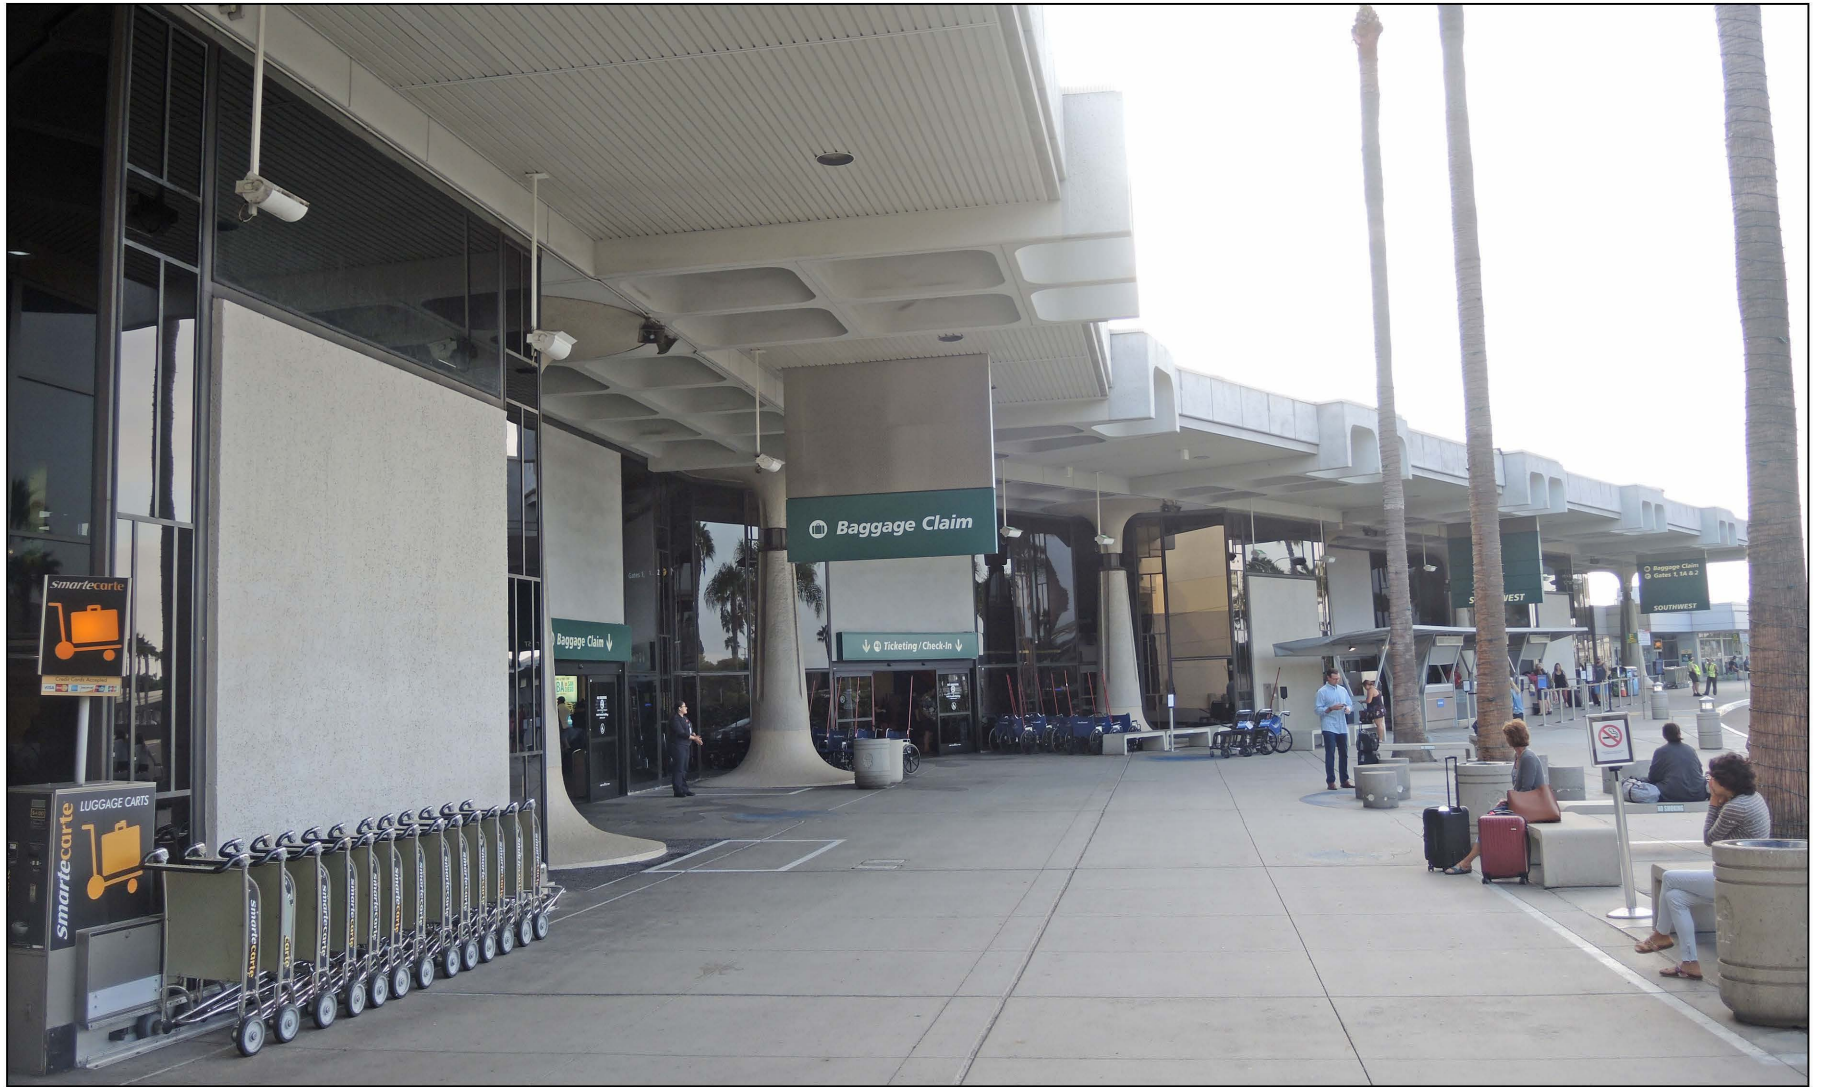
**Plate 6.1-6**  
**View of the Primary (South) Façade of Section A, Facing East**  
The SAN Airfield Improvements and Terminal 1 Replacement Project

The only modifications made to the primary (south) façade of Section A since 1967 include those on the east and central portions of the main crescent-shaped building. At an unknown date, the single band of windows that was present in 1967 (see Plate 6.1–5) was removed and replaced with a glass wall of fixed-pane windows with metal trim (Plate 6.1–10). In 1997, Section B, a smooth concrete and metal sky bridge (Plate 6.1–11), which was designed by SGPA Architecture and Planning (SGPA), was constructed off of a new two-story rectangular structure (Plate 6.1–12) on the central portion of the primary (south) façade of Section A to allow pedestrians easy access to a parking area across the street on the south side of the passenger loading zone.

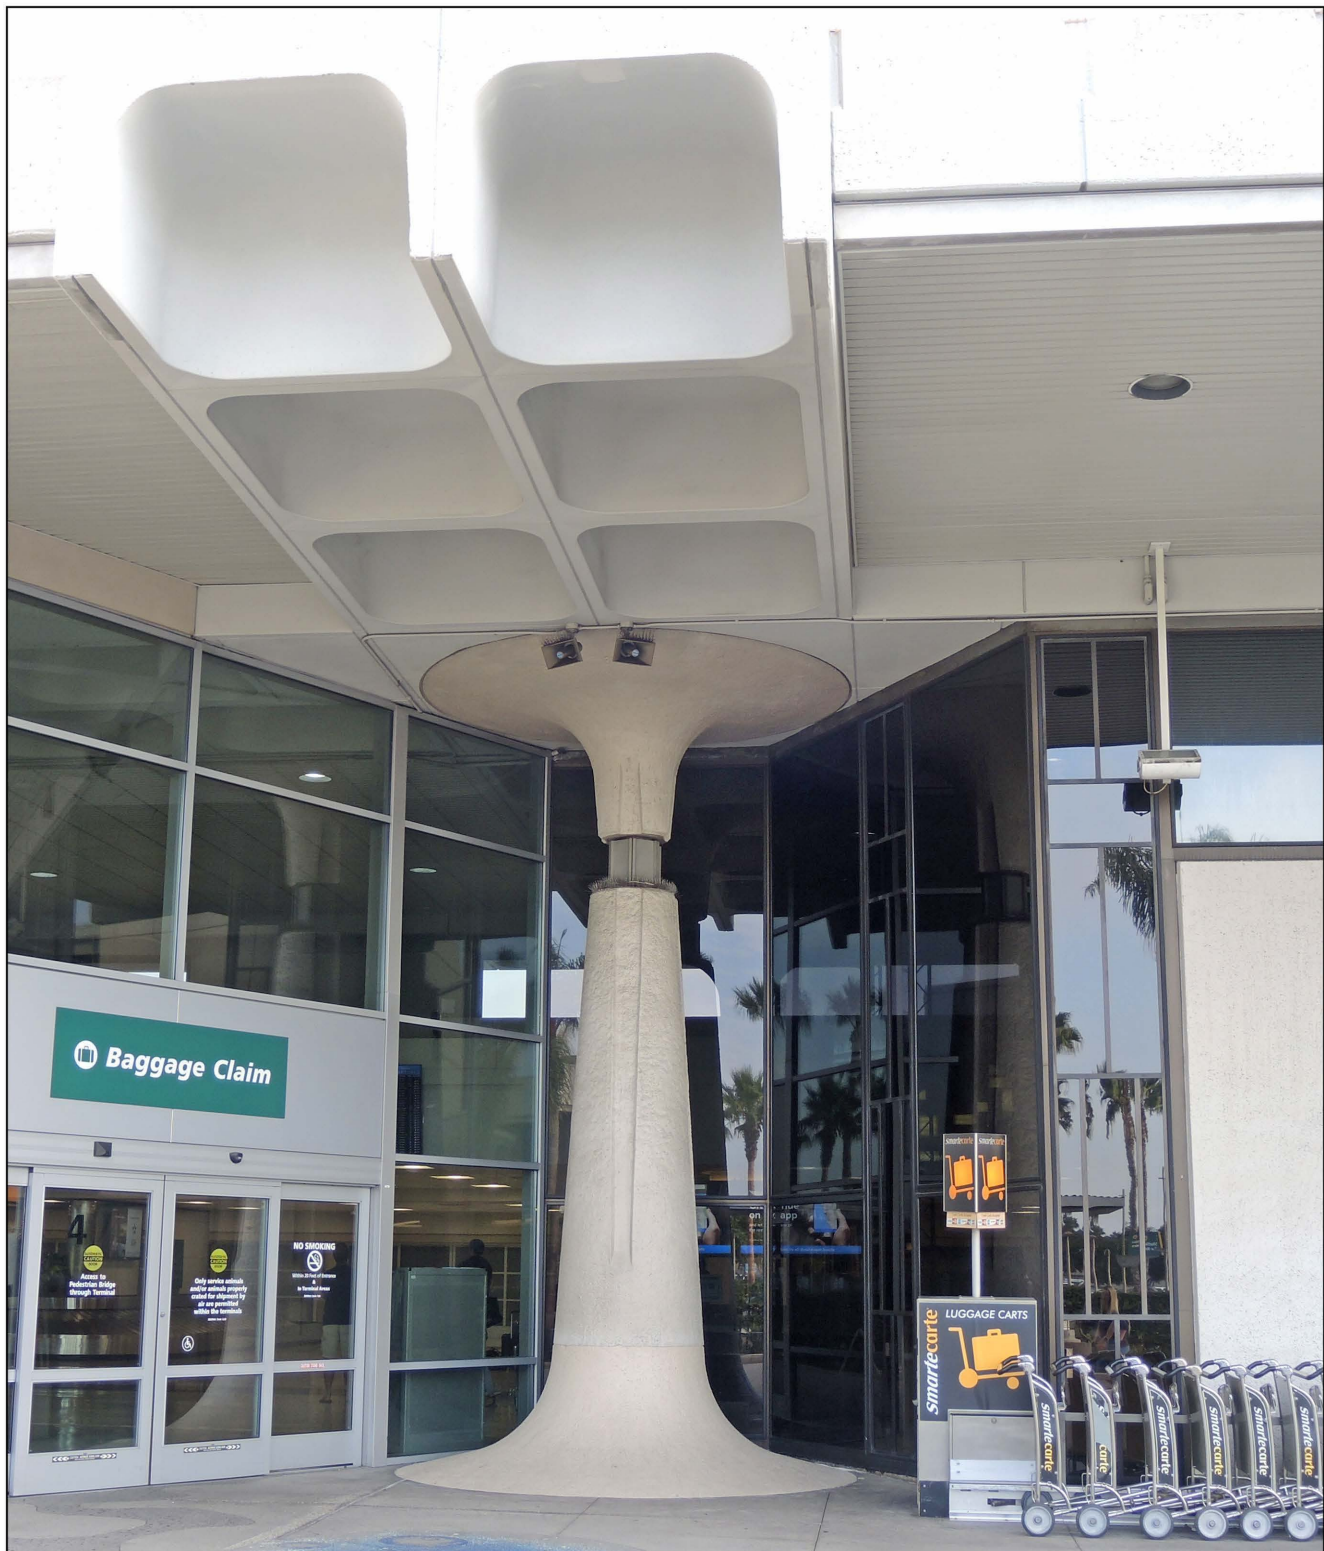
**Plate 6.1-7**

**One of the 18 Support Columns on the Primary  
(South) Façade of Section A, Facing Northeast**
