**Section 106 Assessment for the San Diego International Airport Airfield  
Improvements and Terminal 1 Replacement Project**

**SECTION 106 ASSESSMENT FOR THE  
SAN DIEGO INTERNATIONAL AIRPORT  
AIRFIELD IMPROVEMENTS AND  
TERMINAL 1 REPLACEMENT PROJECT**

**CITY OF SAN DIEGO, CALIFORNIA**

***November 10, 2020; Revised January 8, 2021; Revised February 19, 2021;  
Revised March 12, 2021; Revised April 27, 2021; Revised May 7, 2021***

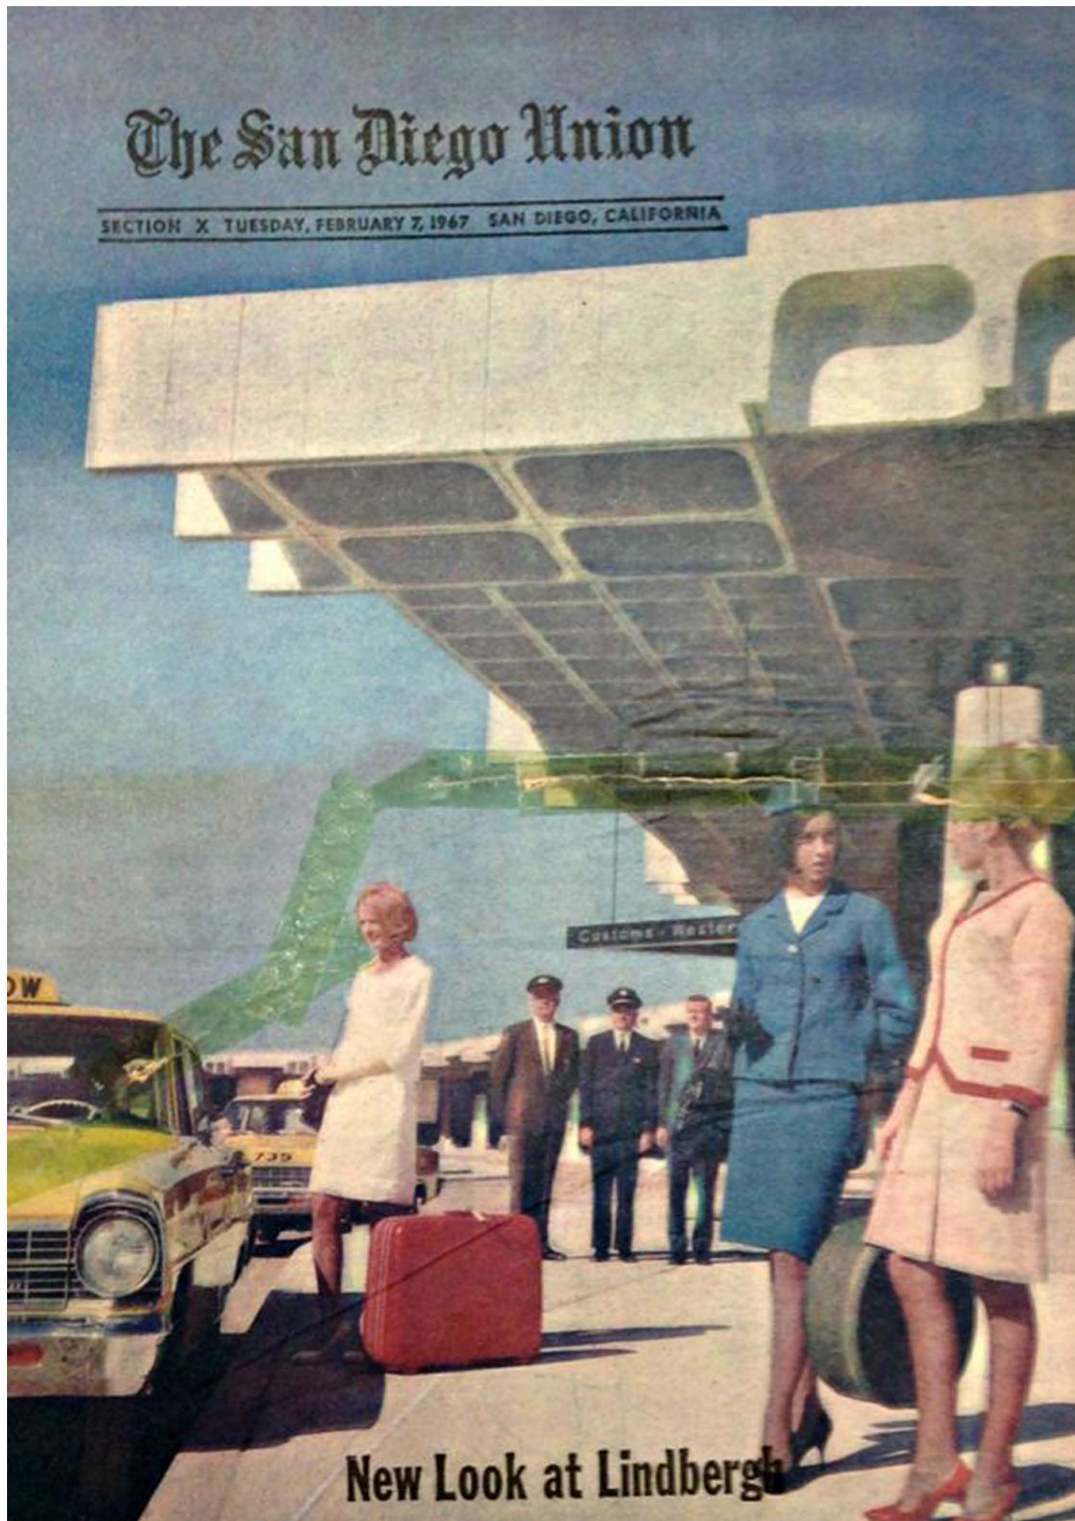
**Plate 6.1-8**

**1967 *San Diego Union* Cover Showing the Concrete Waffle-Slab Roof System Under the Primary (South) Façade Roof Overhang of Section A, Facing West**  
The SAN Airfield Improvements and Terminal 1 Replacement Project

The primary (south) façade of Section A remains the same today as when it was built in 1967 (Plates 6.1–4 through 6.1–6). Section A has an irregular-shaped footprint, a flat roof, and is comprised of a main crescent-shaped portion with two concourse wings that project off the eastern and western portions of the north façade. The crescent-shaped portion of Section A is positioned on an east-west axis. The two wings form separate concourses that each terminate at two identical rotundas. The primary (south) façade of Section A provides public access to the terminal under a wide overhang supported by 18 evenly spaced, poured-concrete columns. The columns taper toward the top where they reach their narrowest point and reveal structural steel (Plate 6.1–7). When constructed, the wide overhang was entirely comprised of concrete (Plate 6.1–8); however, it currently features a mixture of vinyl and concrete (Plate 6.1–9).

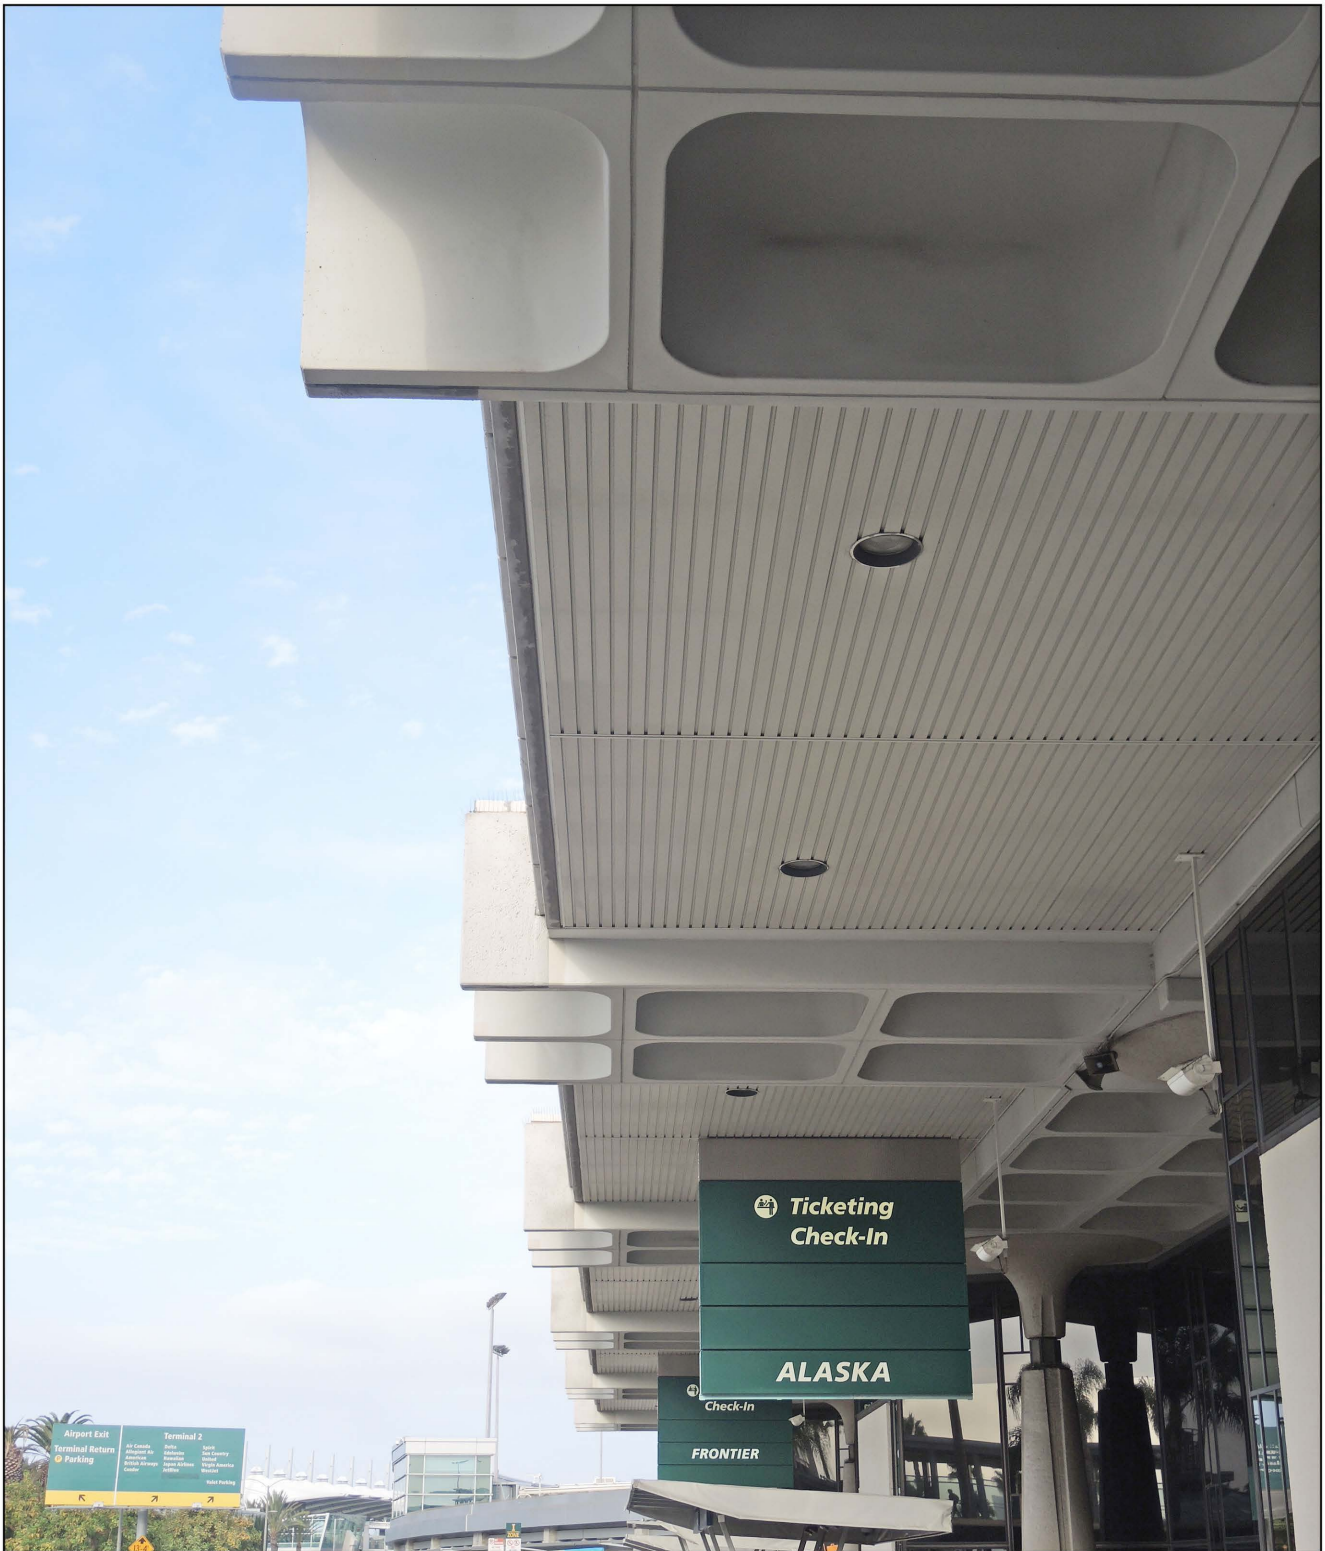
**Plate 6.1–9**

**Current View of the Mixed Concrete Waffle-Slab and Vinyl Roof System  
Under the Primary (South) Façade Roof Overhang of Section A, Facing West  
The SAN Airfield Improvements and Terminal 1 Replacement Project**

Integrity of materials was assessed by determining the presence or absence of original building materials, as well as the possible introduction of materials, which may have altered the architectural design of the building. The installation of Section B (the sky bridge) in the center of the primary (south) façade of Section A and the replacement of original windows on the east portion of the façade added modern materials; however, both modifications conform to the Secretary of the Interior's Standards for Rehabilitation, and the use of modern metal panels and large pieces of glass differentiate the additions from the original building without mimicking or impacting the original design. The introduction of these newer elements did not impact the original building materials. The only new material that did alter the original building is the vinyl soffit that was installed on the underside of the cantilevered overhang. This minimal change, however, has not altered the architectural design, and therefore, the primary (south) façade of Section A retains integrity of materials. The east, north, and west façades of Terminal 1 have been significantly altered since 1967, which impacted original building materials. Although attempts were made to mimic the materials of the original heavy concrete and glass on the west, north, and east façades, Sections C through L are composed of different materials and represent different building technologies. Therefore, the east, north, and west façades of Terminal 1, and therefore the building as a whole, do not retain integrity of materials.

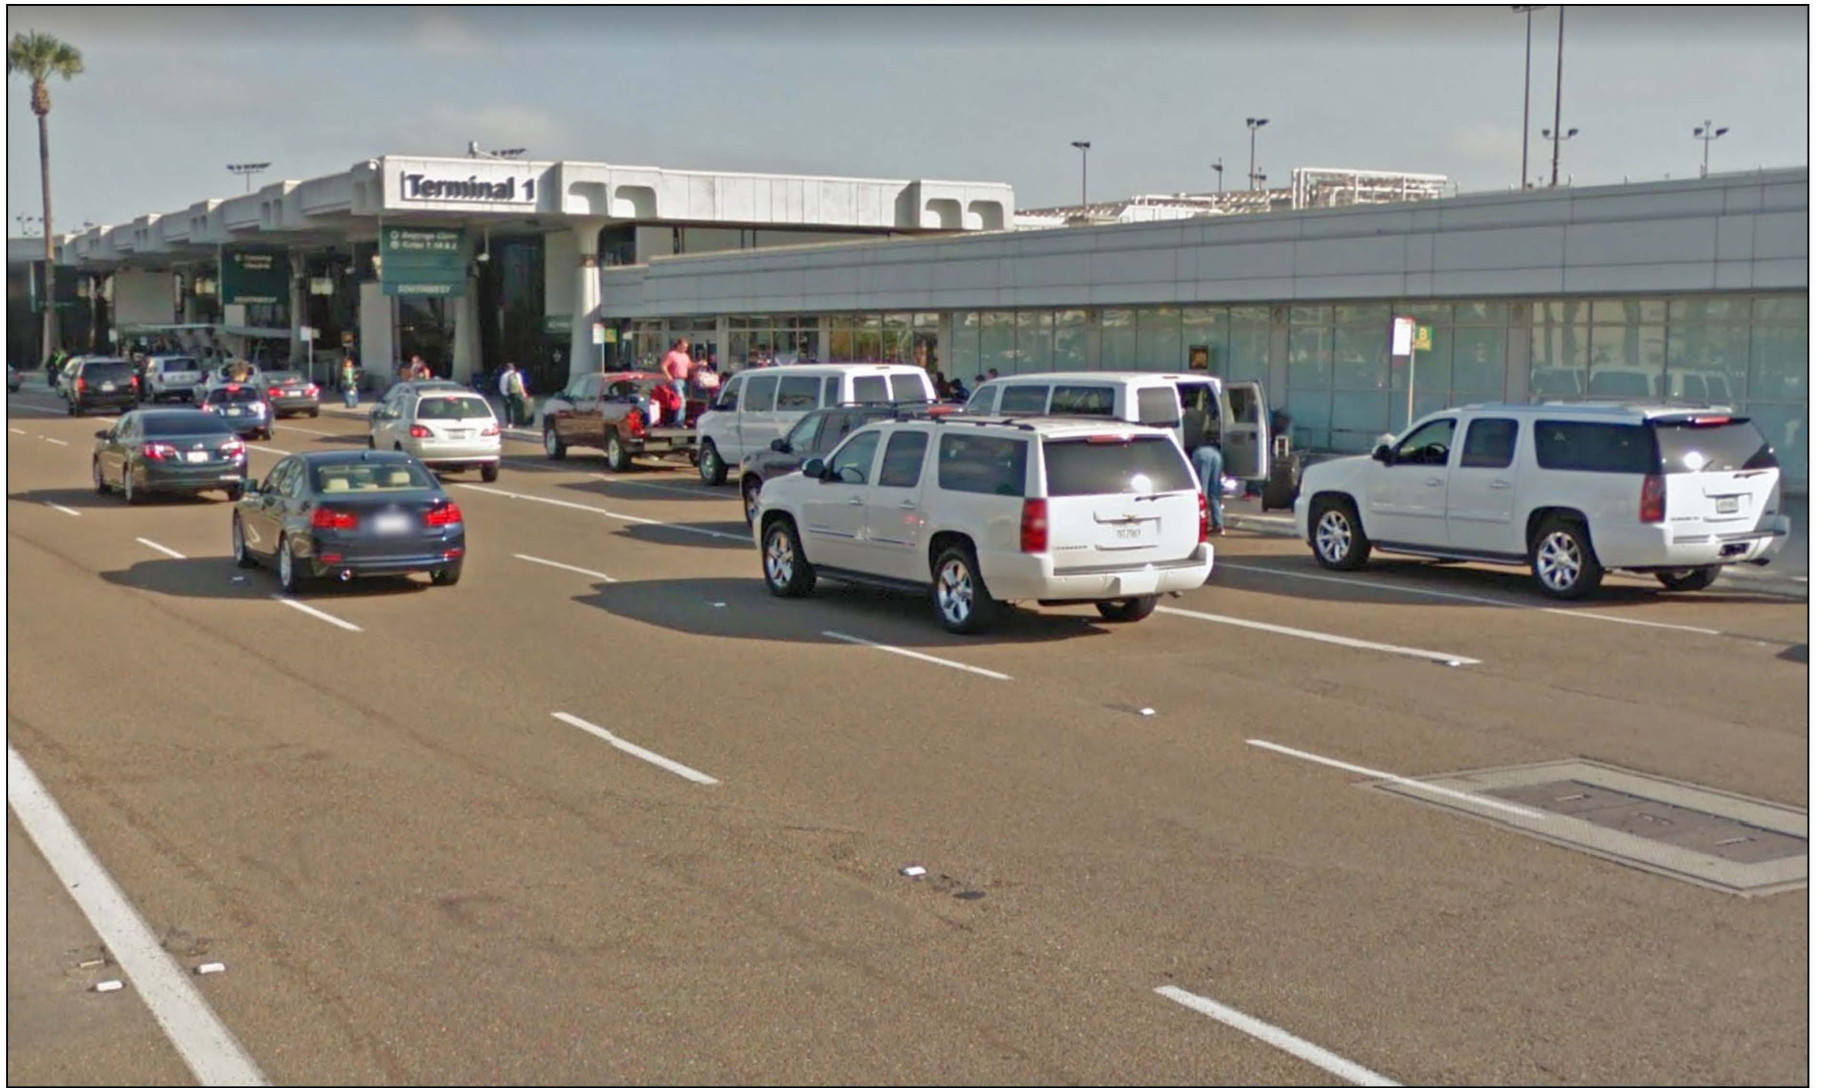
**Plate 6.1-10**

**2015 View of the East Portion of the Primary (South) Façade of Section A  
(Right) Showing the New Glass Wall of Fixed-Pane Windows, Facing Northwest**

The only modifications made to the primary (south) façade of Section A since 1967 include those on the east and central portions of the main crescent-shaped building. At an unknown date, the single band of windows that was present in 1967 (see Plate 6.1–5) was removed and replaced with a glass wall of fixed-pane windows with metal trim (Plate 6.1–10). In 1997, Section B, a smooth concrete and metal sky bridge (Plate 6.1–11), which was designed by SGPA Architecture and Planning (SGPA), was constructed off of a new two-story rectangular structure (Plate 6.1–12) on the central portion of the primary (south) façade of Section A to allow pedestrians easy access to a parking area across the street on the south side of the passenger loading zone.

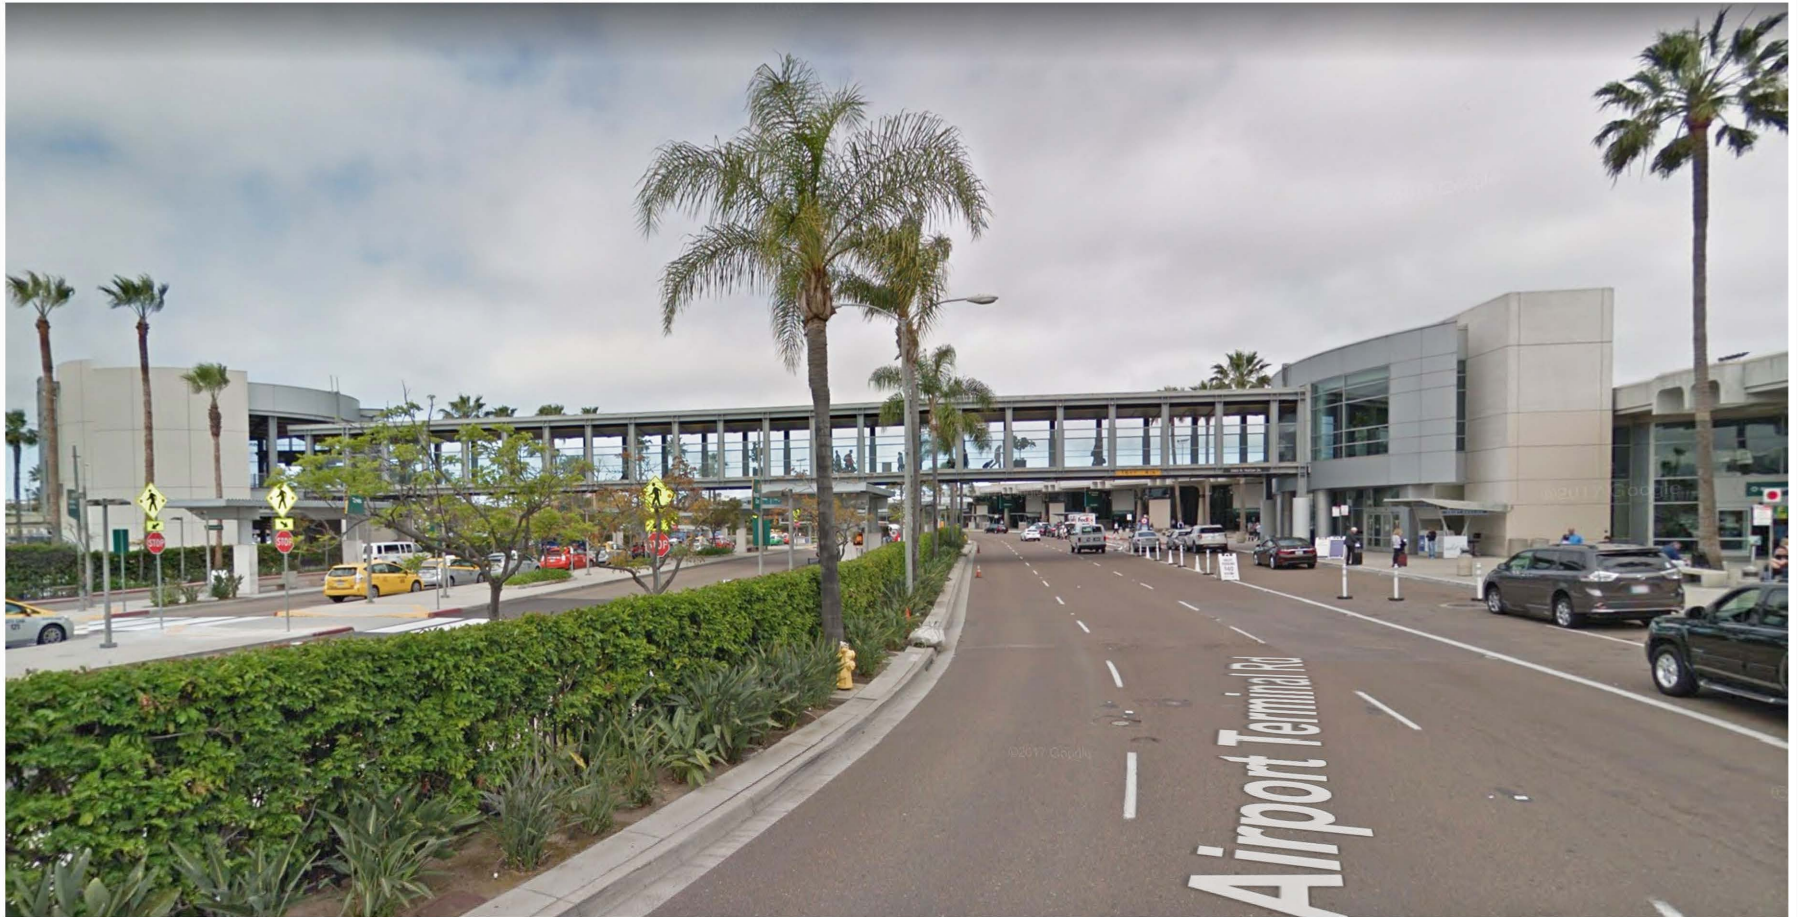
**Plate 6.1-11**

**View of Section B Extending Off the Primary  
(South) Façade of Section A, Facing West**

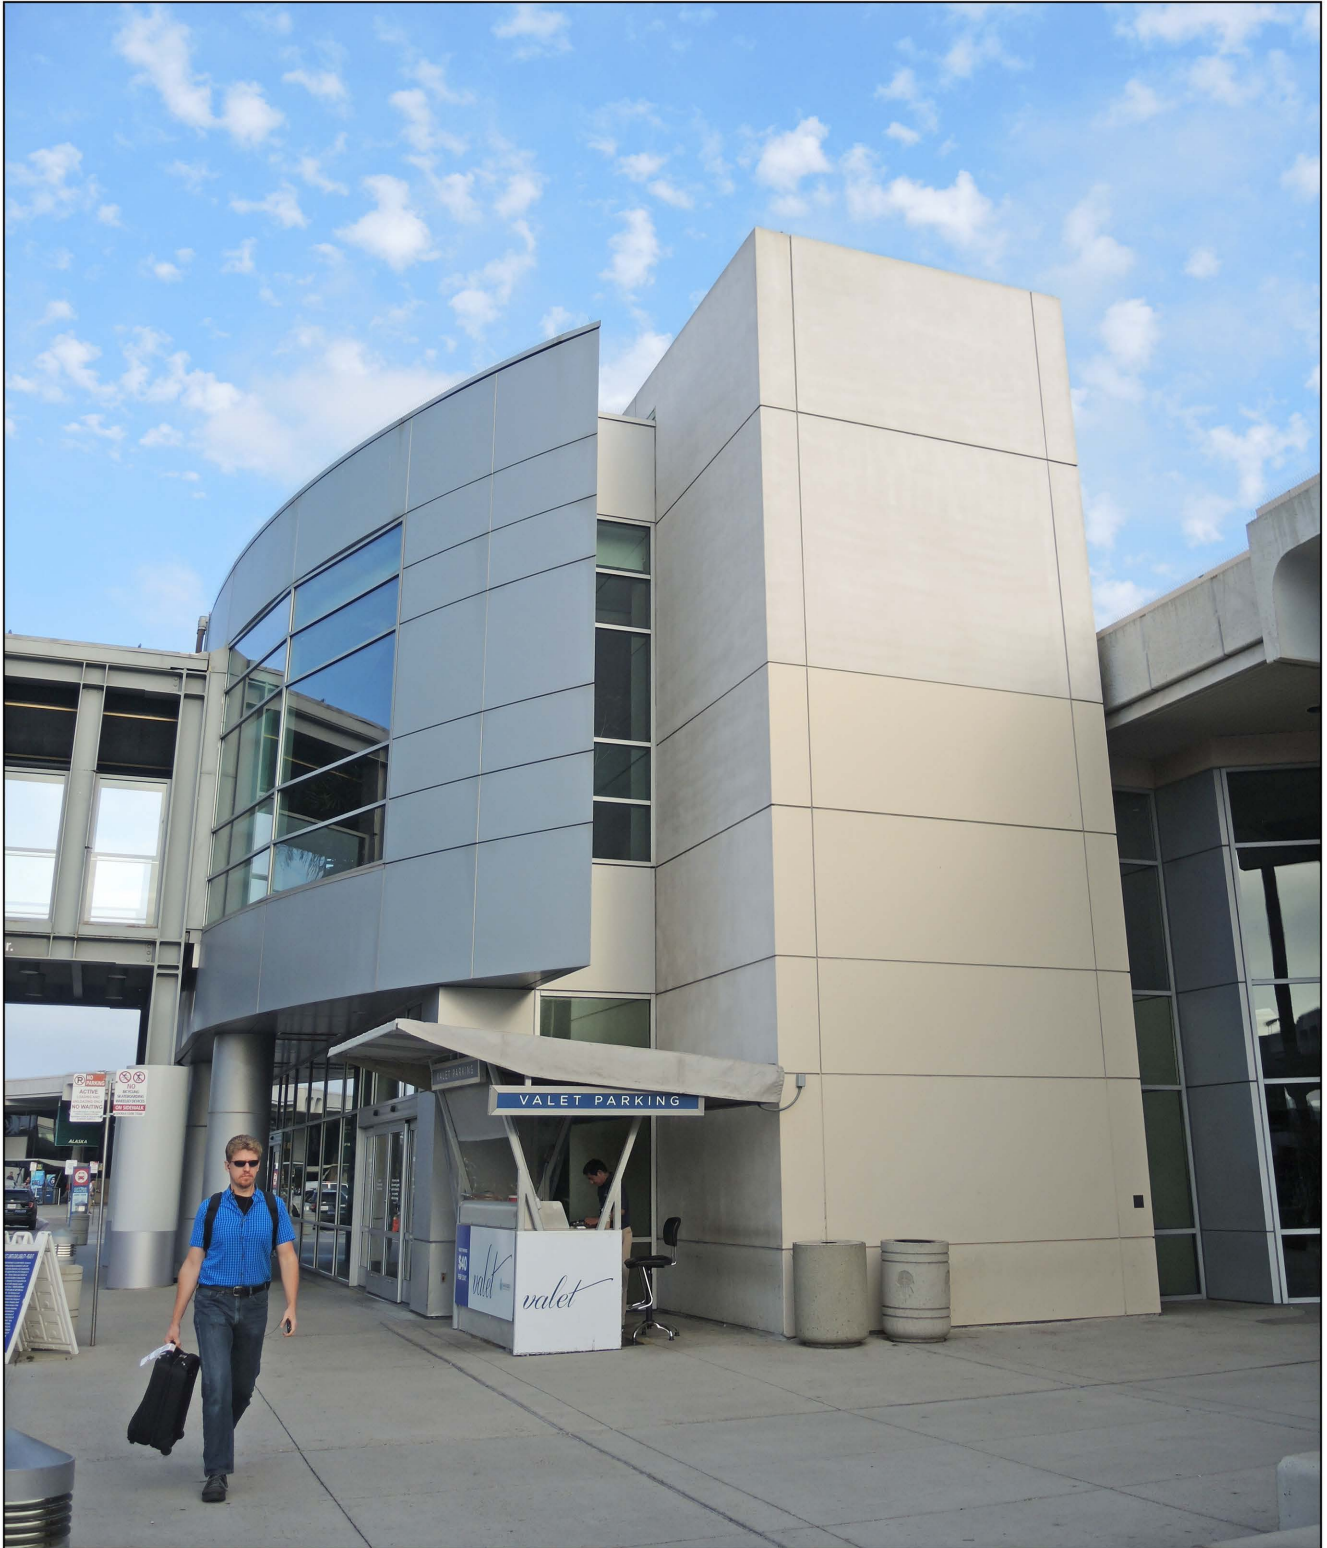
**Plate 6.1–12**

**View of the Two-Story Connecting Structure (Section B)  
on the Primary (South) Façade of Section A, Facing West**  
The SAN Airfield Improvements and Terminal 1 Replacement Project

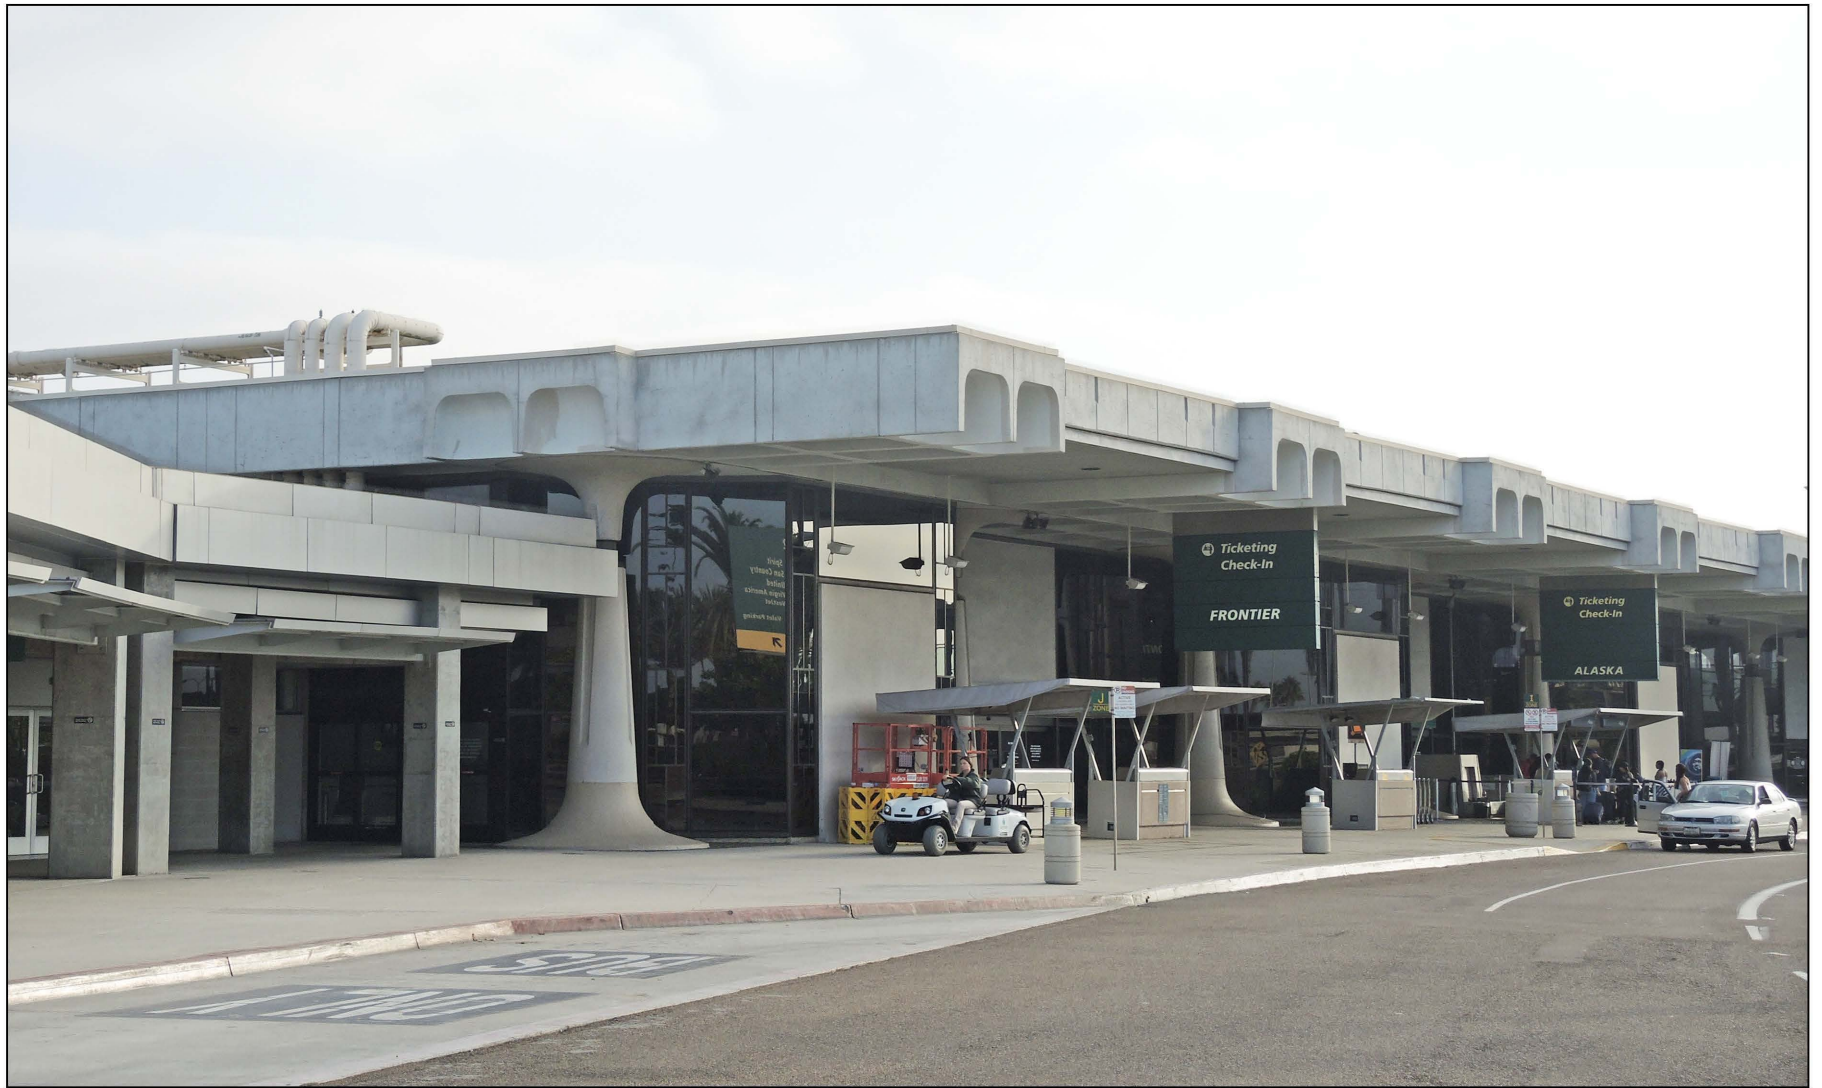
**Plate 6.1-13**  
**View of the West Façade of the Section A, Facing Northeast**  
The SAN Airfield Improvements and Terminal 1 Replacement Project

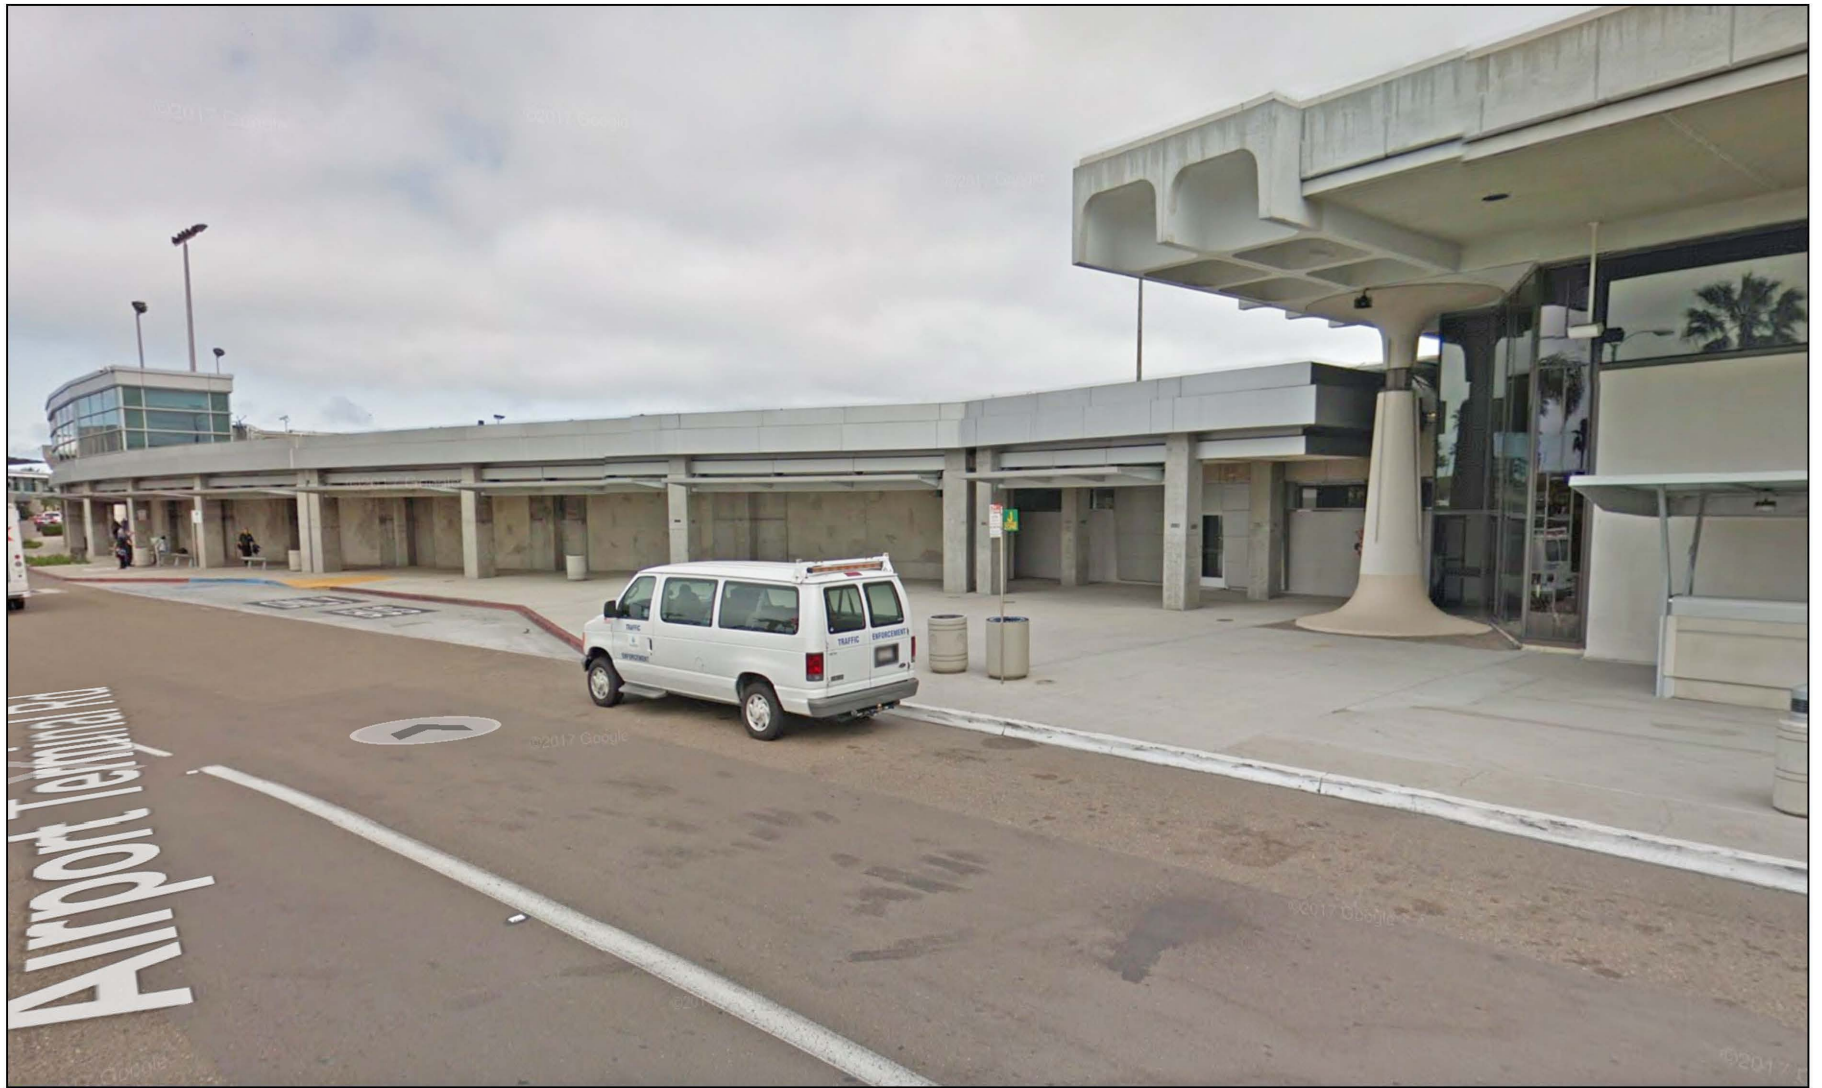
**Plate 6.1-14**

**View of Section C Leading From  
Terminal 1 to Terminal 2 East, Facing Southwest**

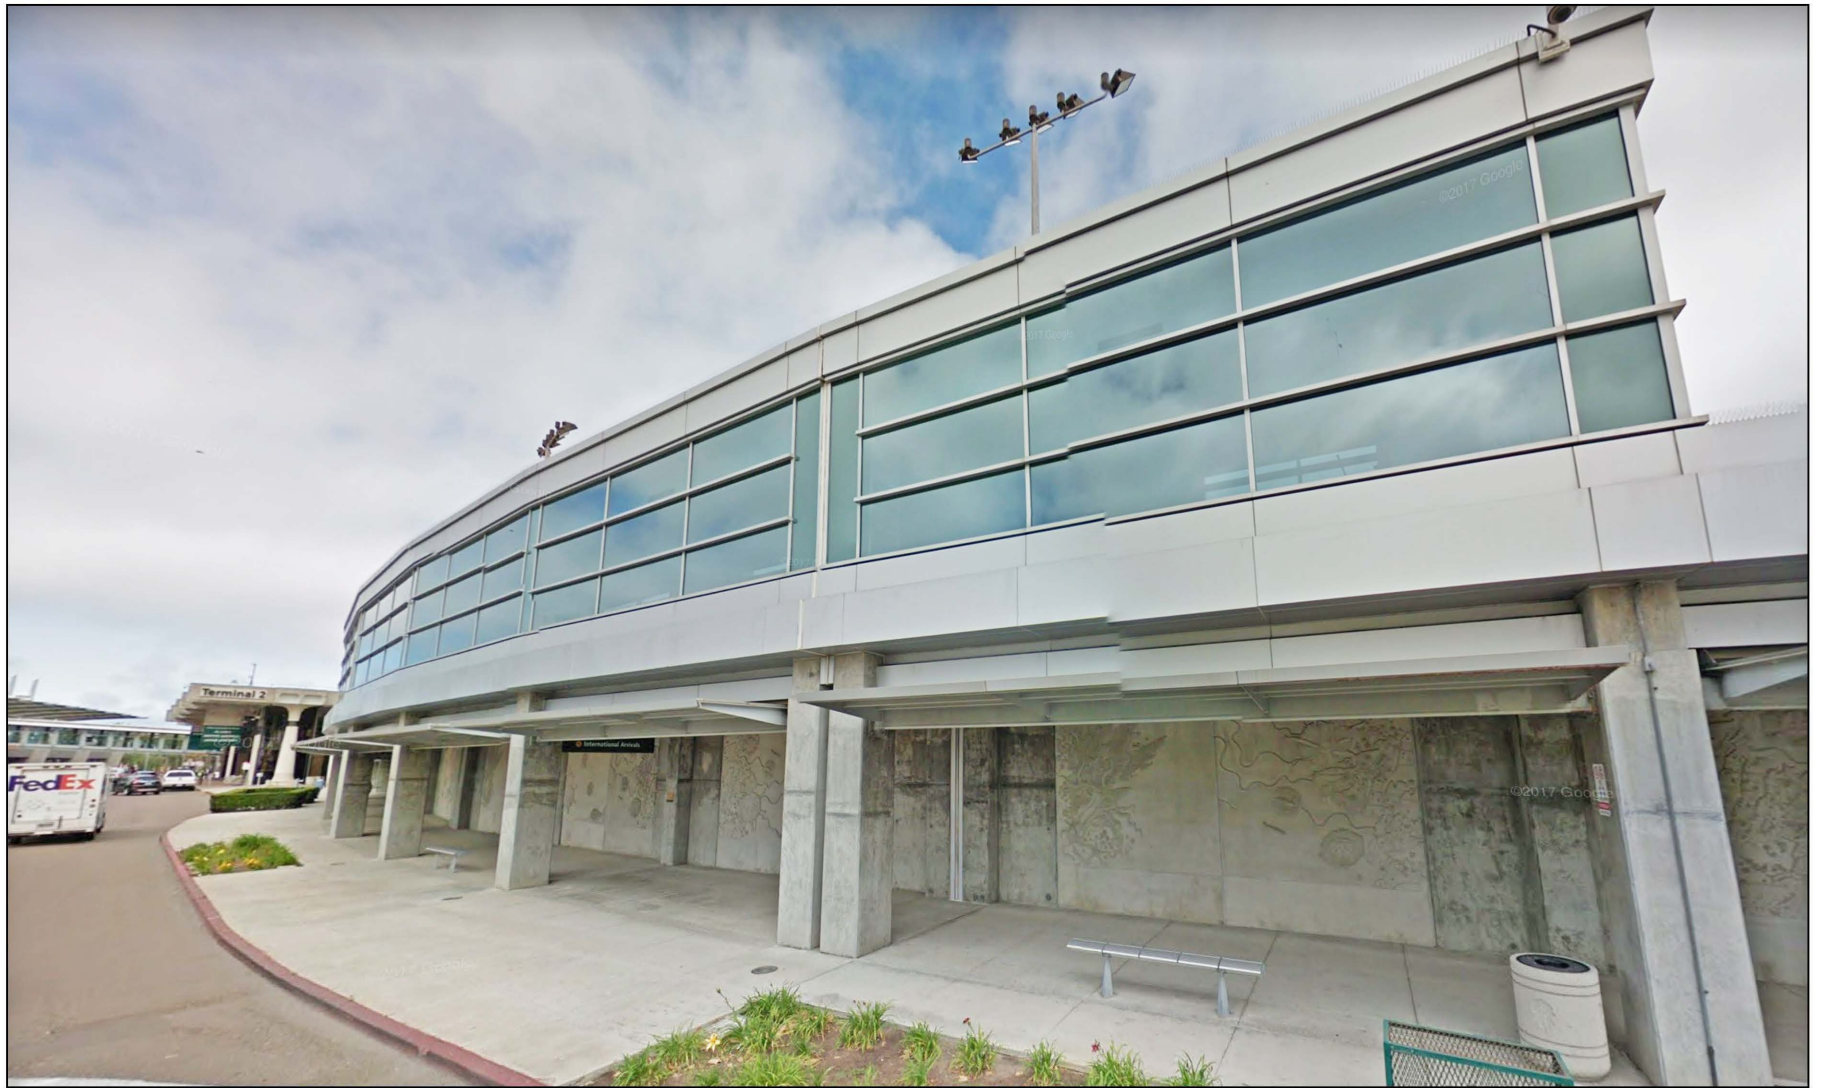
**Plate 6.1-15**

**View of Section C Showing the Covered Walkway  
and International Terminals, Facing Southwest**

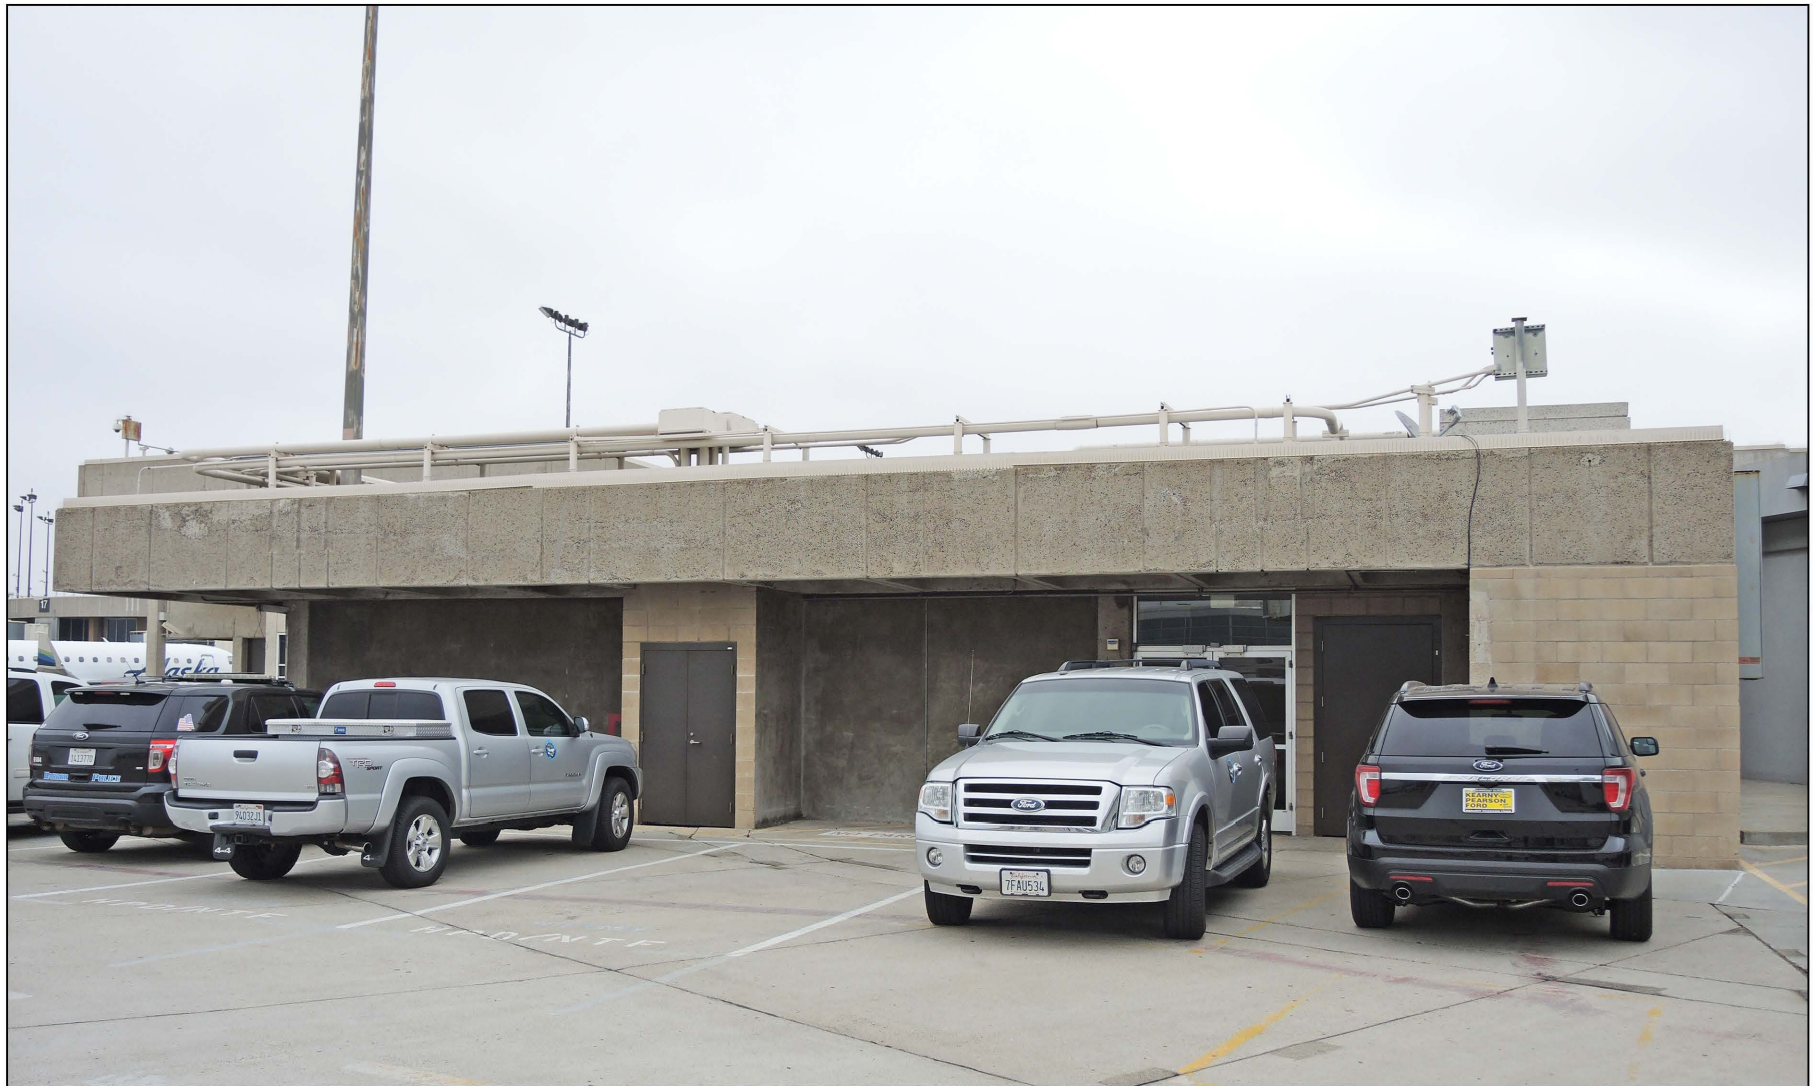
**Plate 6.1-16**

**View of the West Façade of a 1967 Portion of  
Section A North of Section C, Facing East**

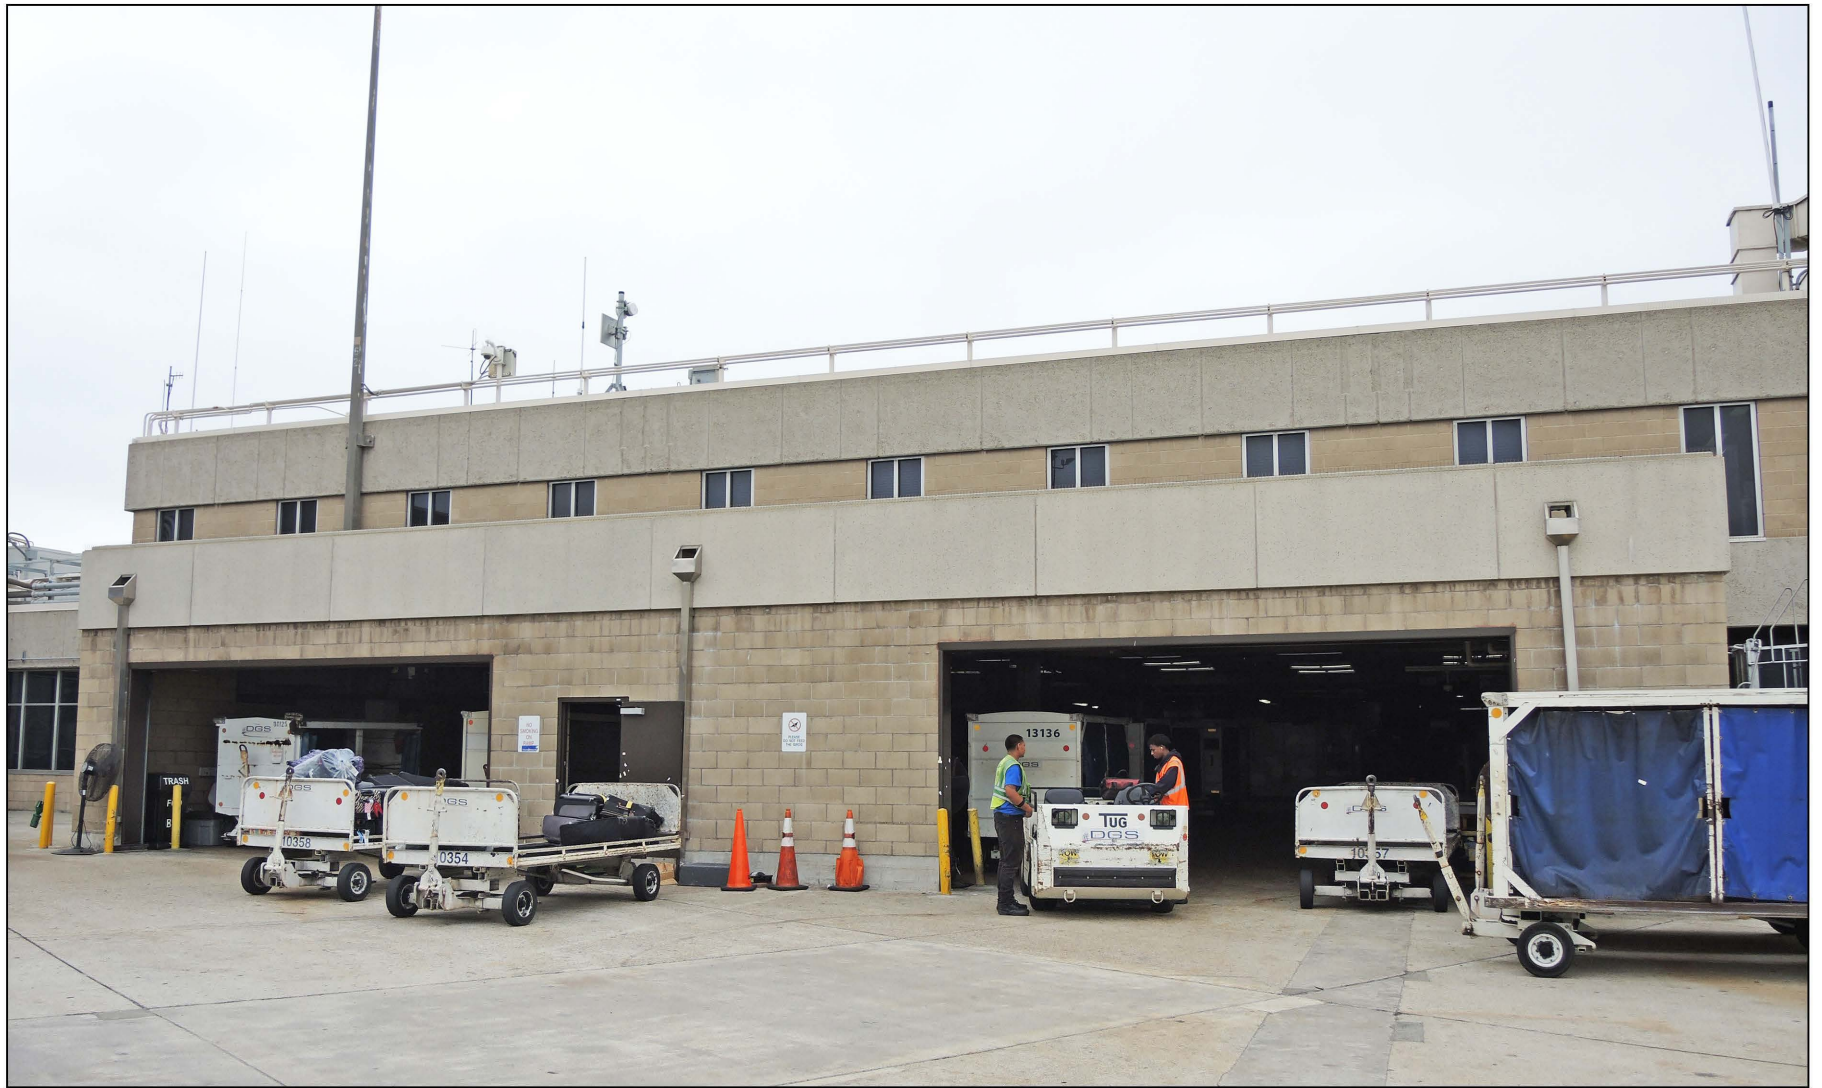
### Plate 6.1-18

### View of the North Façade of Section D, Facing South

The north façade of Section A has been extensively modified over time. The westernmost section of the north façade features Section D, a two-story baggage service and office space addition, which was constructed in 1982. The west façade of Section D features concrete block, a coffered concrete overhang, and fixed-pane windows (Plate 6.1–17). The north façade of Section D features five open bays that lead to baggage facilities and evenly spaced, rectangular, fixed-pane windows that run the length of the second story (Plate 6.1–18).

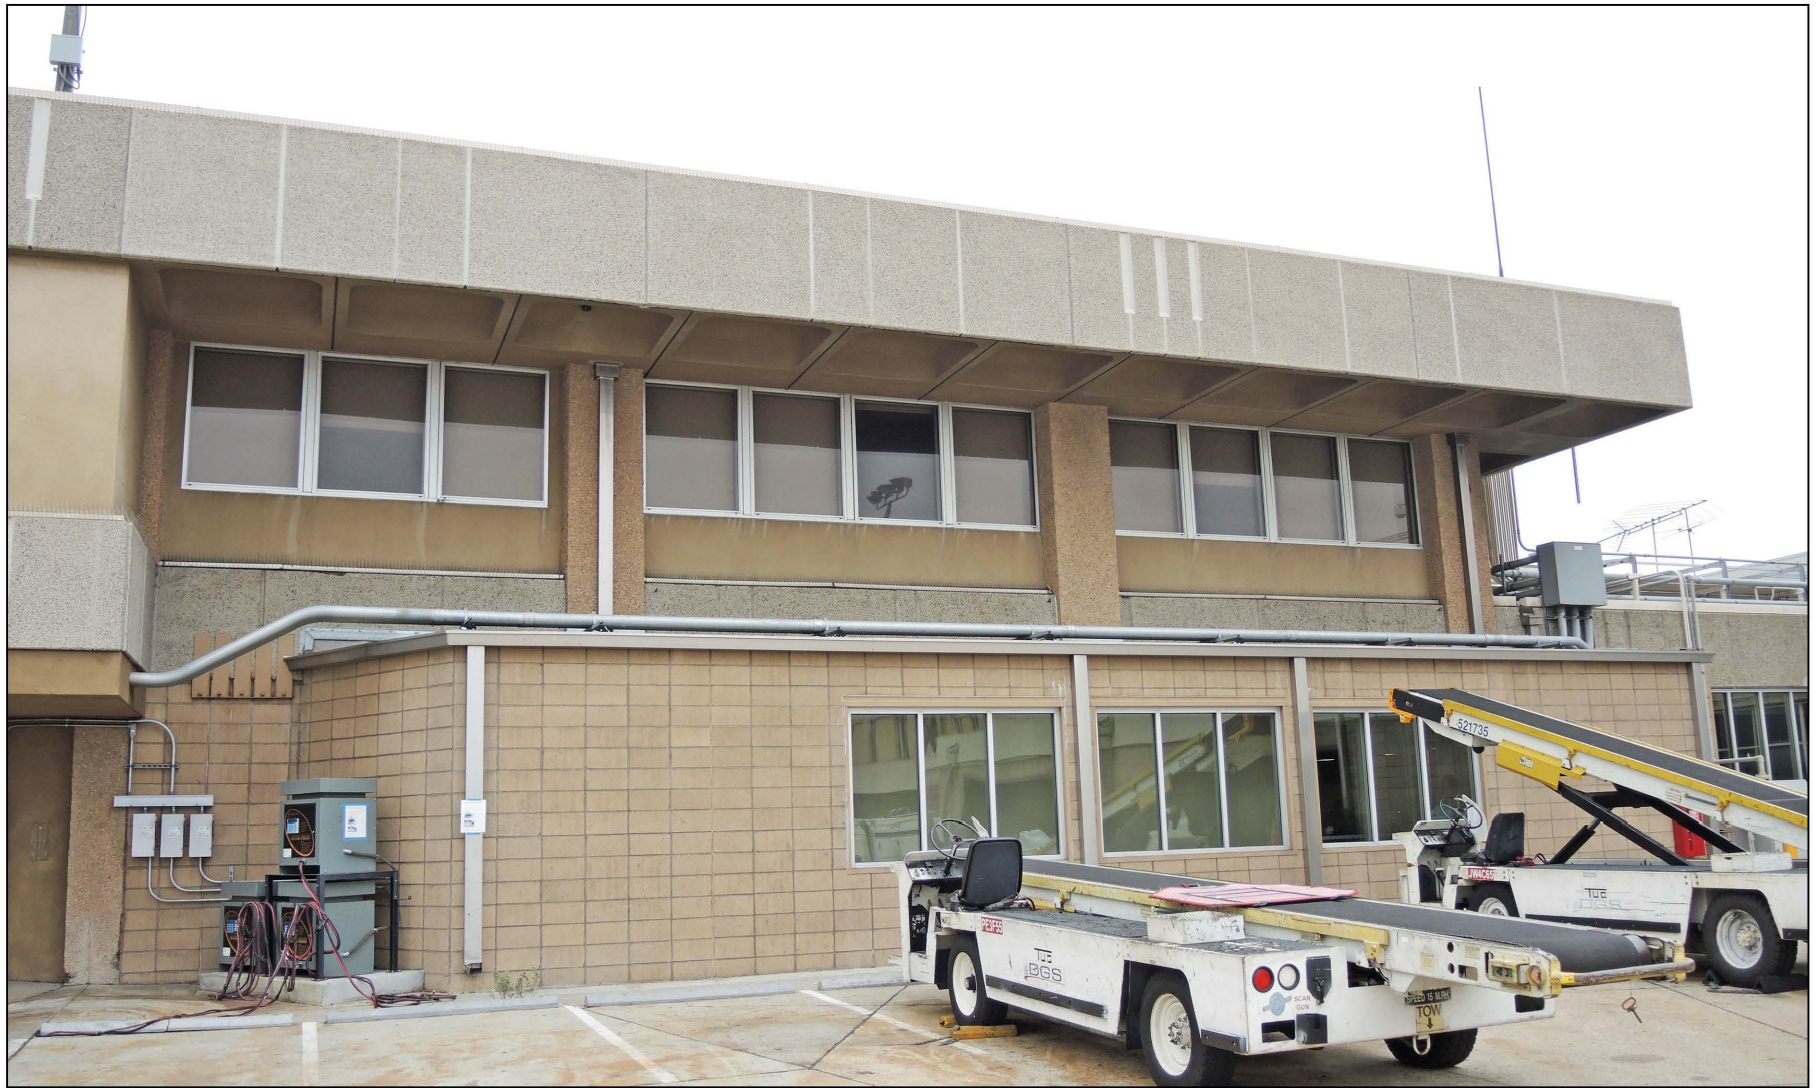
**Plate 6.1-19**

**View of the West Façade of the West Concourse Wing (Sections A and E), Facing East**

The Section A west concourse wing projects from the north façade of the main terminal immediately east of Section D and houses Gates 11 through 18. A second story, Section E, was added to the Section A west concourse wing in 1990. The first story of the Section A west concourse wing is a mix of concrete block, smooth stucco, simple metal doors, and fixed-pane windows (Plate 6.1–19). Section E also features a mix of concrete block, smooth stucco, and fixed-pane windows (see Plates 6.1–19 and Plate 6.1–20). The concrete band on the first story (Section A) becomes a coffered overhang on the rotunda portion of the wing (see Plate 6.1–20). Most of Section E also exhibits a coffered concrete overhang, except in the areas around the eight gates, which were built out to accommodate the jet bridges, which were added in the 1980s (Plate 6.1–21).
