**Section 106 Assessment for the San Diego International Airport Airfield  
Improvements and Terminal 1 Replacement Project**

**SECTION 106 ASSESSMENT FOR THE  
SAN DIEGO INTERNATIONAL AIRPORT  
AIRFIELD IMPROVEMENTS AND  
TERMINAL 1 REPLACEMENT PROJECT**

**CITY OF SAN DIEGO, CALIFORNIA**

***November 10, 2020; Revised January 8, 2021; Revised February 19, 2021;  
Revised March 12, 2021; Revised April 27, 2021; Revised May 7, 2021***

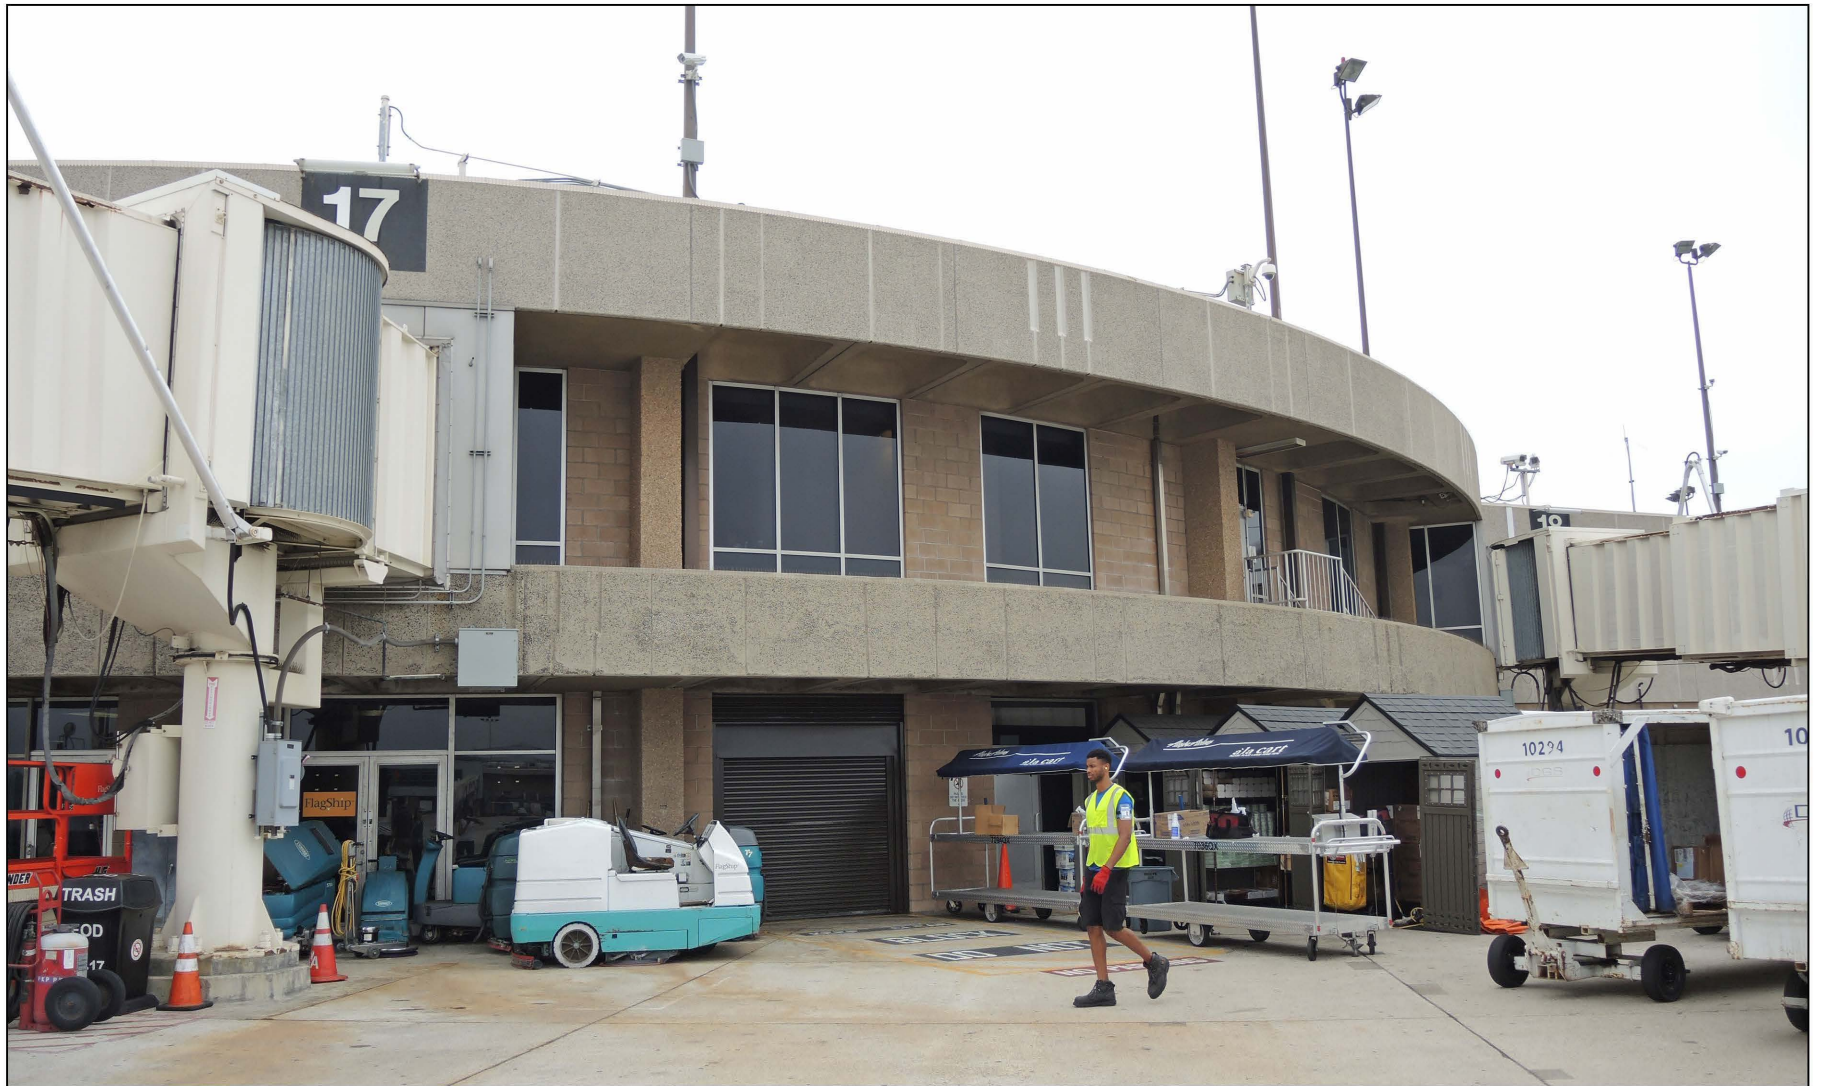
**Plate 6.1-20**

**View of the Northwest Façade of the Rotunda Portion  
of the West Concourse Wing (Sections A and E), Facing Southeast**

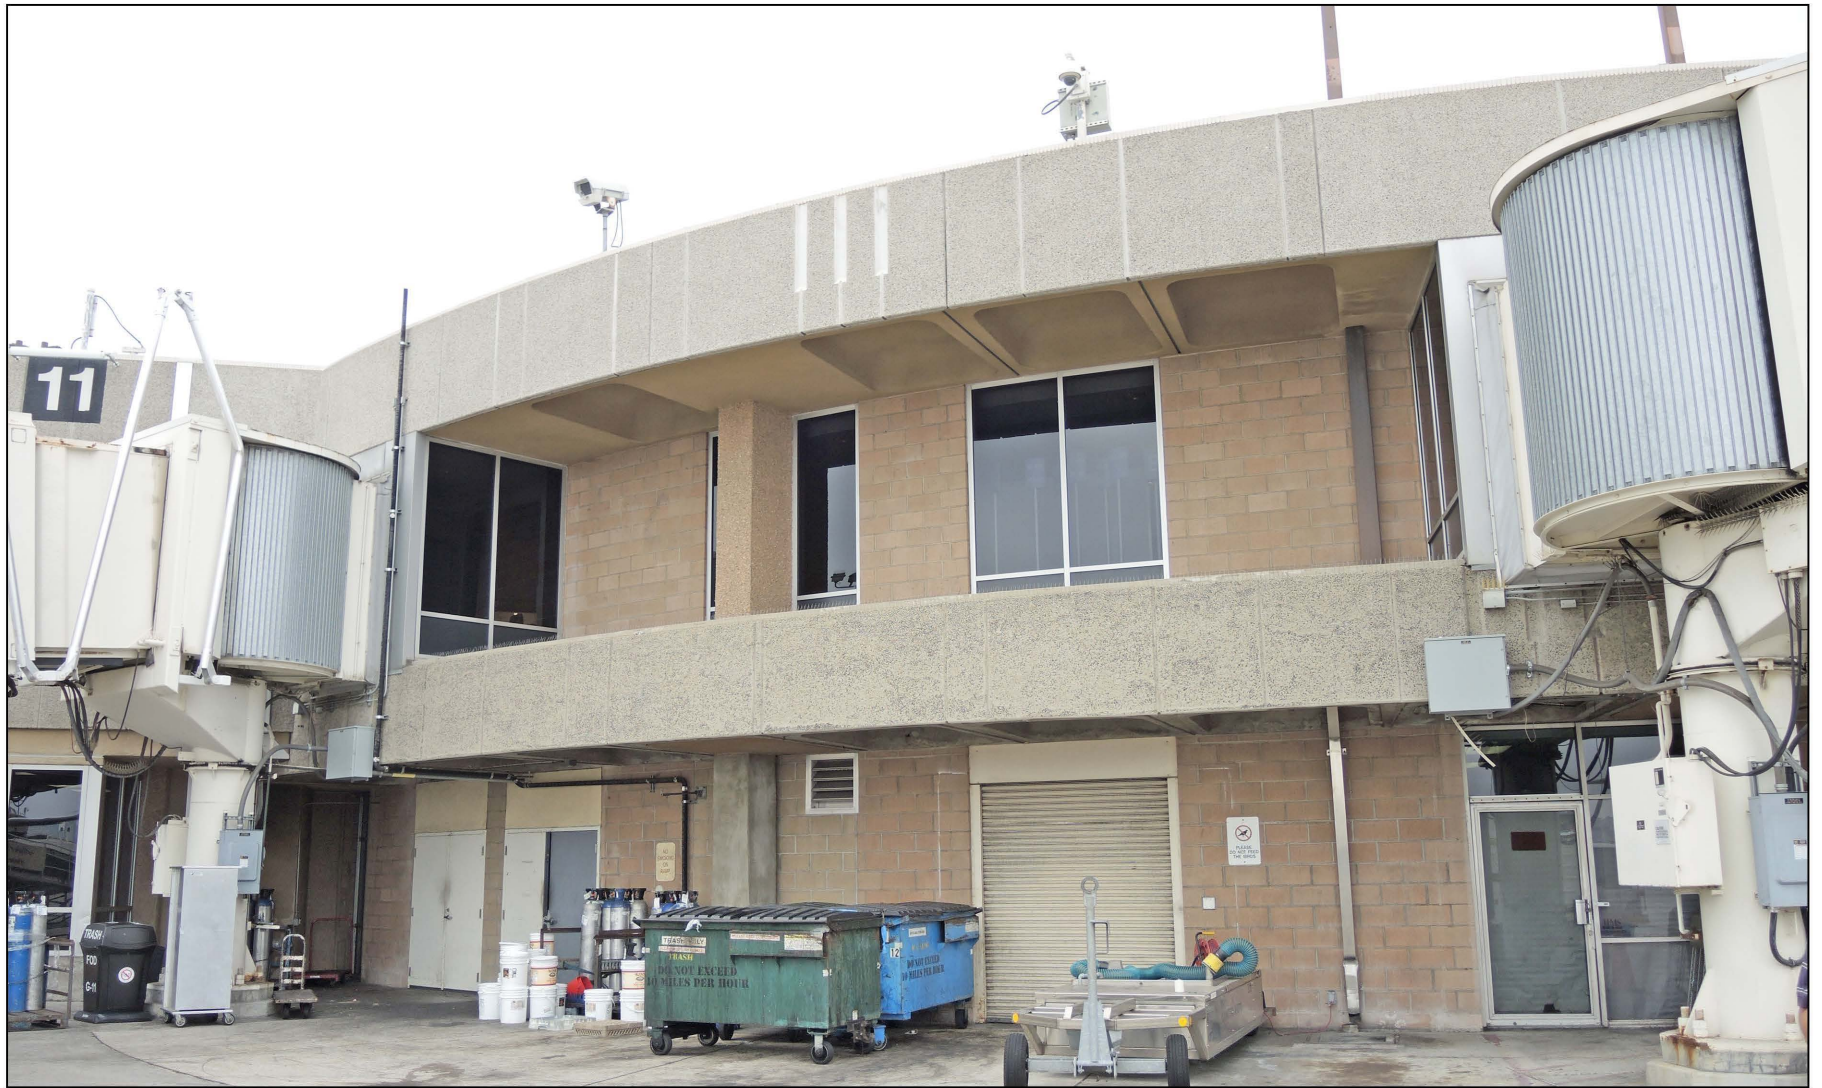
**Plate 6.1-21**

**View of the Jet Bridge Connection at Gate 11 on the East Façade  
of the Rotunda Portion of Sections A and E, Facing West  
The SAN Airfield Improvements and Terminal 1 Replacement Project**

The Section A west concourse wing projects from the north façade of the main terminal immediately east of Section D and houses Gates 11 through 18. A second story, Section E, was added to the Section A west concourse wing in 1990. The first story of the Section A west concourse wing is a mix of concrete block, smooth stucco, simple metal doors, and fixed-pane windows (Plate 6.1–19). Section E also features a mix of concrete block, smooth stucco, and fixed-pane windows (see Plates 6.1–19 and Plate 6.1–20). The concrete band on the first story (Section A) becomes a coffered overhang on the rotunda portion of the wing (see Plate 6.1–20). Most of Section E also exhibits a coffered concrete overhang, except in the areas around the eight gates, which were built out to accommodate the jet bridges, which were added in the 1980s (Plate 6.1–21).

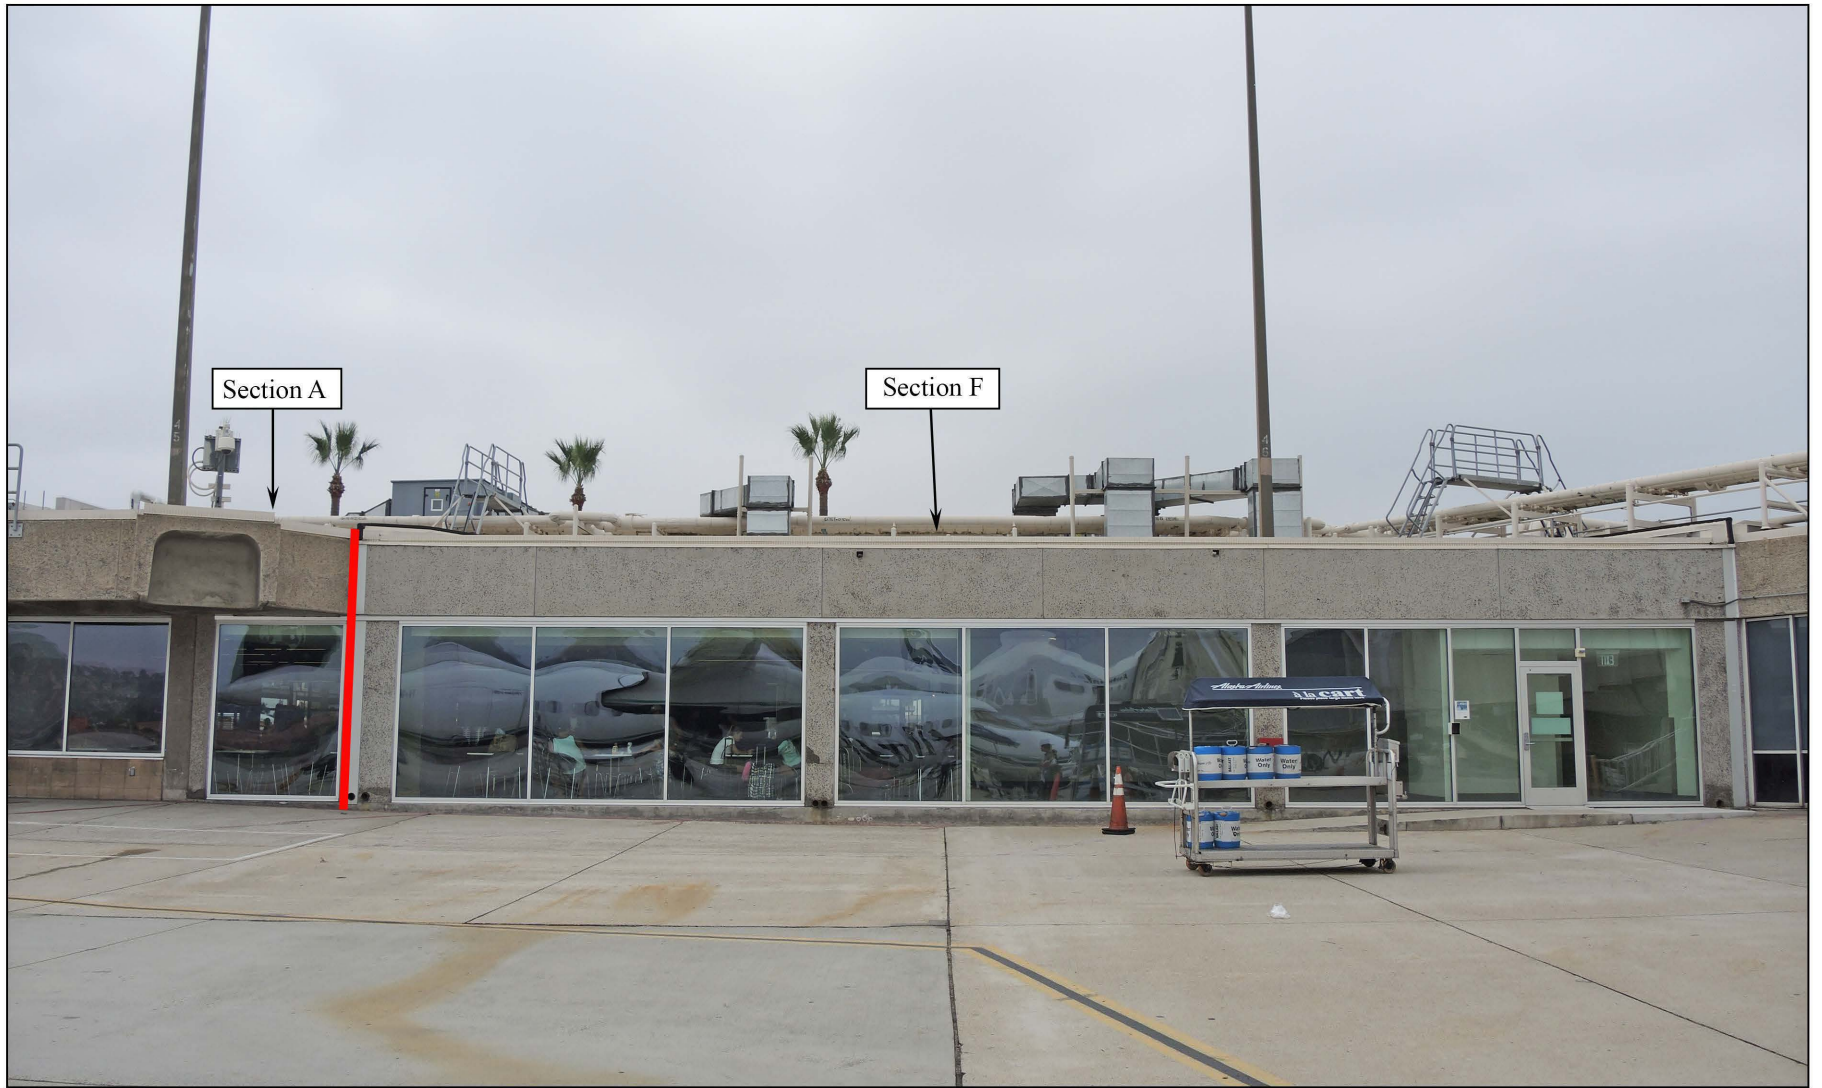
### Plate 6.1-22

### View of the North Façade of Section F, Facing South

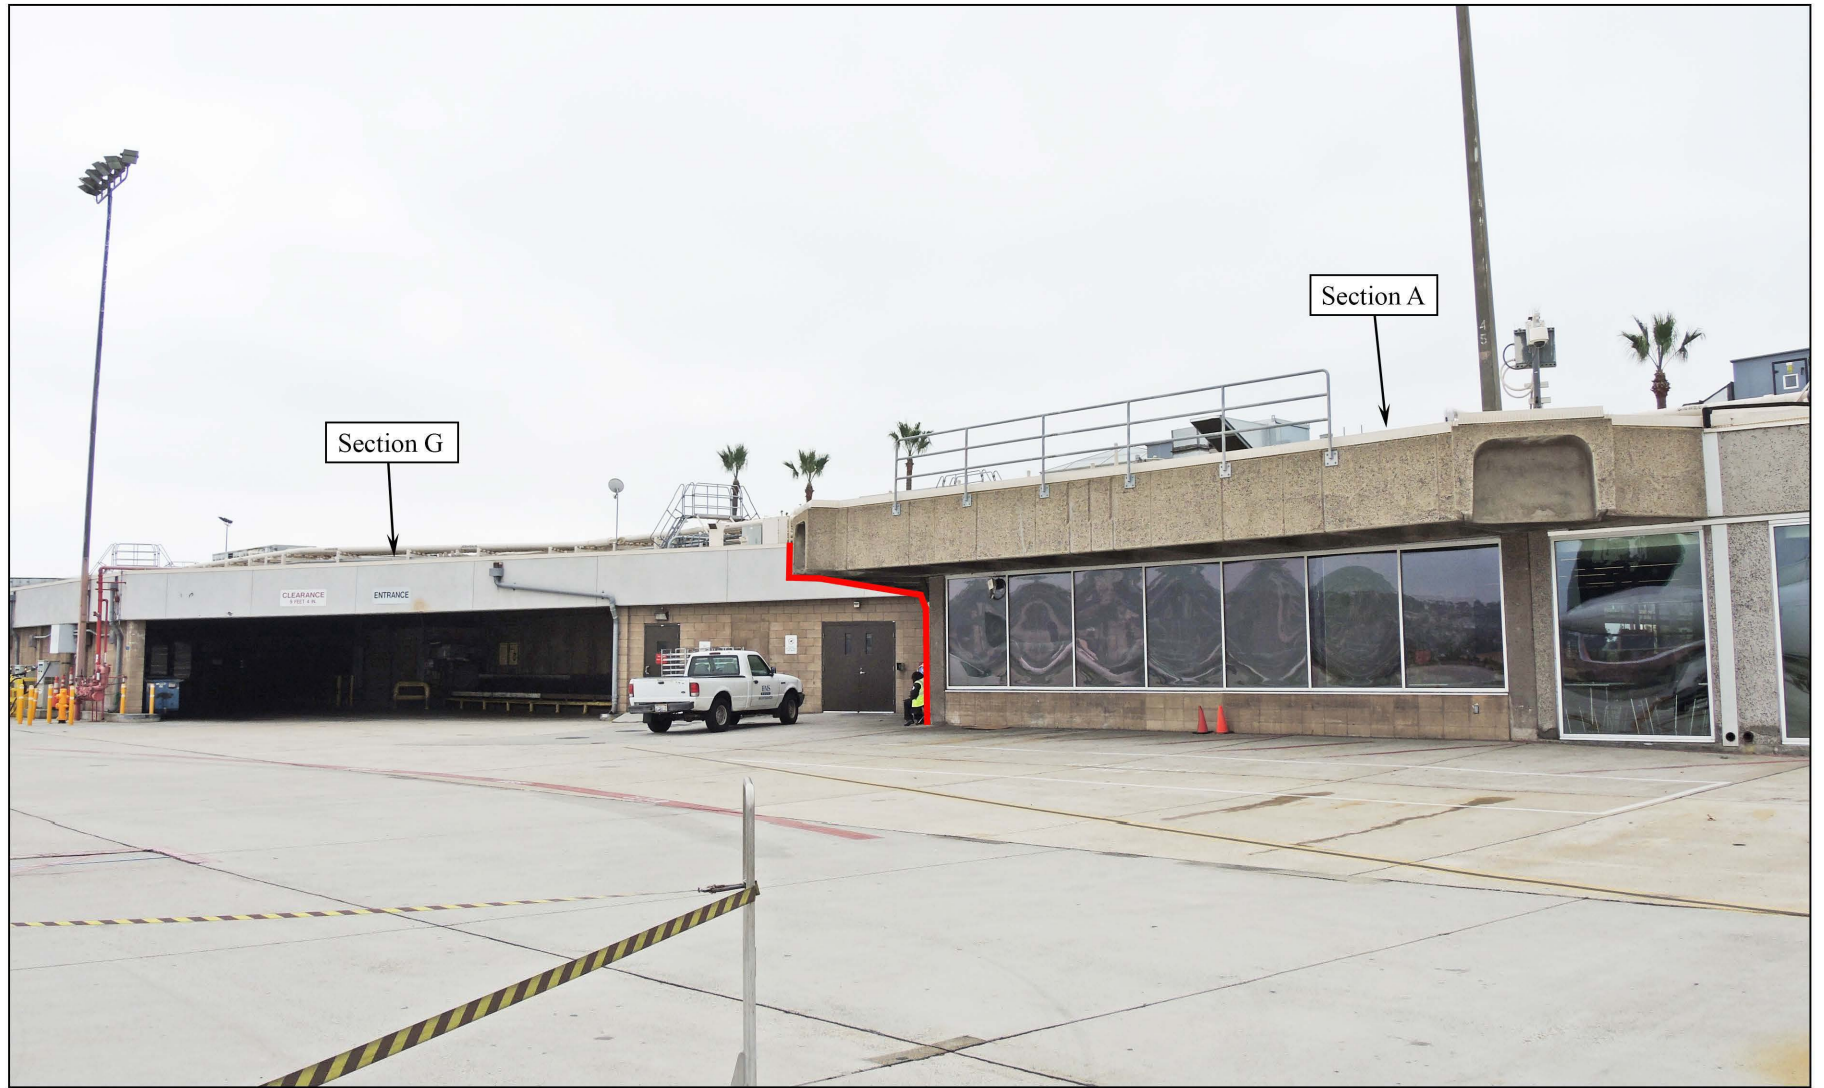
**Plate 6.1-23**

**View of the North Façade of the Original 1967 Projecting Bay on Section A (Right)  
and the Northwest Façade of Section G (Left), Facing Southeast**

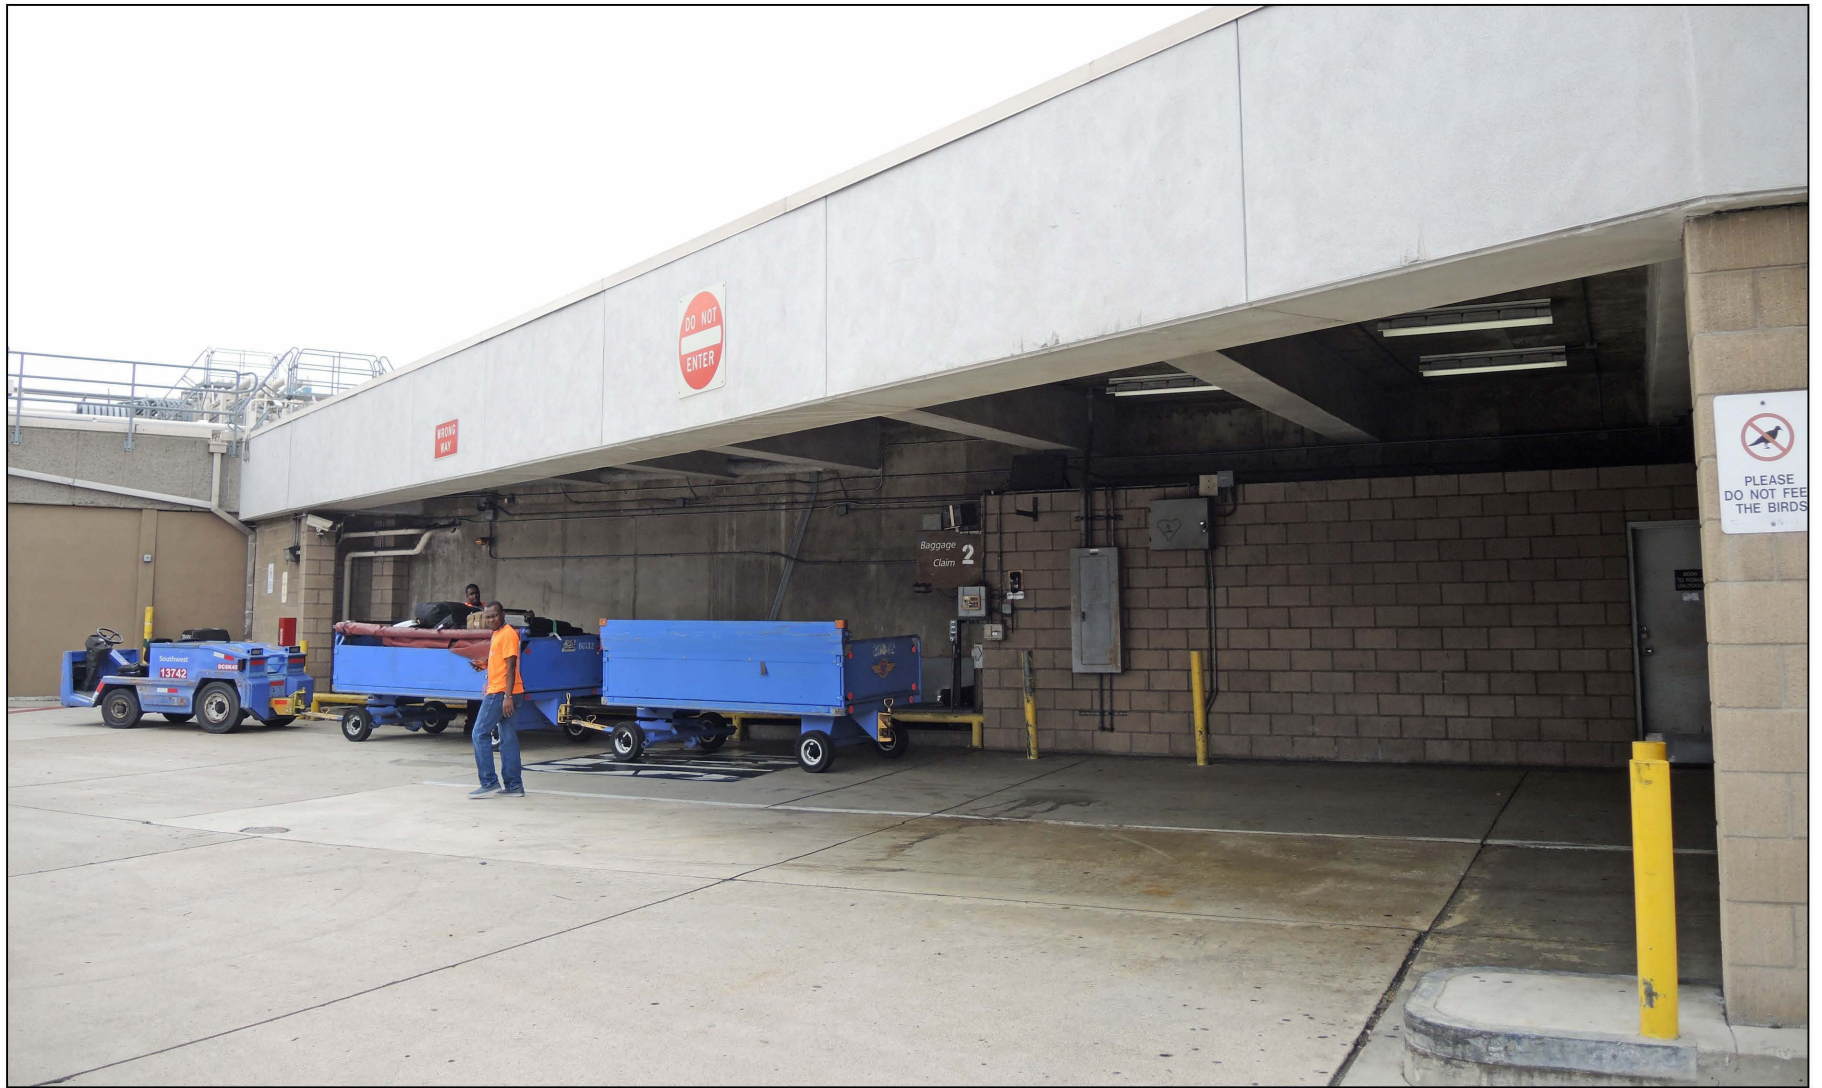
**Plate 6.1-24**

**View of the the Section G Baggage Facilities  
on the North Façade of Section A, Facing Southeast**

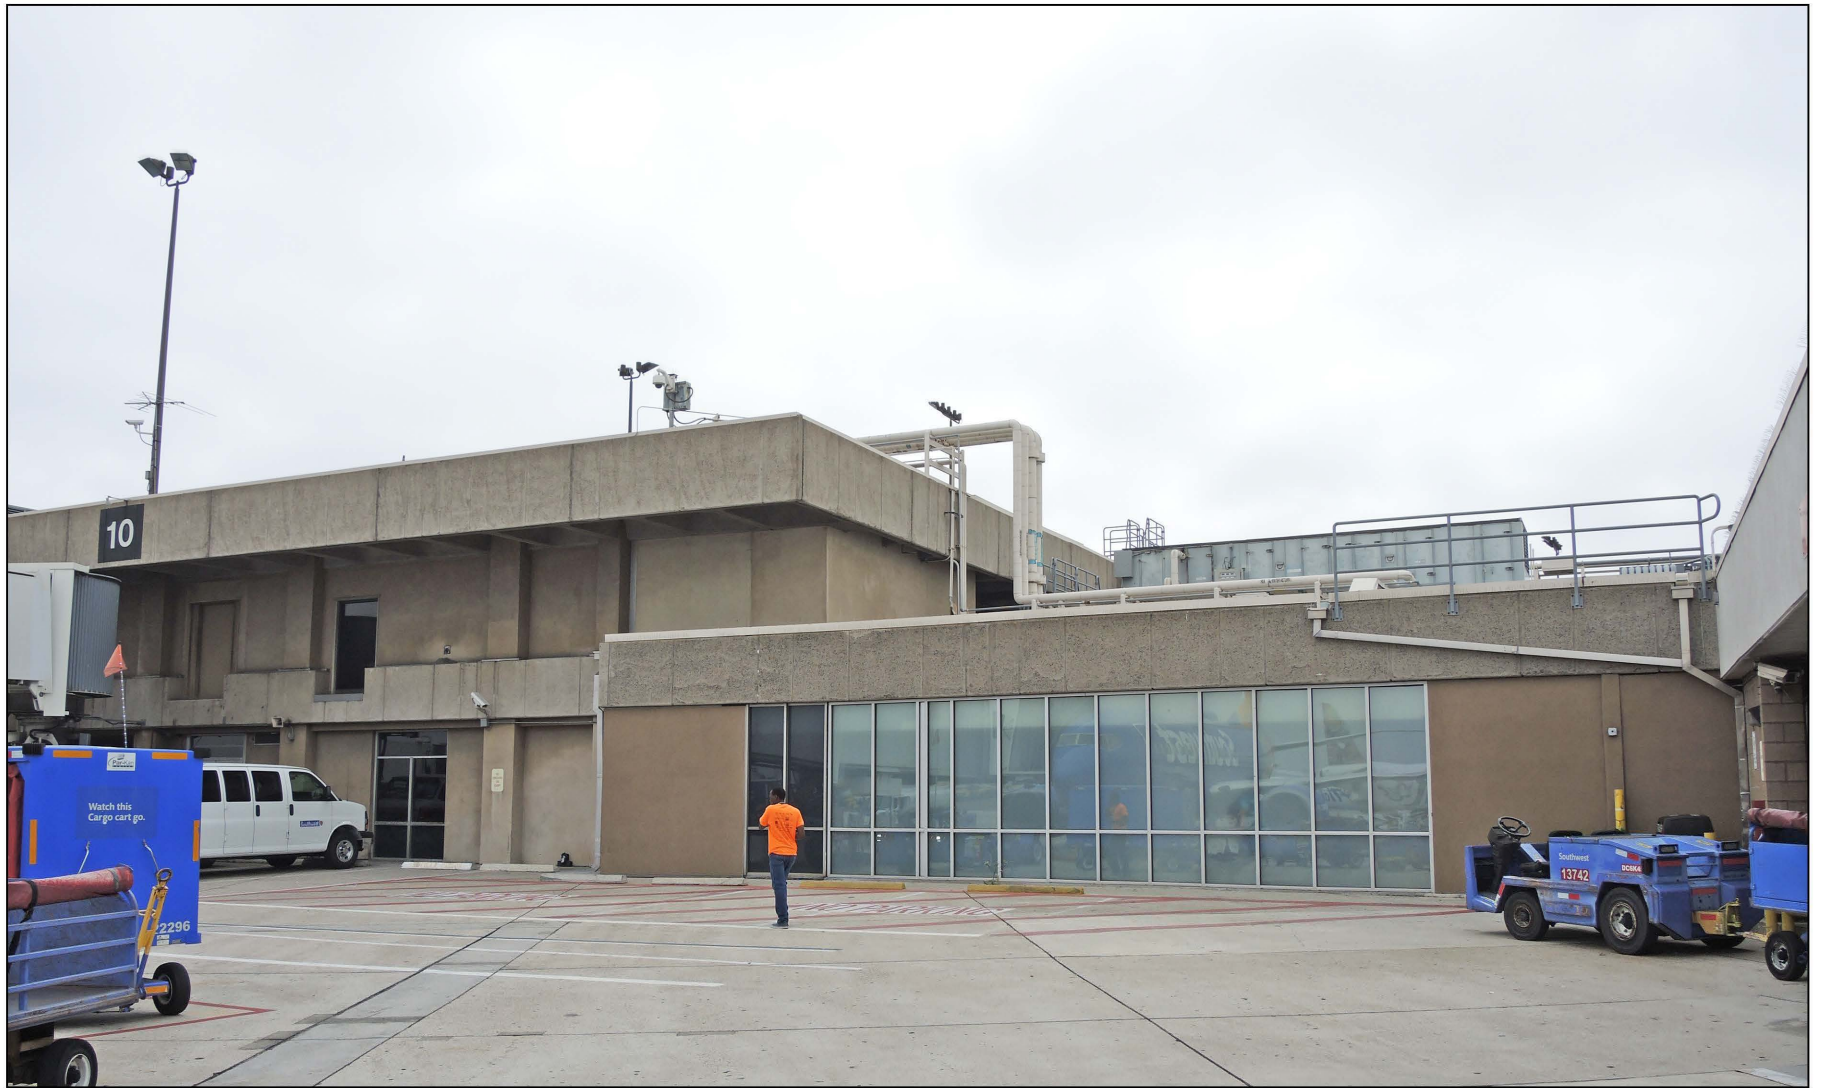
**Plate 6.1-25**

**View of the West Façade of the Section A East Concourse Wing, Facing East**

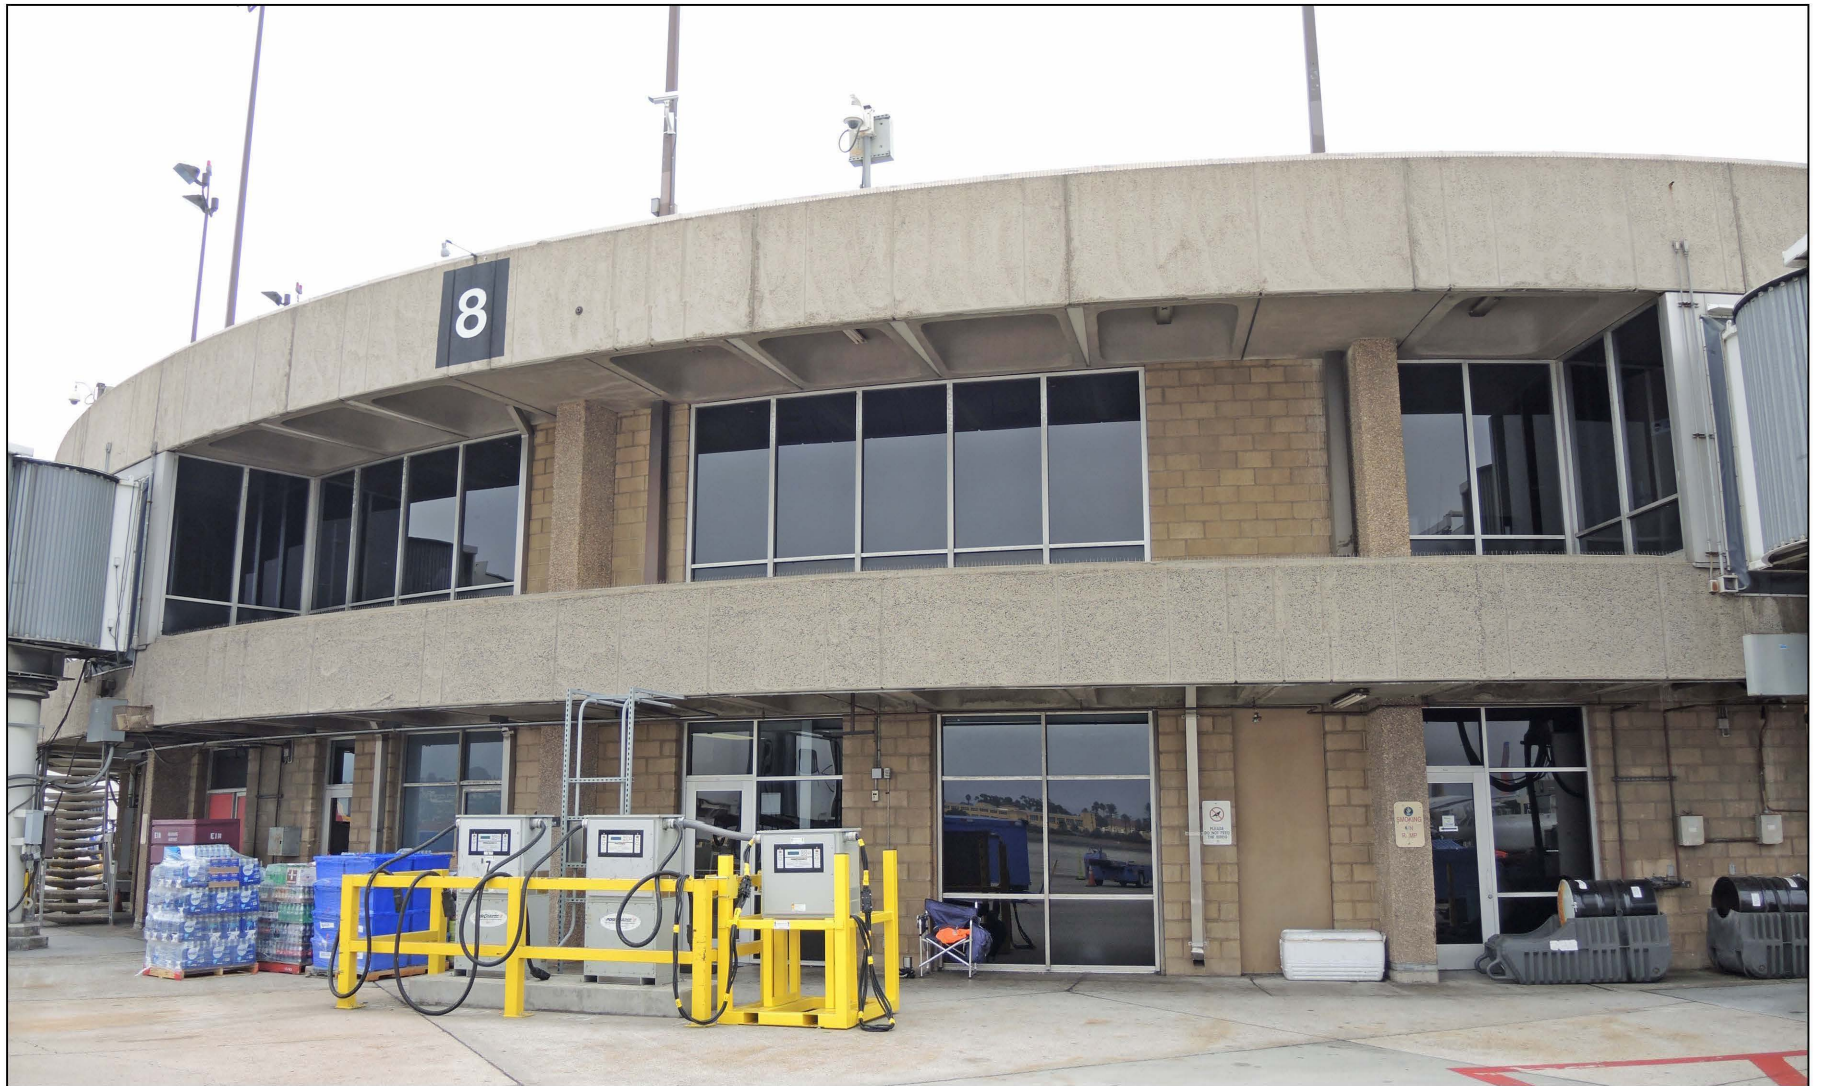
**Plate 6.1-26**

**View of the West Façade of the Rotunda Portion  
of the East Concourse Wing (Sections A and H), Facing Southeast**

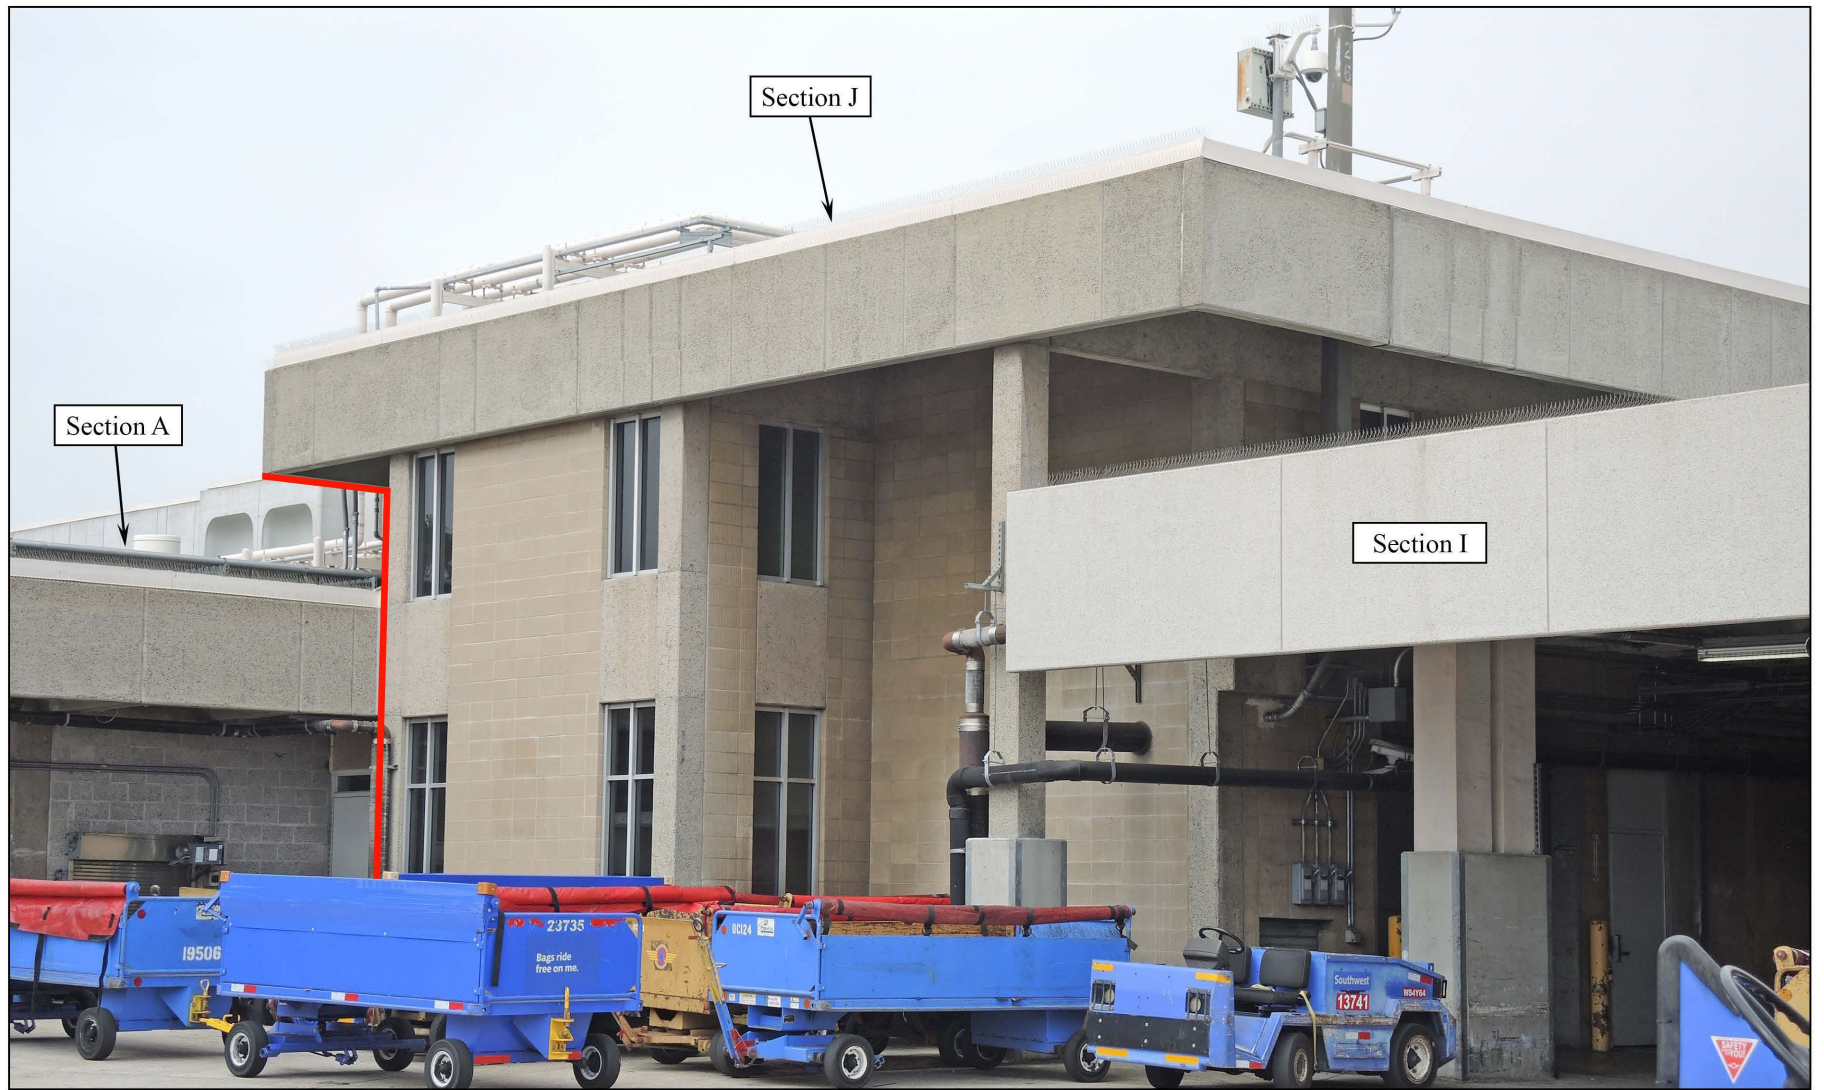
**Plate 6.1-28**

**View of the Section J Office Between the North Façade of  
Section A (Left) and Section I (Right), Facing South  
The SAN Airfield Improvements and Terminal 1 Replacement Project**

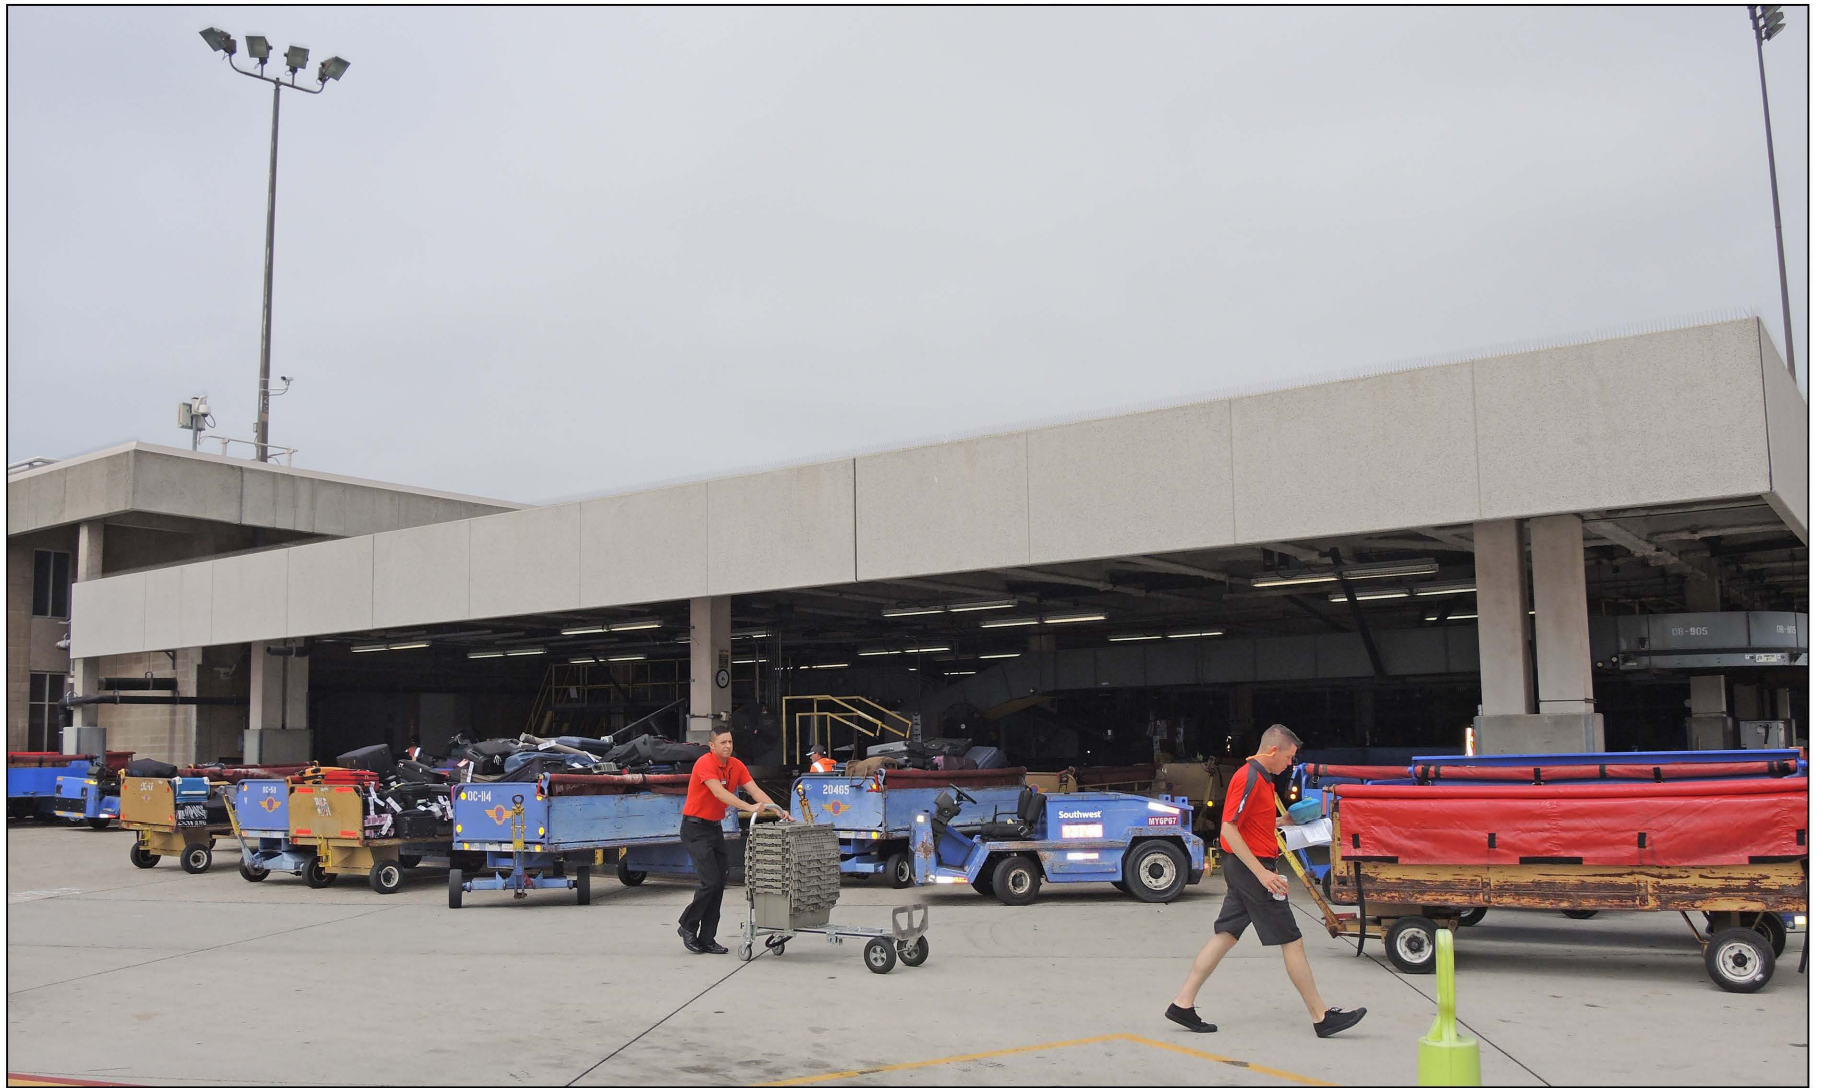
**Plate 6.1-29**

**View of the East Façade of Section I, Facing South**

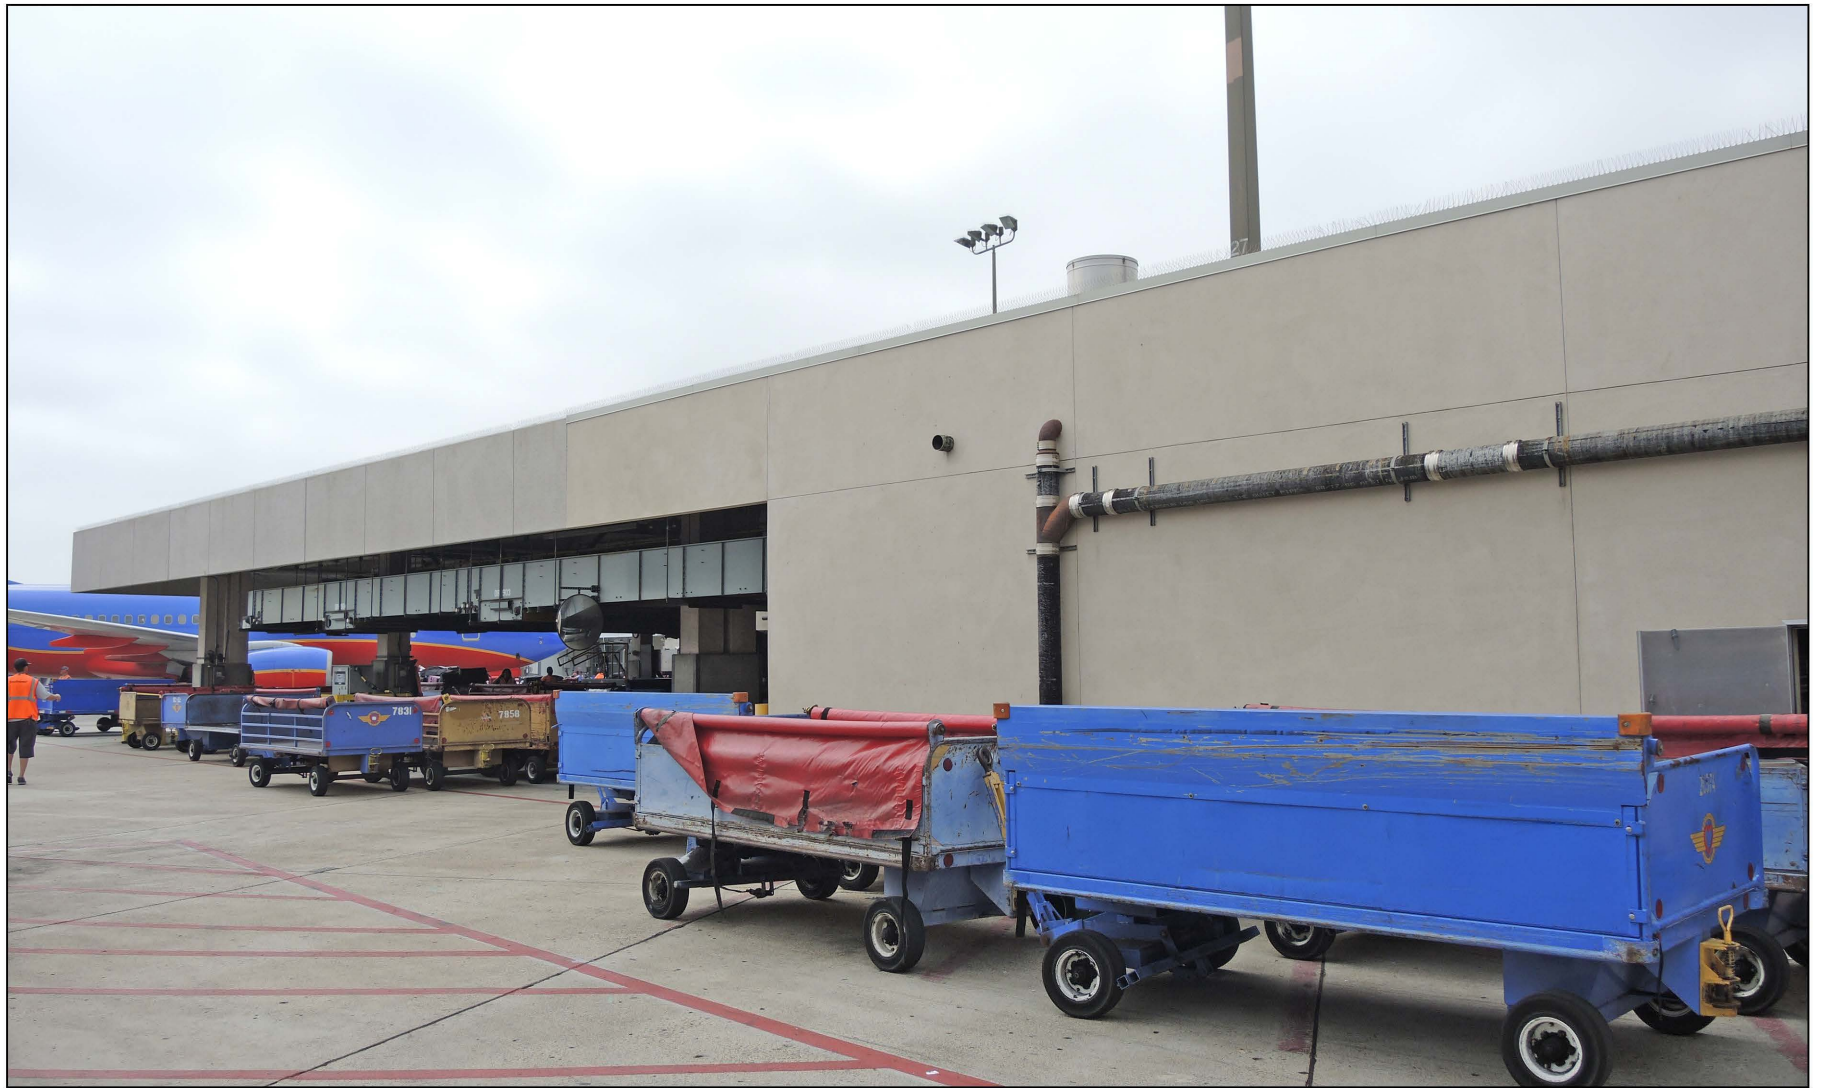
**Plate 6.1-30**

**View of the North Façade of Section I, Facing East**

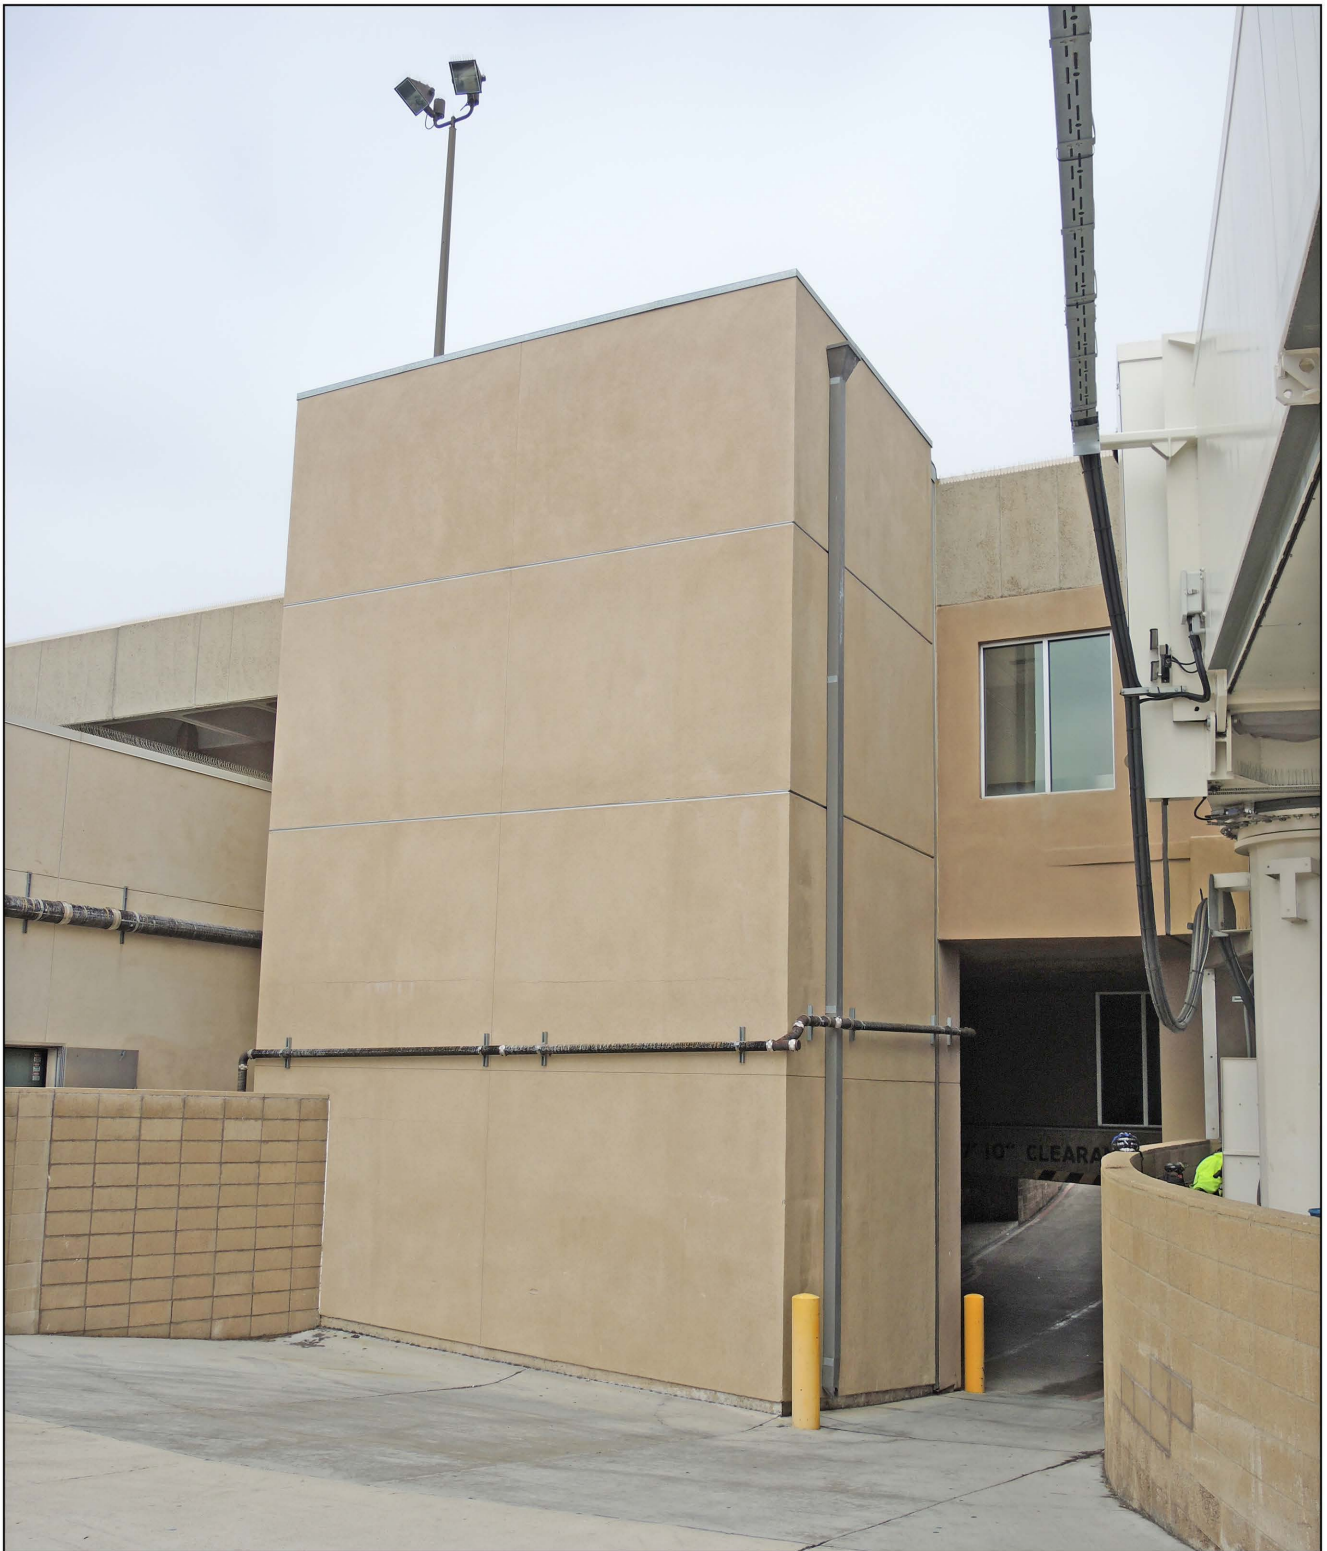
**Plate 6.1-31**

**View of Section I on the East Façade of the  
Section A East Concourse Wing, Facing West**
