**Section 106 Assessment for the San Diego International Airport Airfield  
Improvements and Terminal 1 Replacement Project**

**SECTION 106 ASSESSMENT FOR THE  
SAN DIEGO INTERNATIONAL AIRPORT  
AIRFIELD IMPROVEMENTS AND  
TERMINAL 1 REPLACEMENT PROJECT**

**CITY OF SAN DIEGO, CALIFORNIA**

***November 10, 2020; Revised January 8, 2021; Revised February 19, 2021;  
Revised March 12, 2021; Revised April 27, 2021; Revised May 7, 2021***

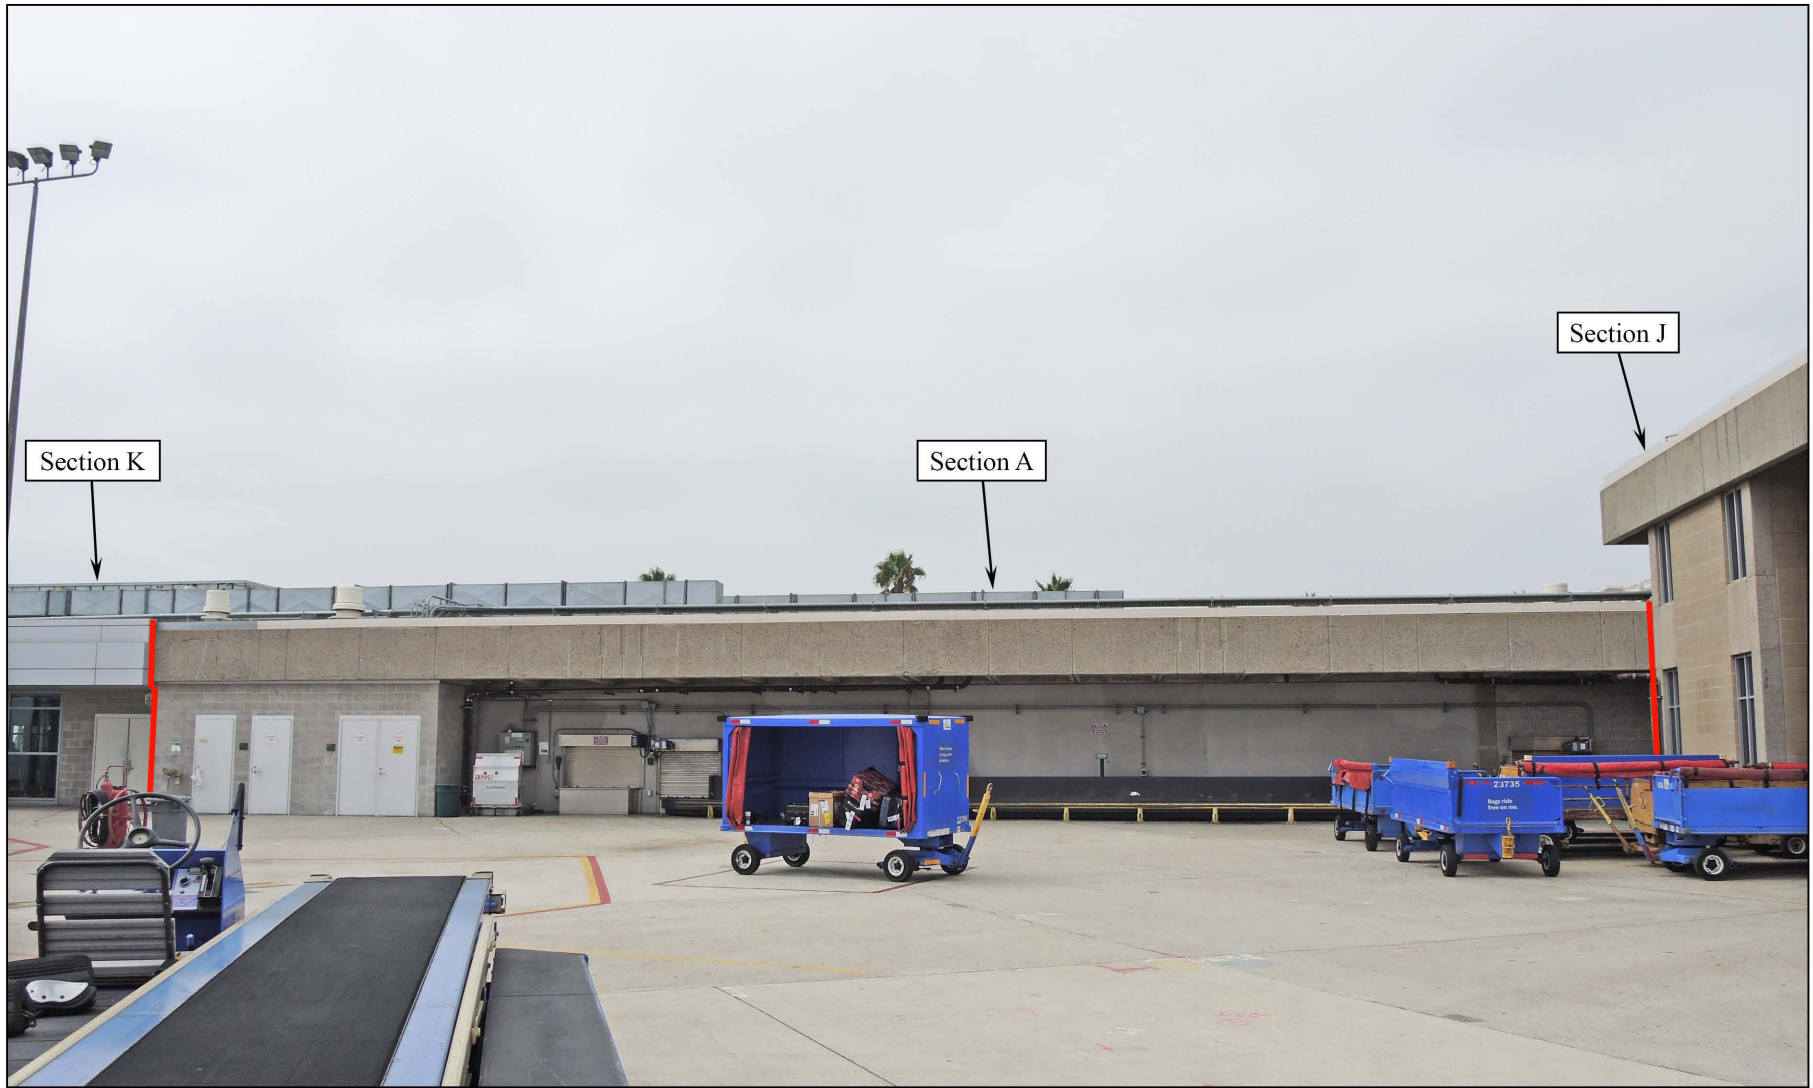
**Plate 6.1-32**

**View of the North Façade of the Original 1967 Portion of Section A Between  
the Section J Office (Right) and Section K (Left), Facing South**

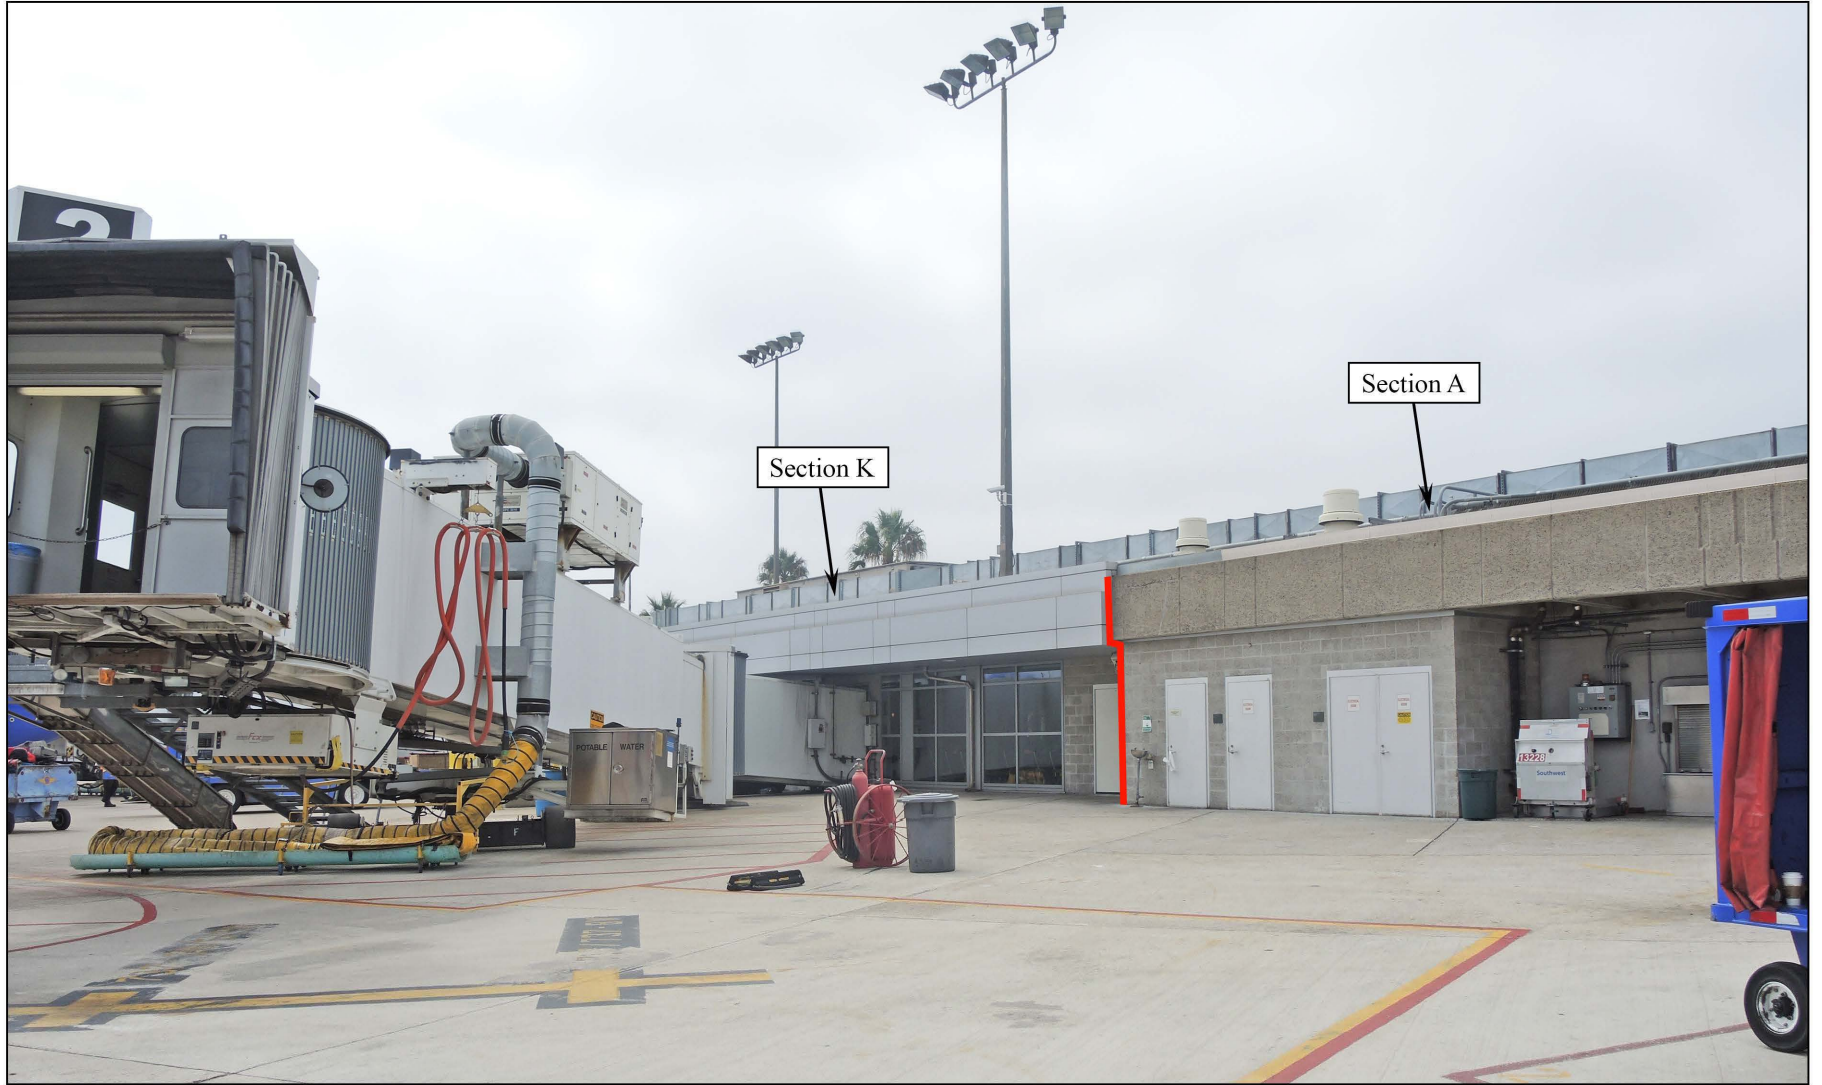
**Plate 6.1-33**  
**View of Section K at the Northeast Corner of Section A (Right), Facing South**  
The SAN Airfield Improvements and Terminal 1 Replacement Project

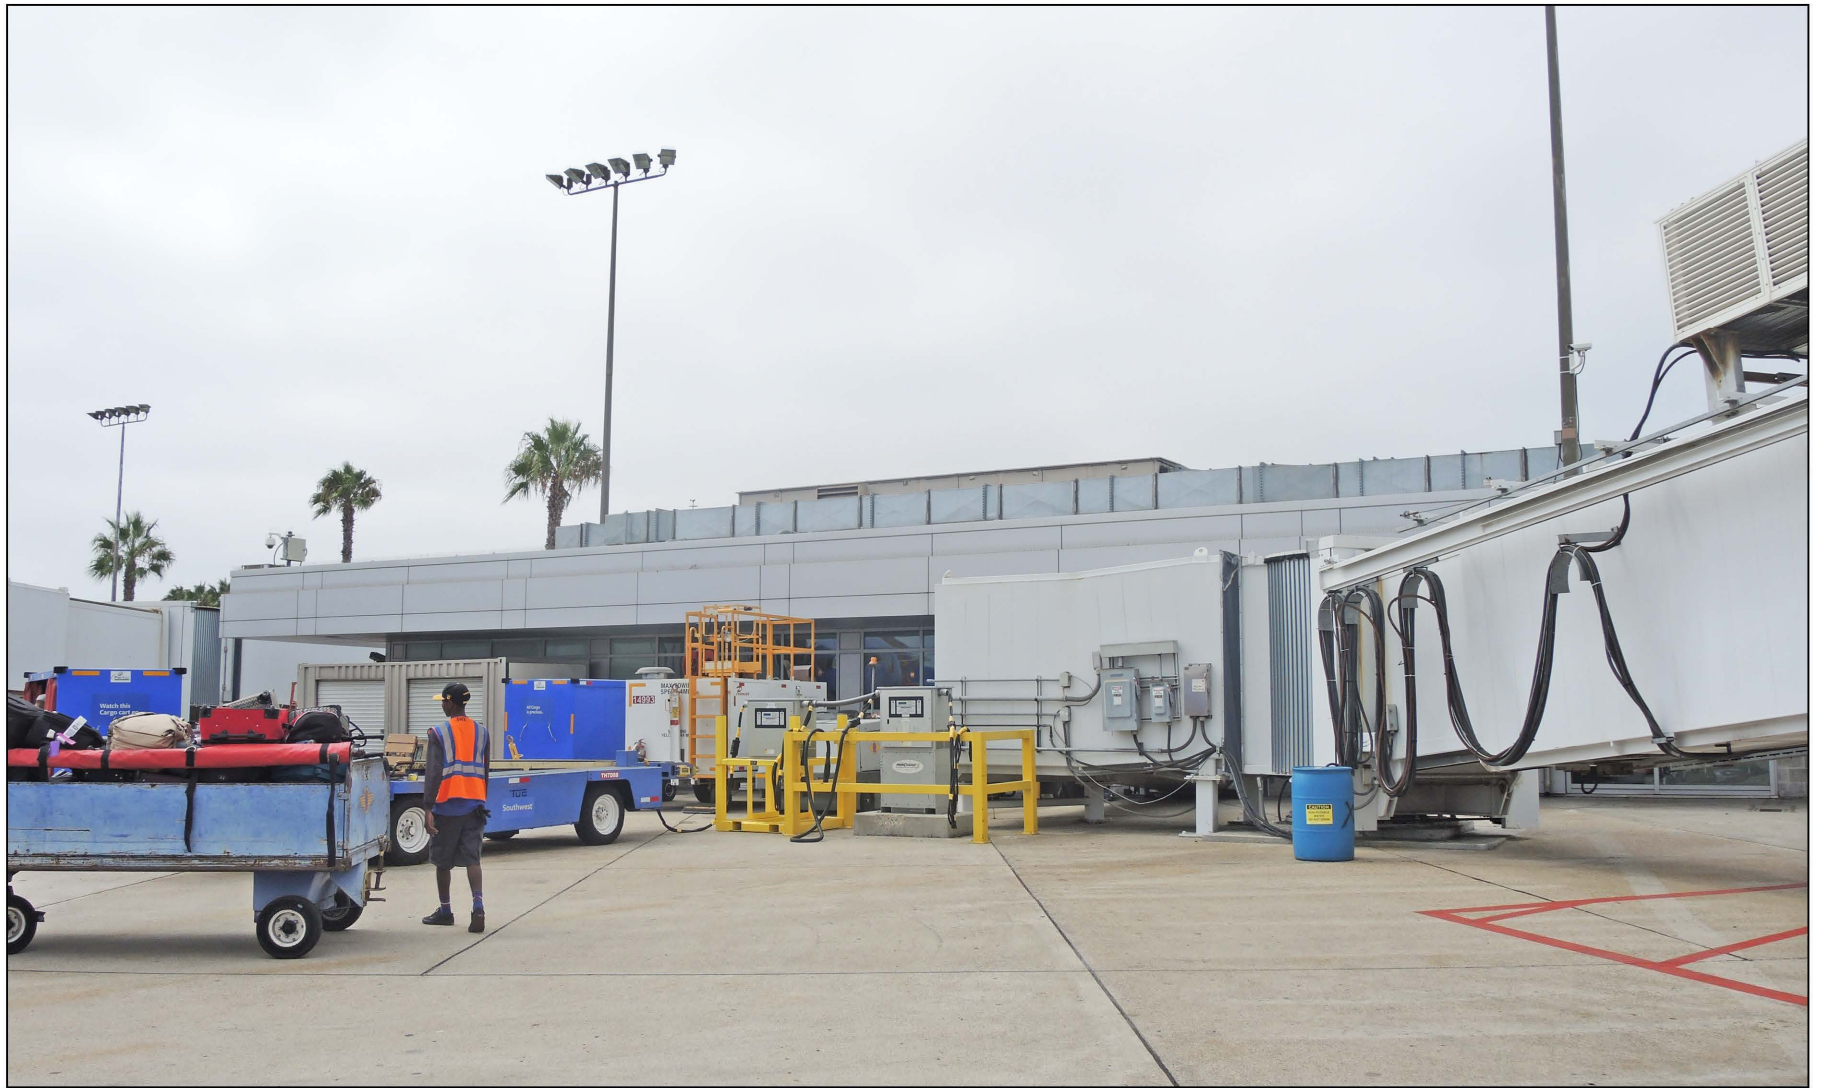
**Plate 6.1-34**  
**View of Gates 1 and 2 on the North Façade of Section K, Facing South**  
The SAN Airfield Improvements and Terminal 1 Replacement Project

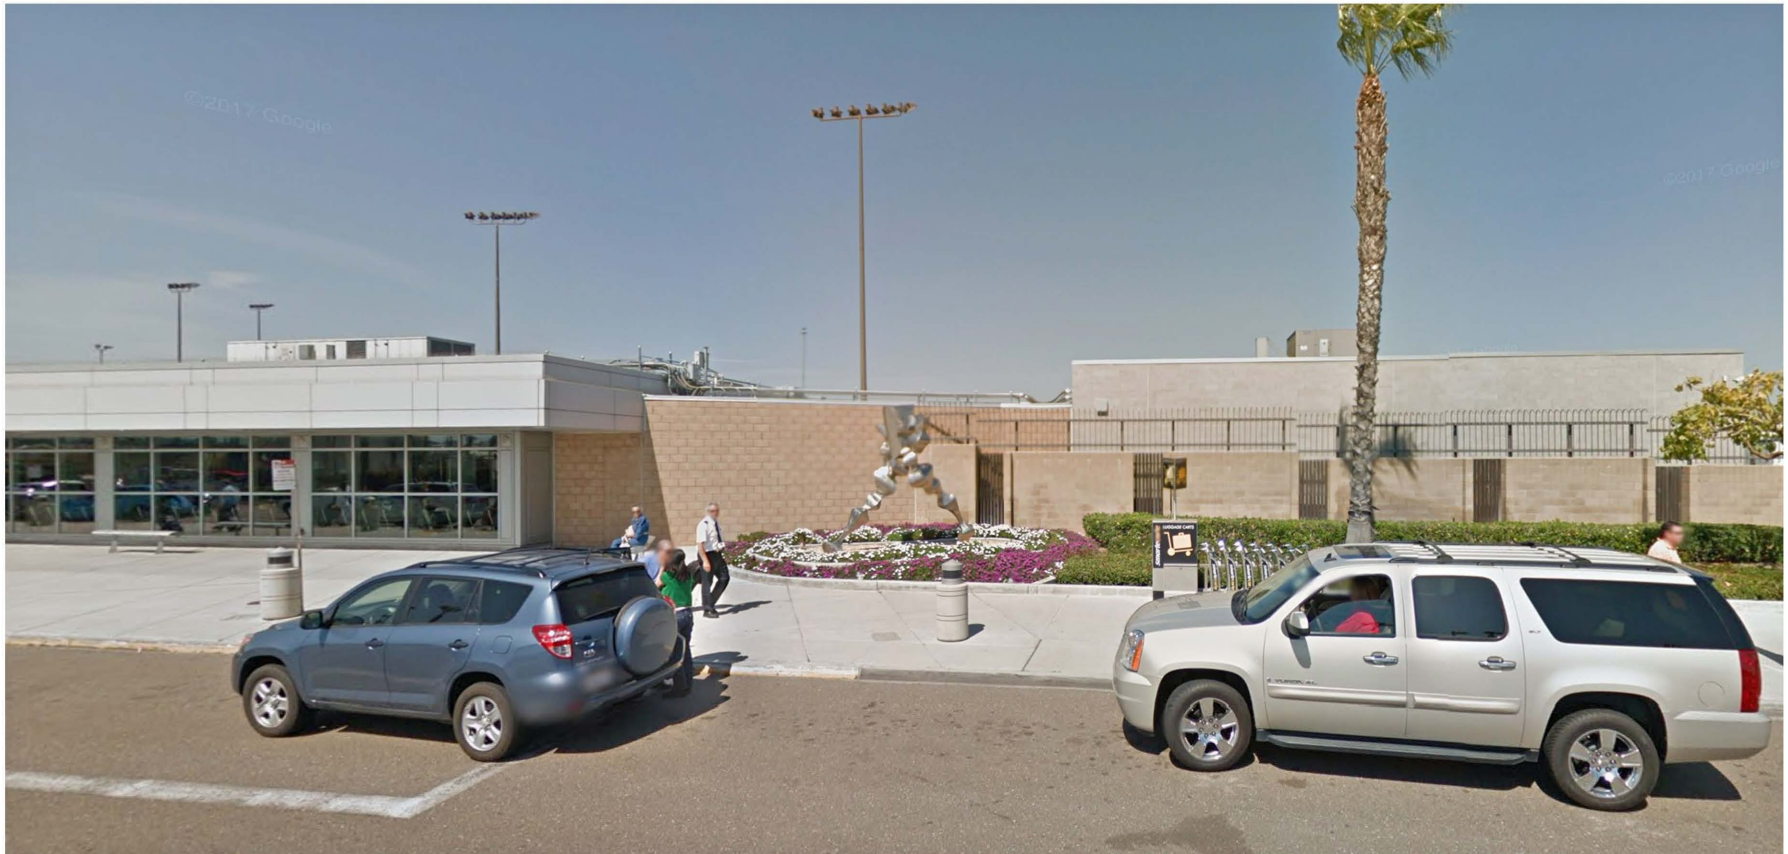
**Plate 6.1-35**  
**View of the South Façade of Section L, Facing Northeast**  
The SAN Airfield Improvements and Terminal 1 Replacement Project  
*(Image courtesy of Google Street View)*

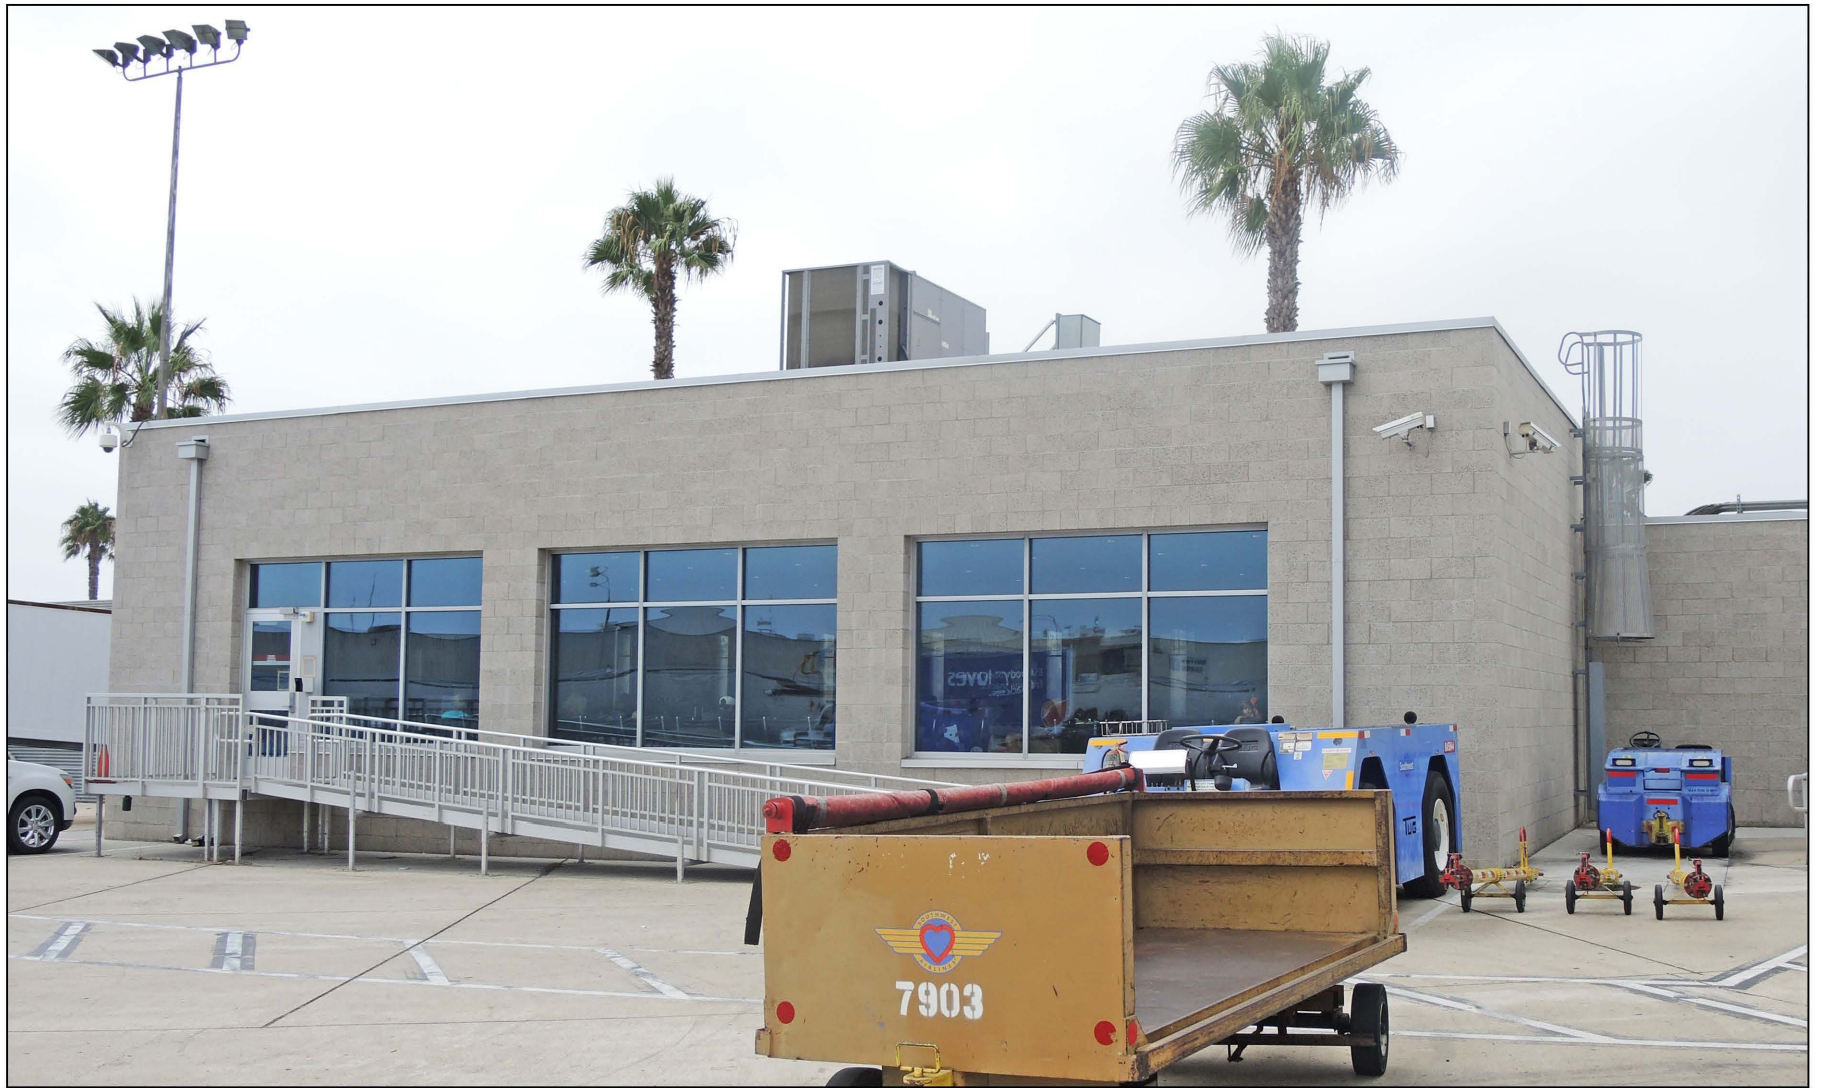
**Plate 6.1-36**  
**View of the North Façade of Section L, Facing South**  
The SAN Airfield Improvements and Terminal 1 Replacement Project

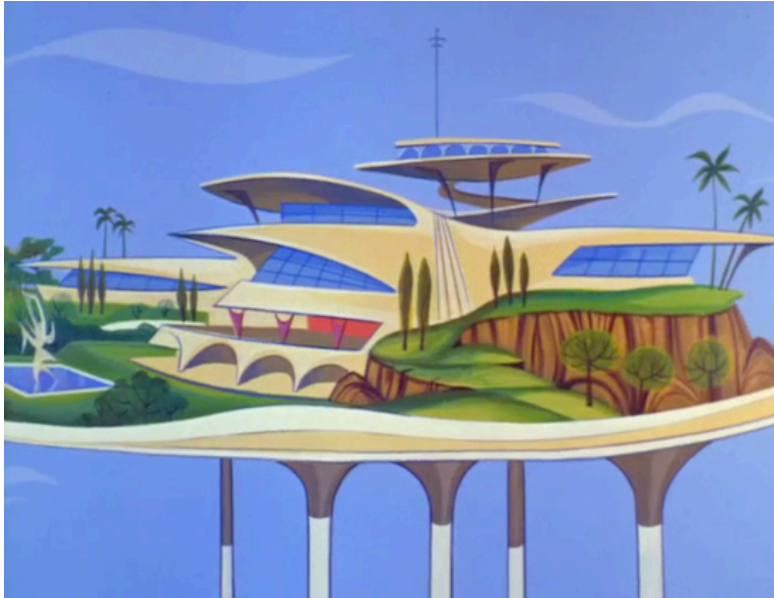
**Plate 6.1–37: Example of “Jetsons”-esque-style pillars.**  
*(Illustration courtesy of Smithsonian Magazine)*

columns in Terminal 2 East, which were described by the *San Diego Union* (1979) as “elegant poseurs” designed for “a purely aesthetic effect.” The curved tapering of the columns, which resemble “Jetsons”-esque supports (Plate 6.37–1), also introduce “abstract ... curved shapes” (City of San Diego 2007), a Primary character-defining feature of the Futurist architectural style. Therefore, the primary (south) façade of Section A does possess this Primary character-defining feature of Brutalism.

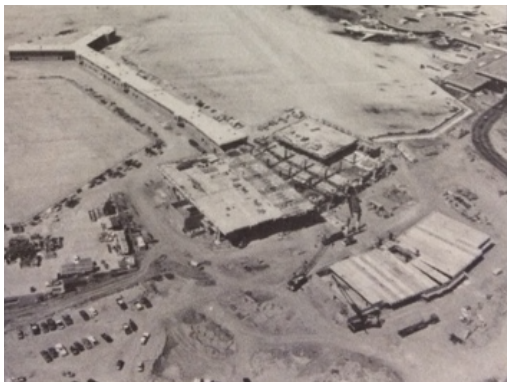
**Plate 6.2–2: Construction of Terminal 2 East in 1977. (Courtesy of San Diego Unified Port District 1991)**

Paderewski, Dean & Associates, who designed Terminal 1, was also selected to design Terminal 2 East, along with builder M.H. Golden Construction Co. (*San Diego Union* 1977a). Construction began in 1977, 100 yards west of Terminal 1 (Plate 6.2–2). Terminal 2 East opened to the public on July 11, 1979, over six months after its projected completion date (*San Diego Union* 1979a), with 10 gates that were exclusively operated by American Airlines, Western Airlines, and Delta Airlines (*San Diego Union* 1979a). When originally constructed, Terminal 2 East was referred to as the "West Terminal" and Terminal 1 was referred to as the

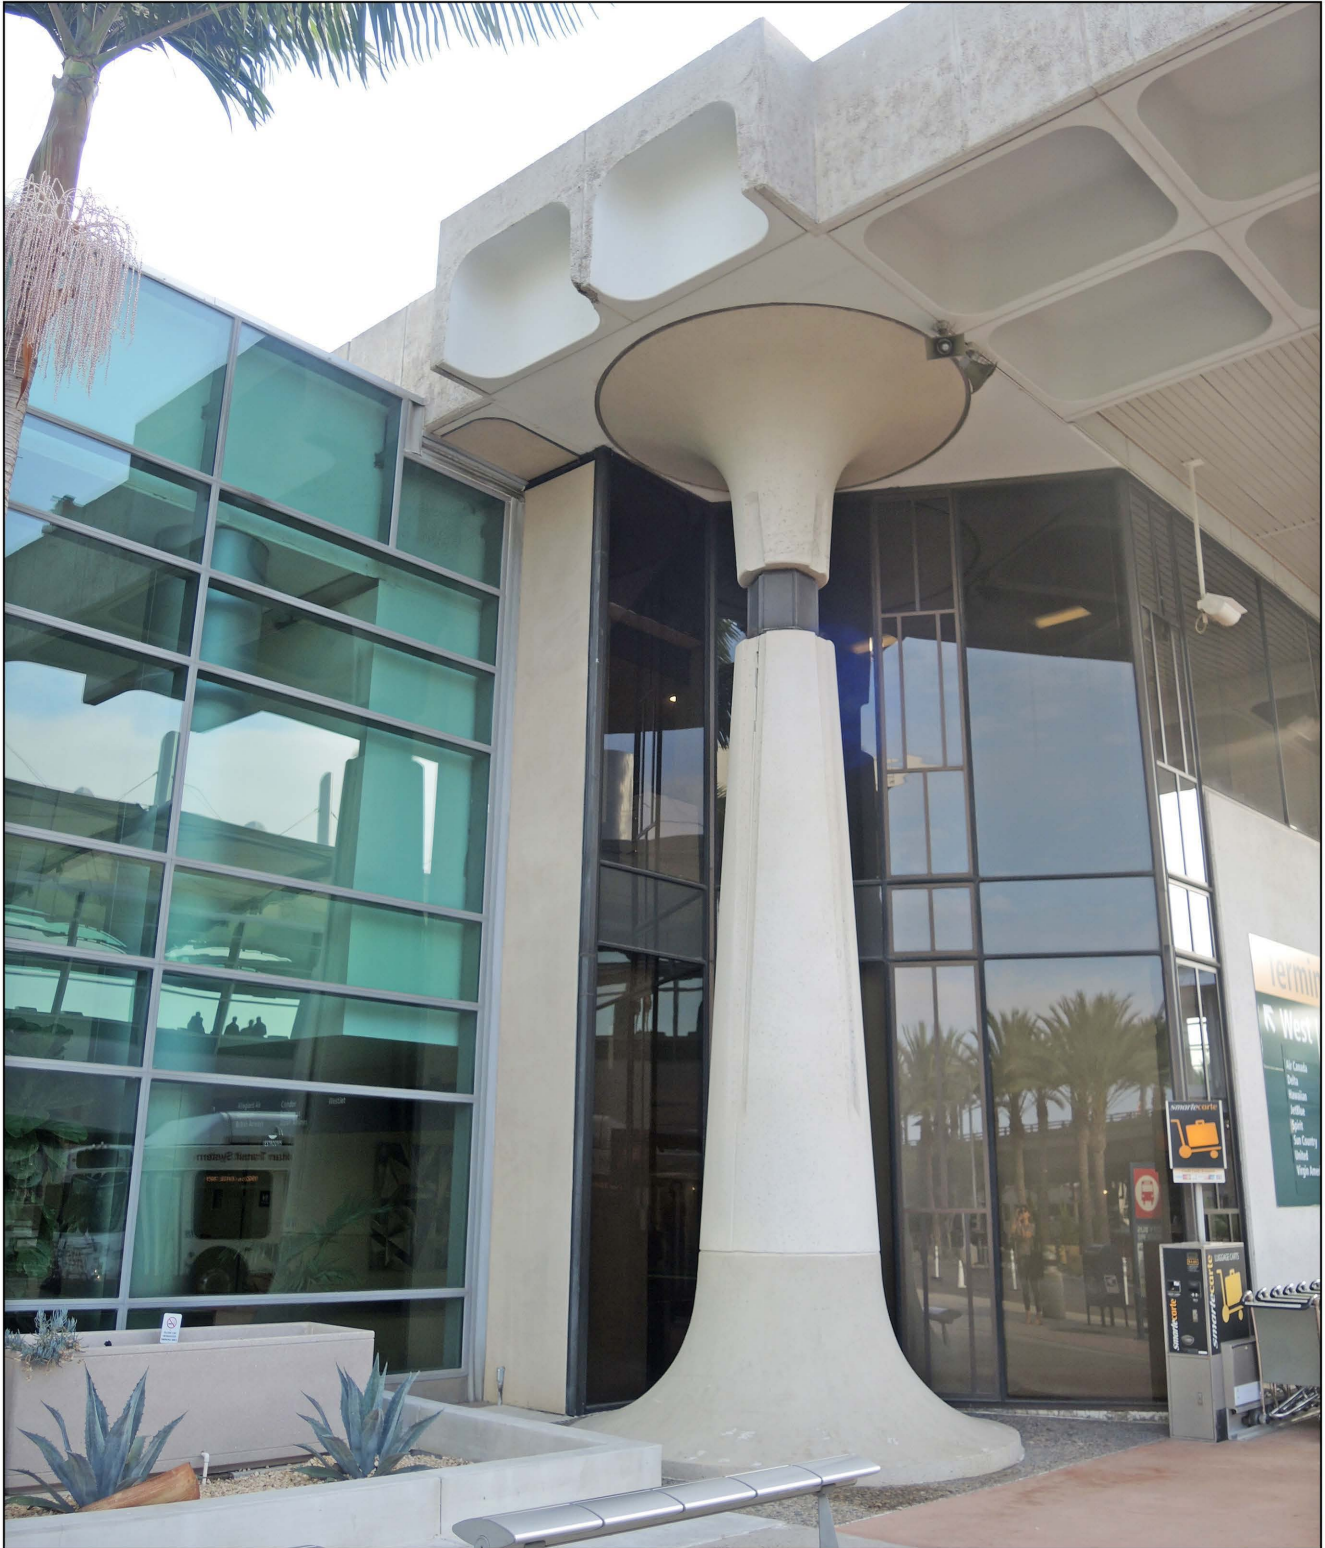
**Plate 6.2-4**

**One of 10 Concrete Support Columns on the  
Primary (South) Façade of Section A, Facing Northeast**  
The SAN Airfield Improvements and Terminal 1 Replacement Project

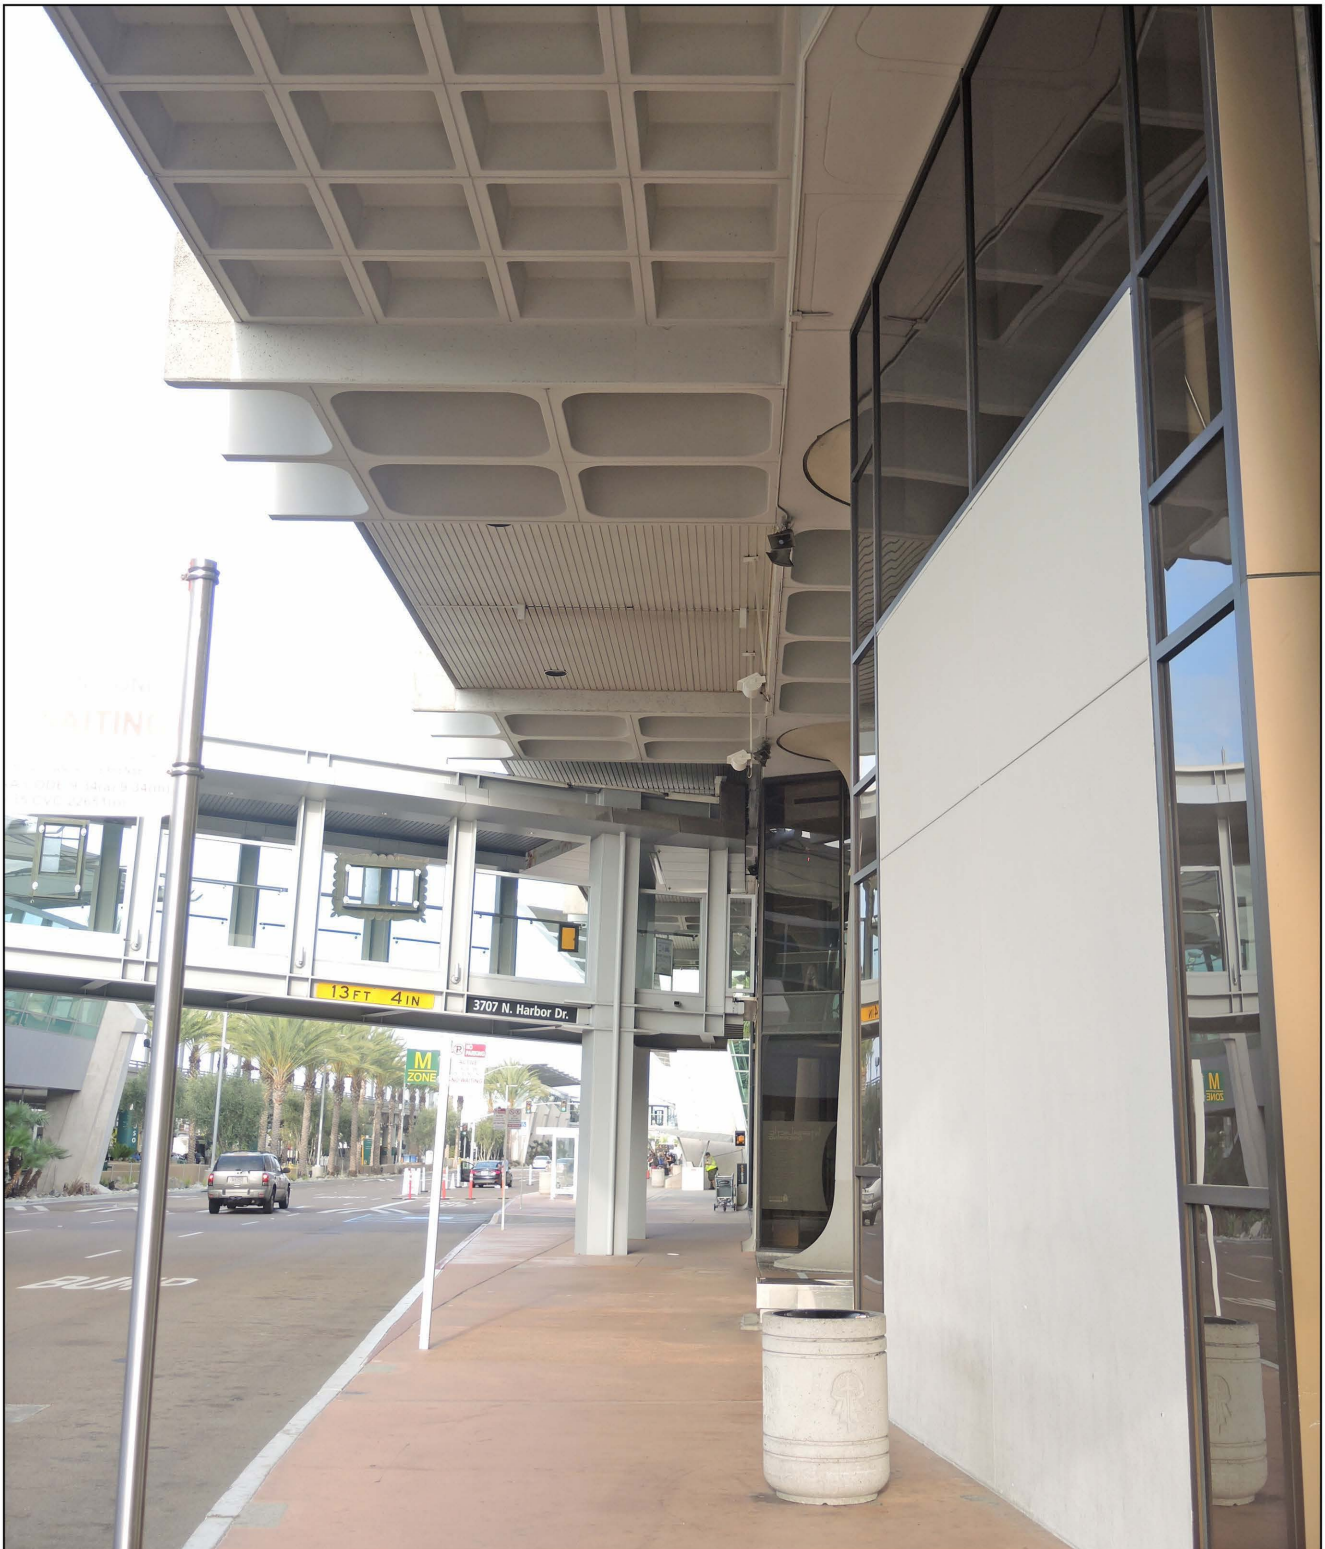
**Plate 6.2-6**

**Current View of the Mixed Concrete Waffle-Slab  
and Vinyl Roof System Under the Primary (South)  
Façade Roof Overhang of Section A, Facing West**

Rehabilitation recommend the use of materials that differentiate additions from an original building, Sections C through J have greatly obscured the original west, north, and east façades of Terminal 2 East, which does not conform. In addition, the removal of the original materials associated with the original sky bridge and baggage claim building negatively impacted integrity of materials on the primary (south) façade of Section A. Therefore, Terminal 2 East does not retain integrity of materials.

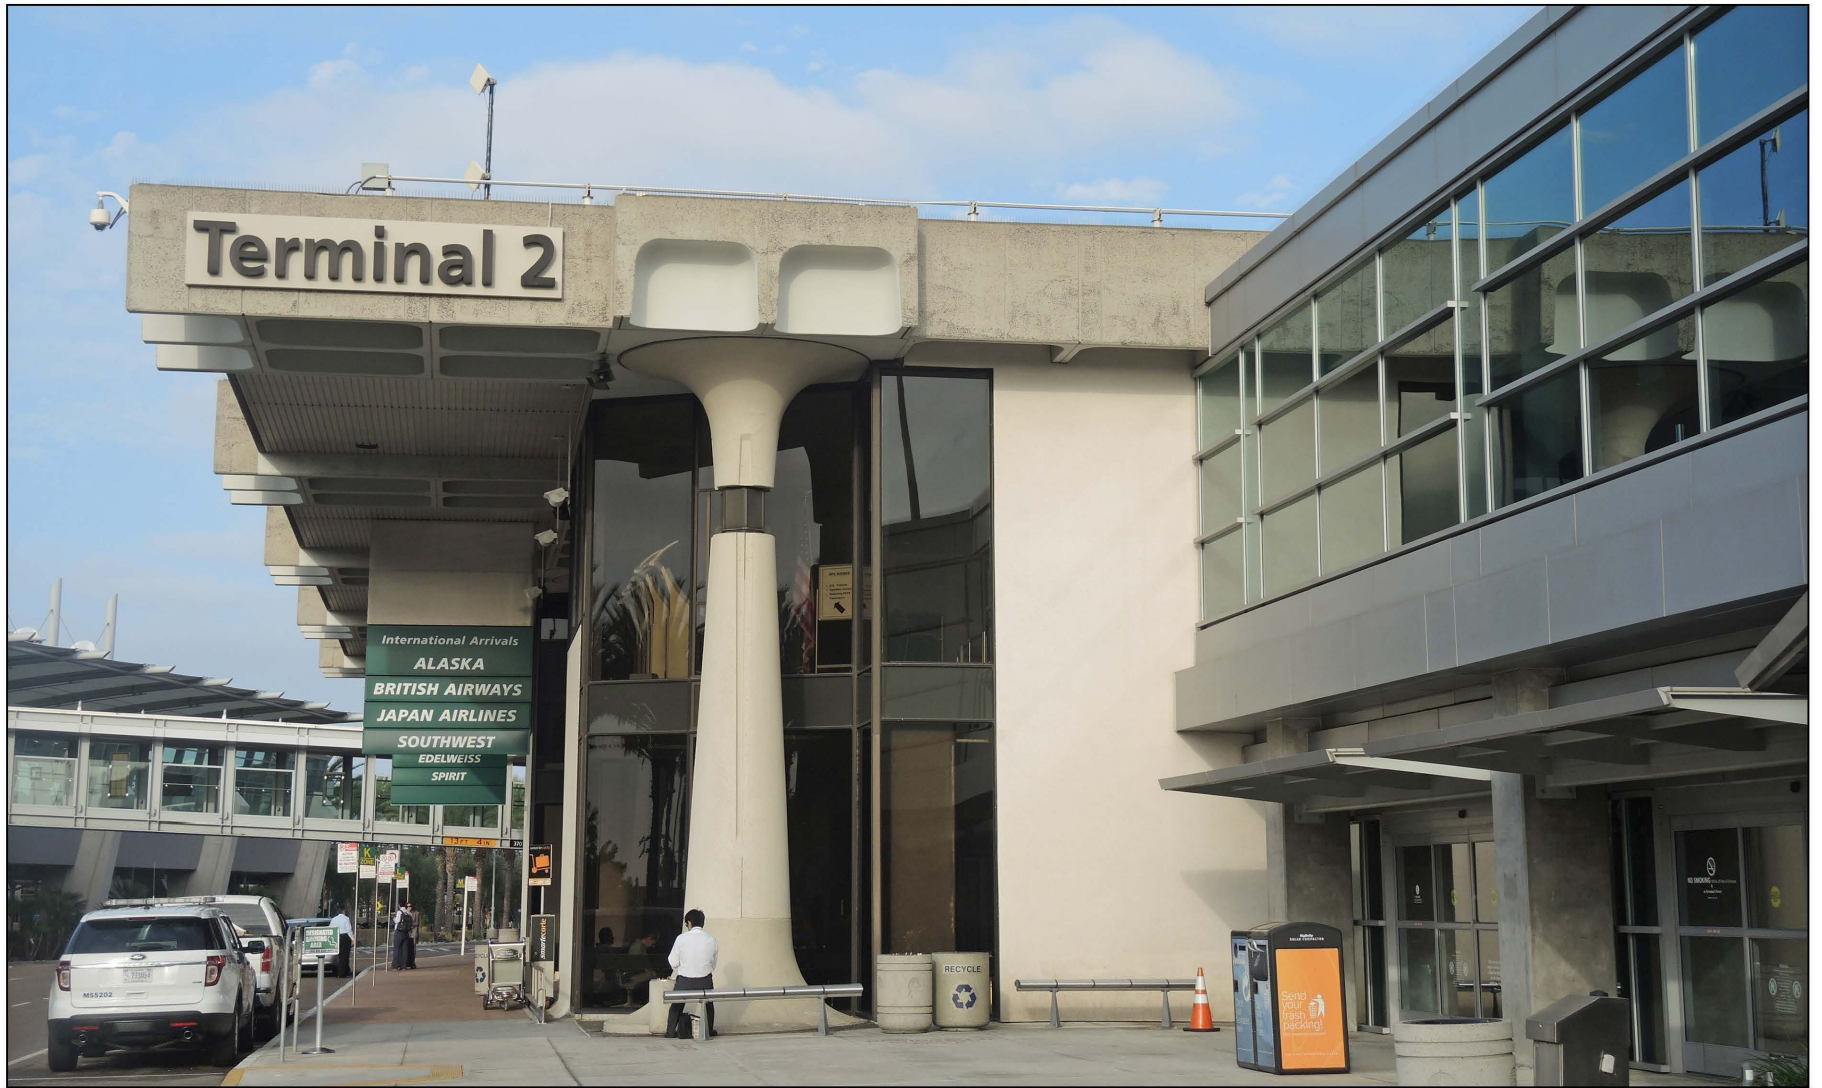
**Plate 6.2-7**

**View of the Primary (South) Façade of Section A, Facing West**

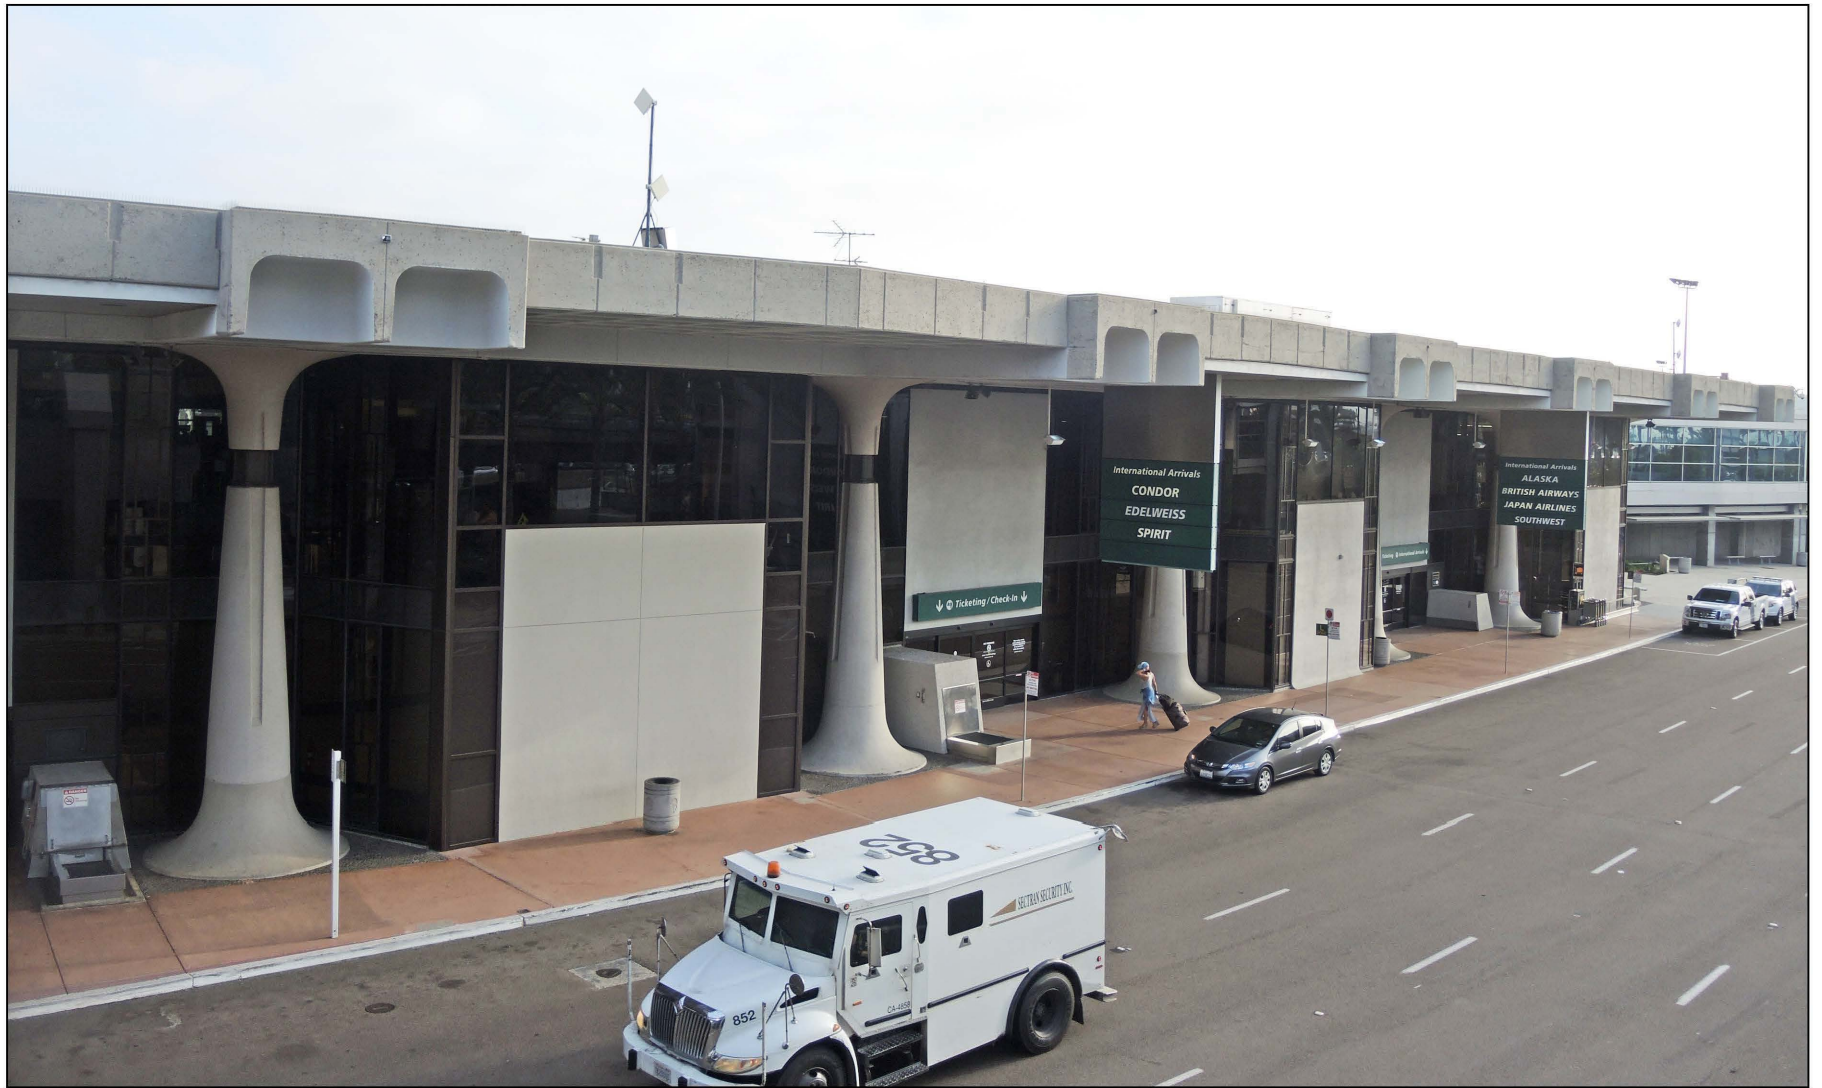
### Plate 6.2-8

### View of the Primary (South) Façade of Section A, Facing Northeast

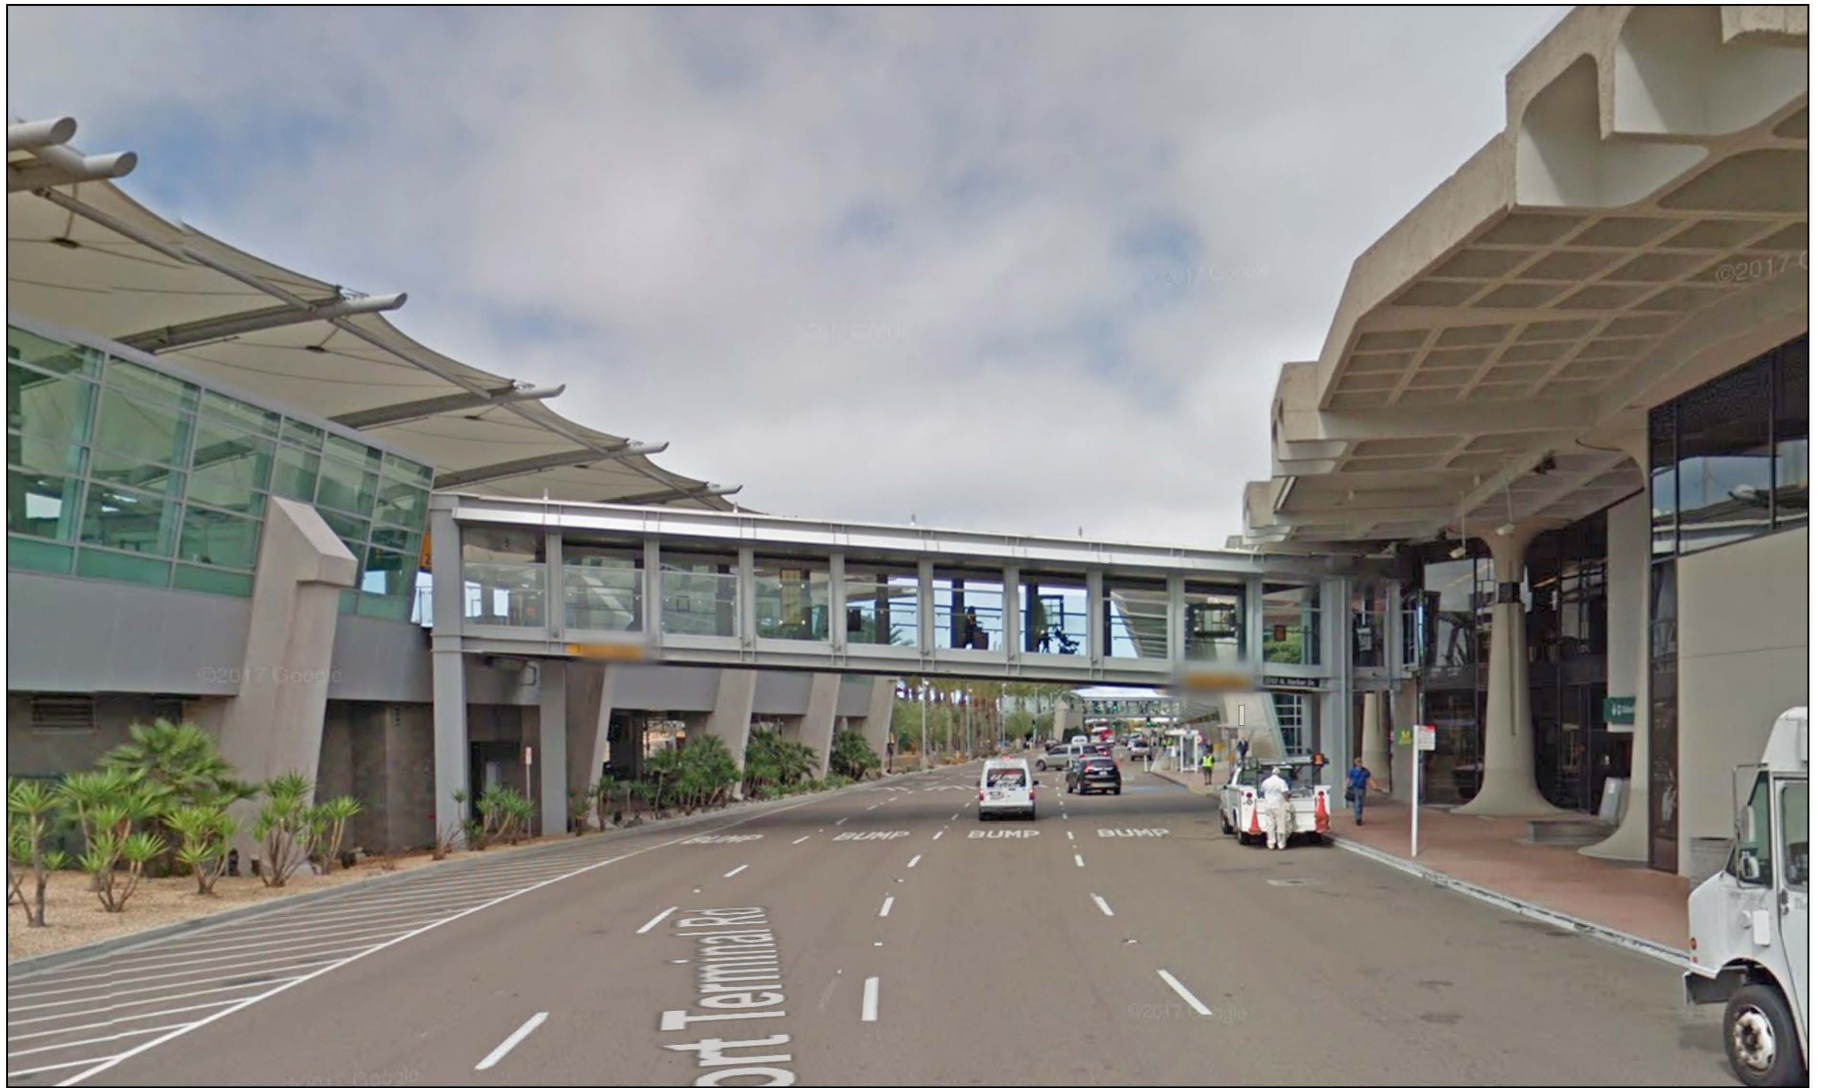
**Plate 6.2-9**

Section B, a sky bridge, was built toward the west side of the primary (south) façade of Section A in 2012. Section B is made of modern metal and glass and connects to a covered-canopy loading zone across the circulation road (Plate 6.2–9). The original baggage claim building, which used to be located across the interior circulation road, was accessible through a now-demolished sky bridge that was attached to the middle of the primary (south) façade of Section A. The original baggage claim building and original sky bridge were demolished in 2010.

**View of Section B Extending Off the Primary (South) Façade of Section A,  
Leading to the Covered Loading Zone Across the Circulation Road, Facing West**
