**Section 106 Assessment for the San Diego International Airport Airfield  
Improvements and Terminal 1 Replacement Project**

**SECTION 106 ASSESSMENT FOR THE  
SAN DIEGO INTERNATIONAL AIRPORT  
AIRFIELD IMPROVEMENTS AND  
TERMINAL 1 REPLACEMENT PROJECT**

**CITY OF SAN DIEGO, CALIFORNIA**

***November 10, 2020; Revised January 8, 2021; Revised February 19, 2021;  
Revised March 12, 2021; Revised April 27, 2021; Revised May 7, 2021***

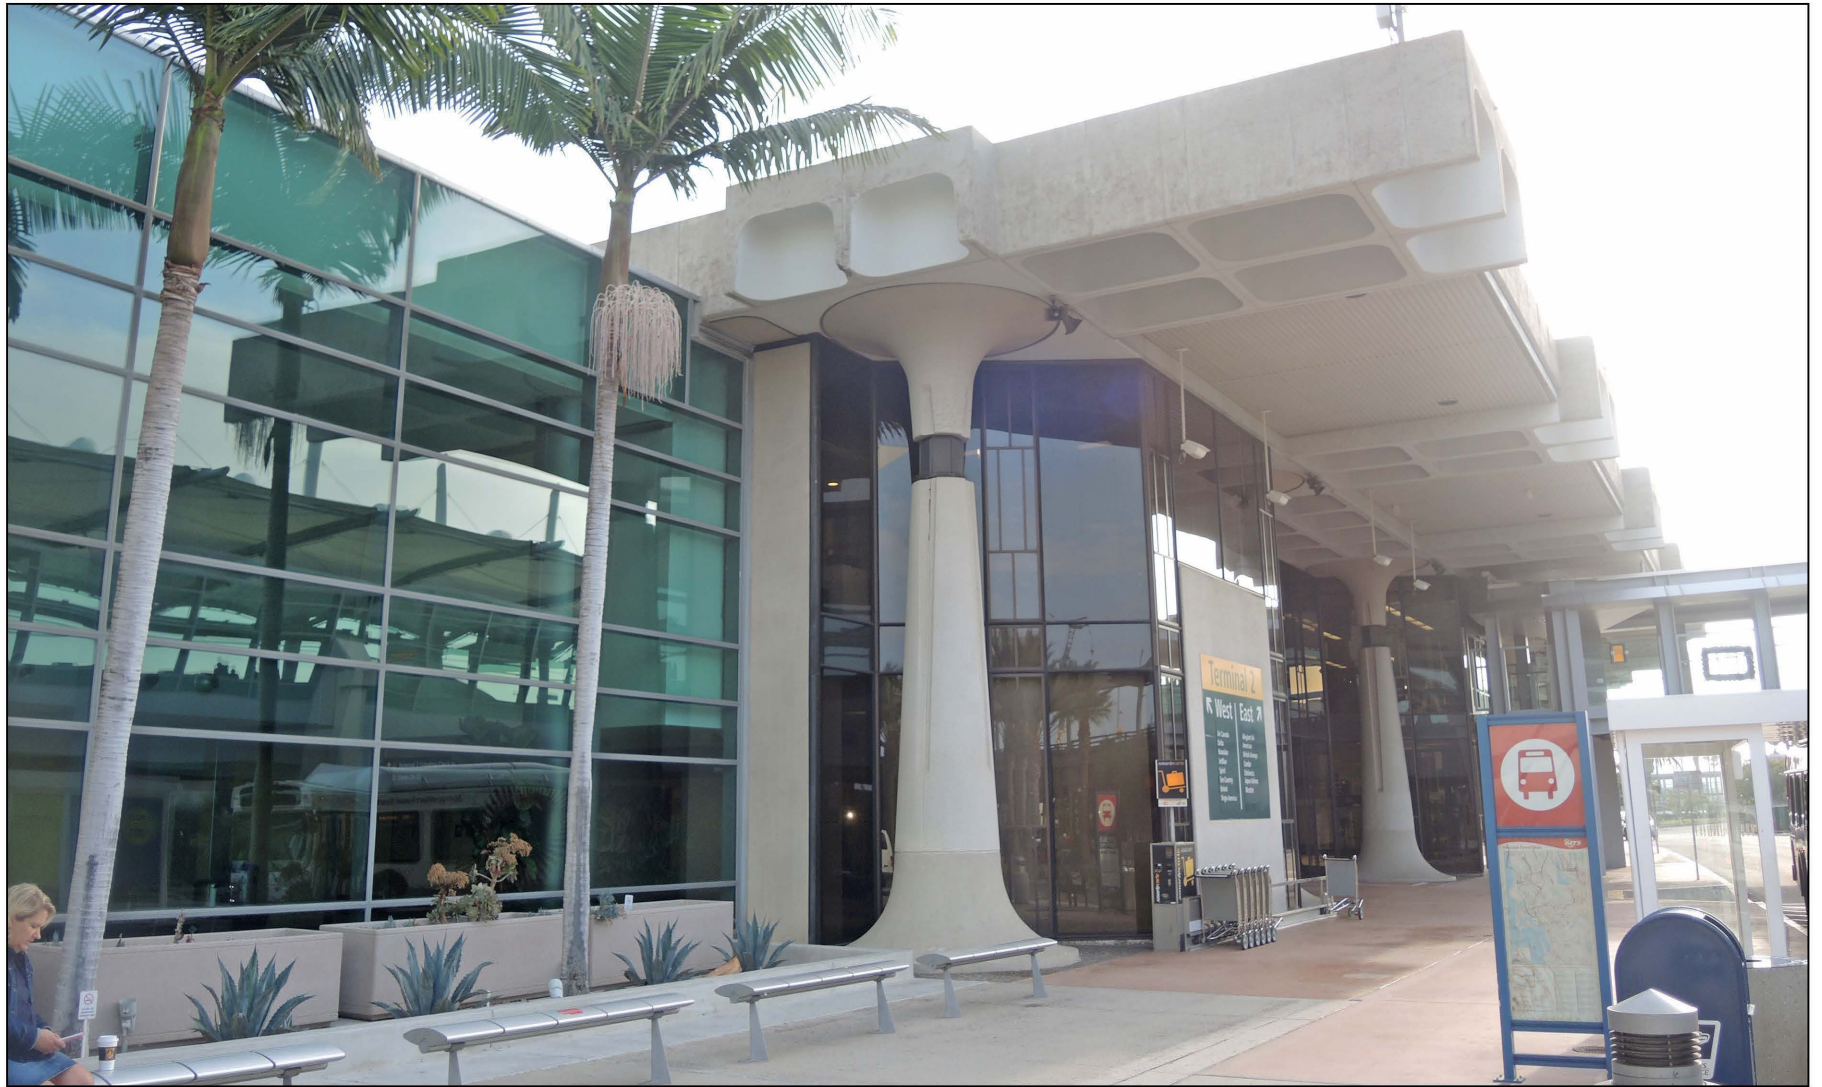
**Plate 6.2-10**

**View of the Coffered Concrete Overhang and a Concrete Support Column on the West Façade of Section A, Facing Northeast**

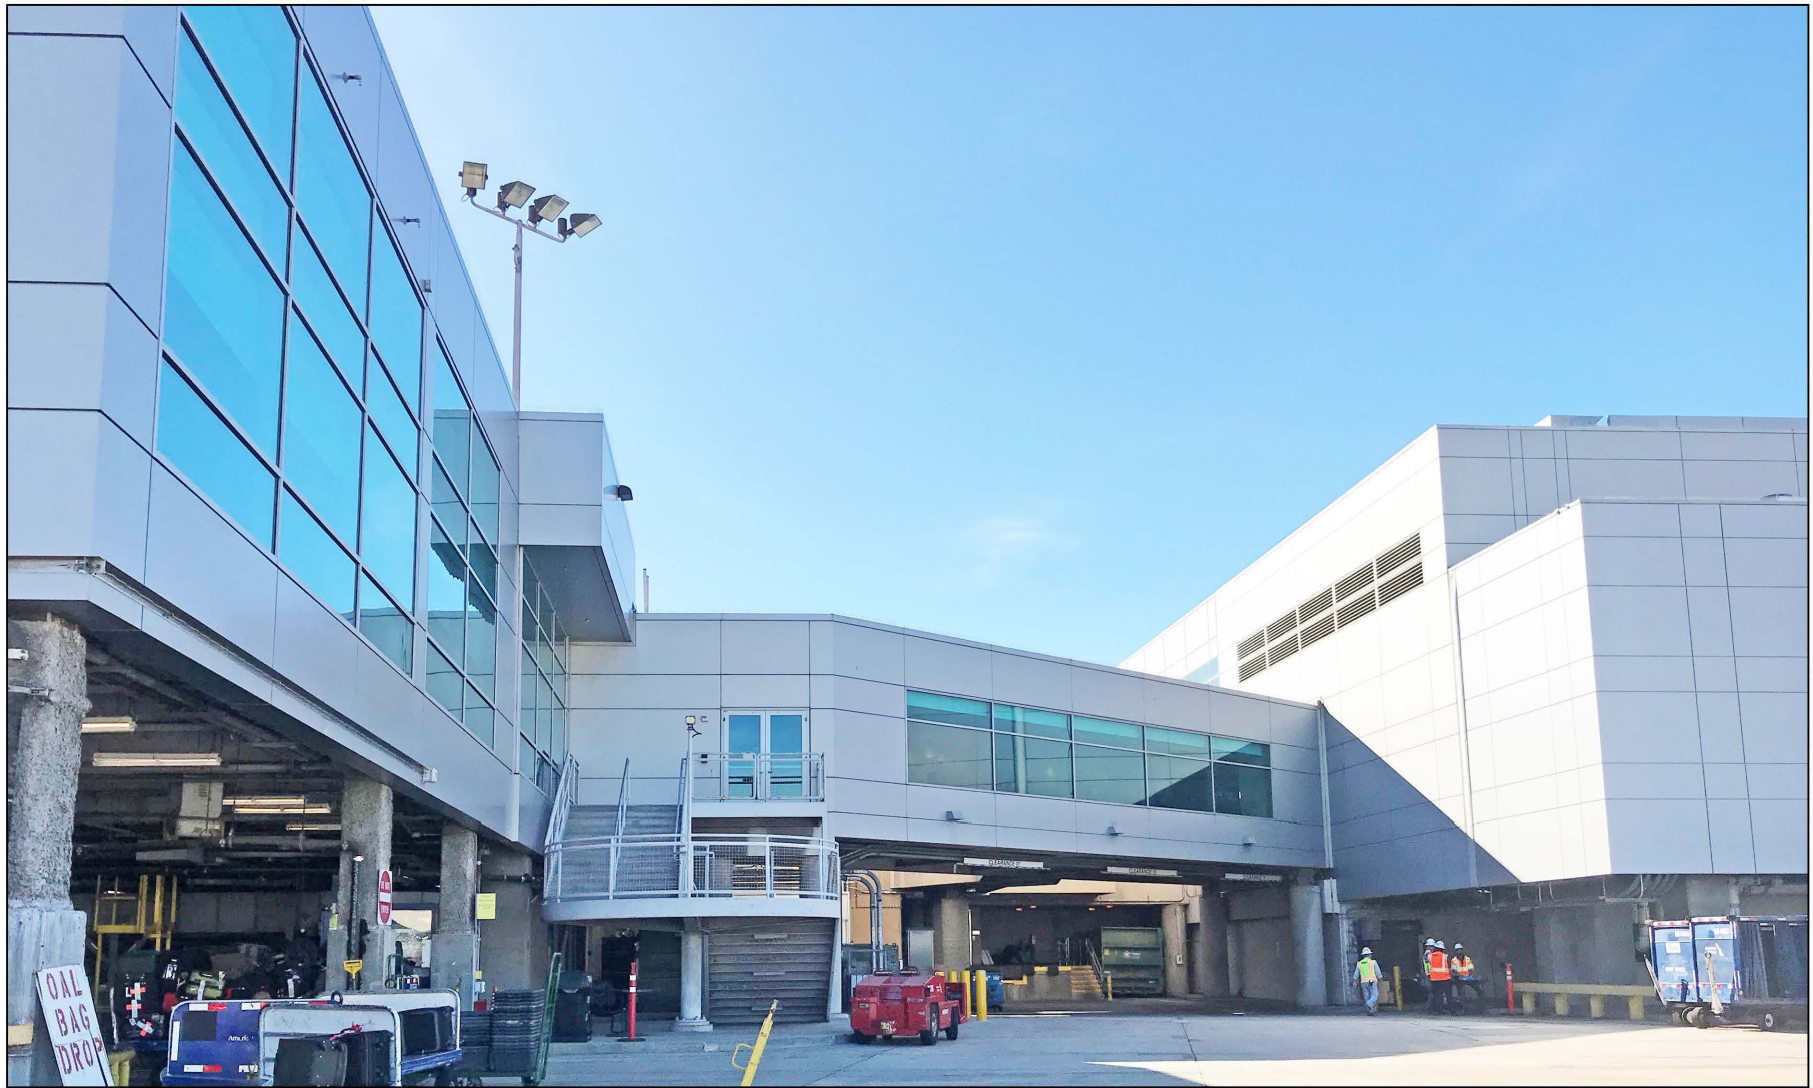
**Plate 6.2-12**

**View of the North Façade of Section C Connecting the West Façade of  
Section A (Left) With the East Façade of Terminal 2 West (Right), Facing South**

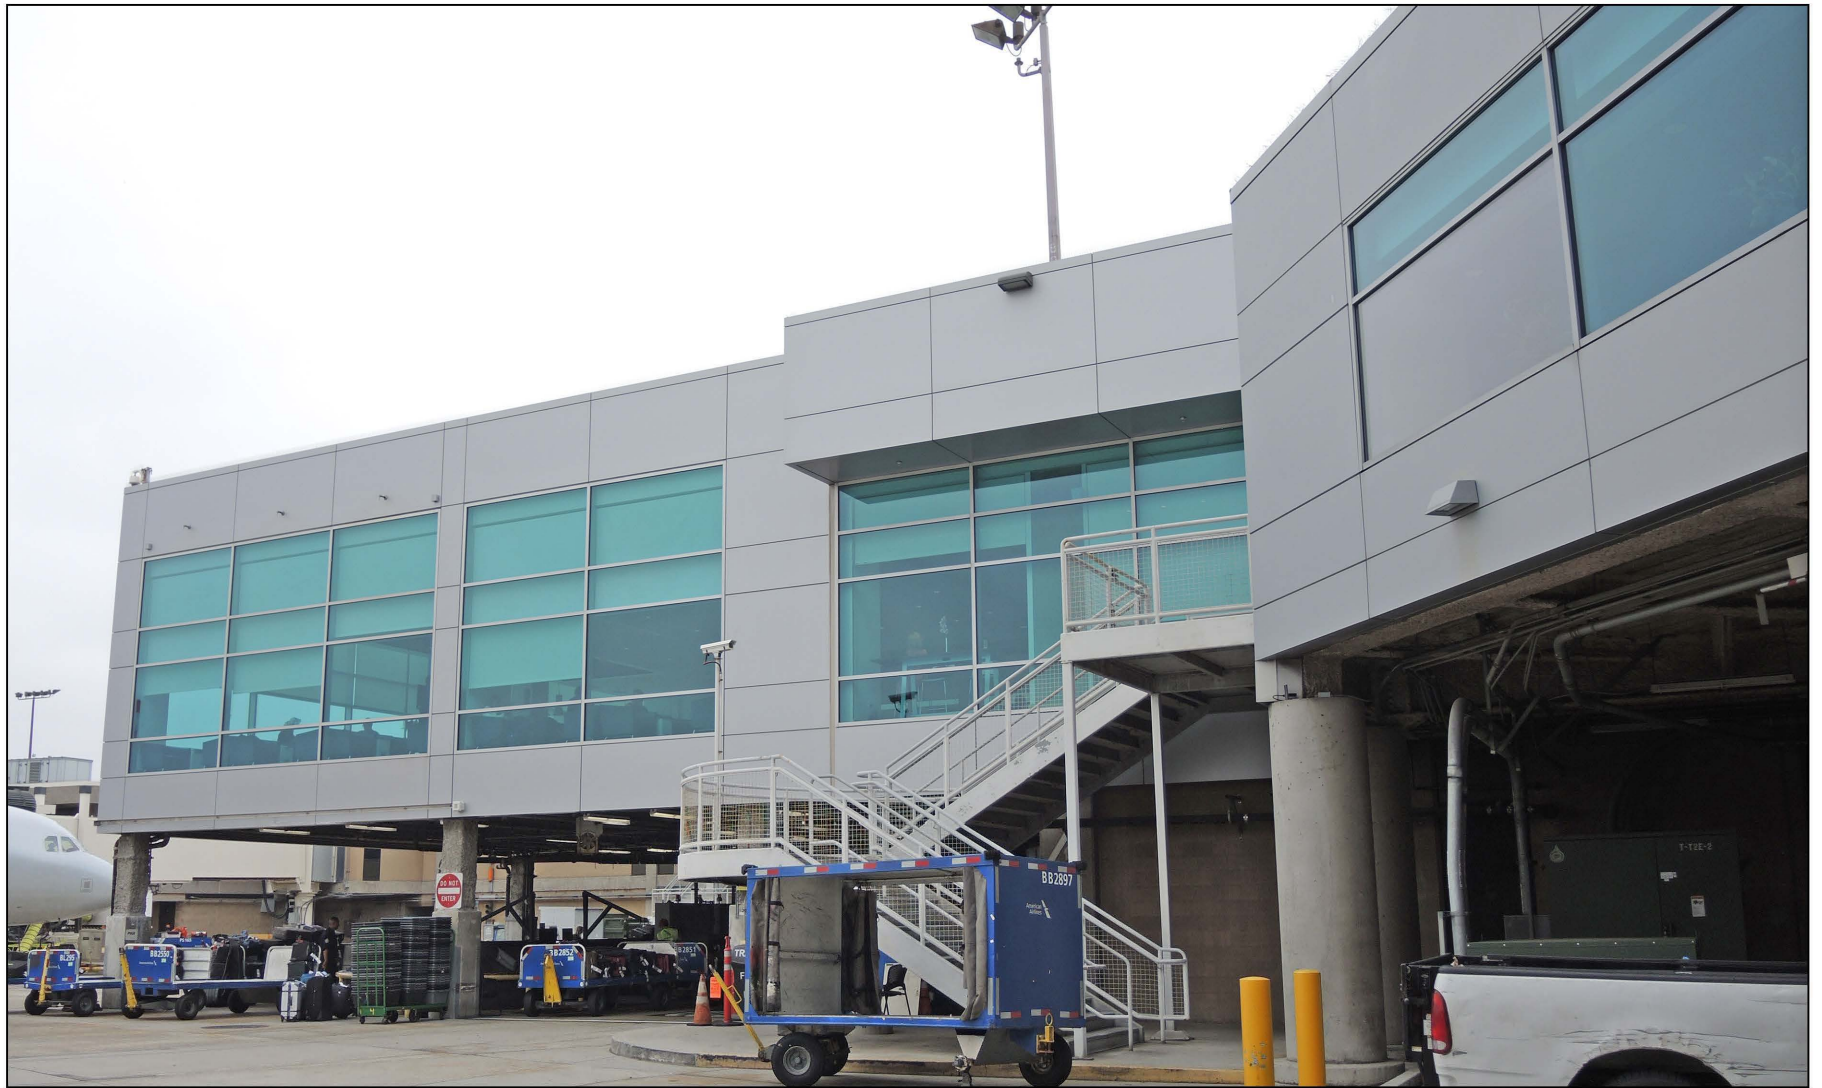
**Plate 6.2-13**

**View of the West Façade of Section D (Left), Facing East**

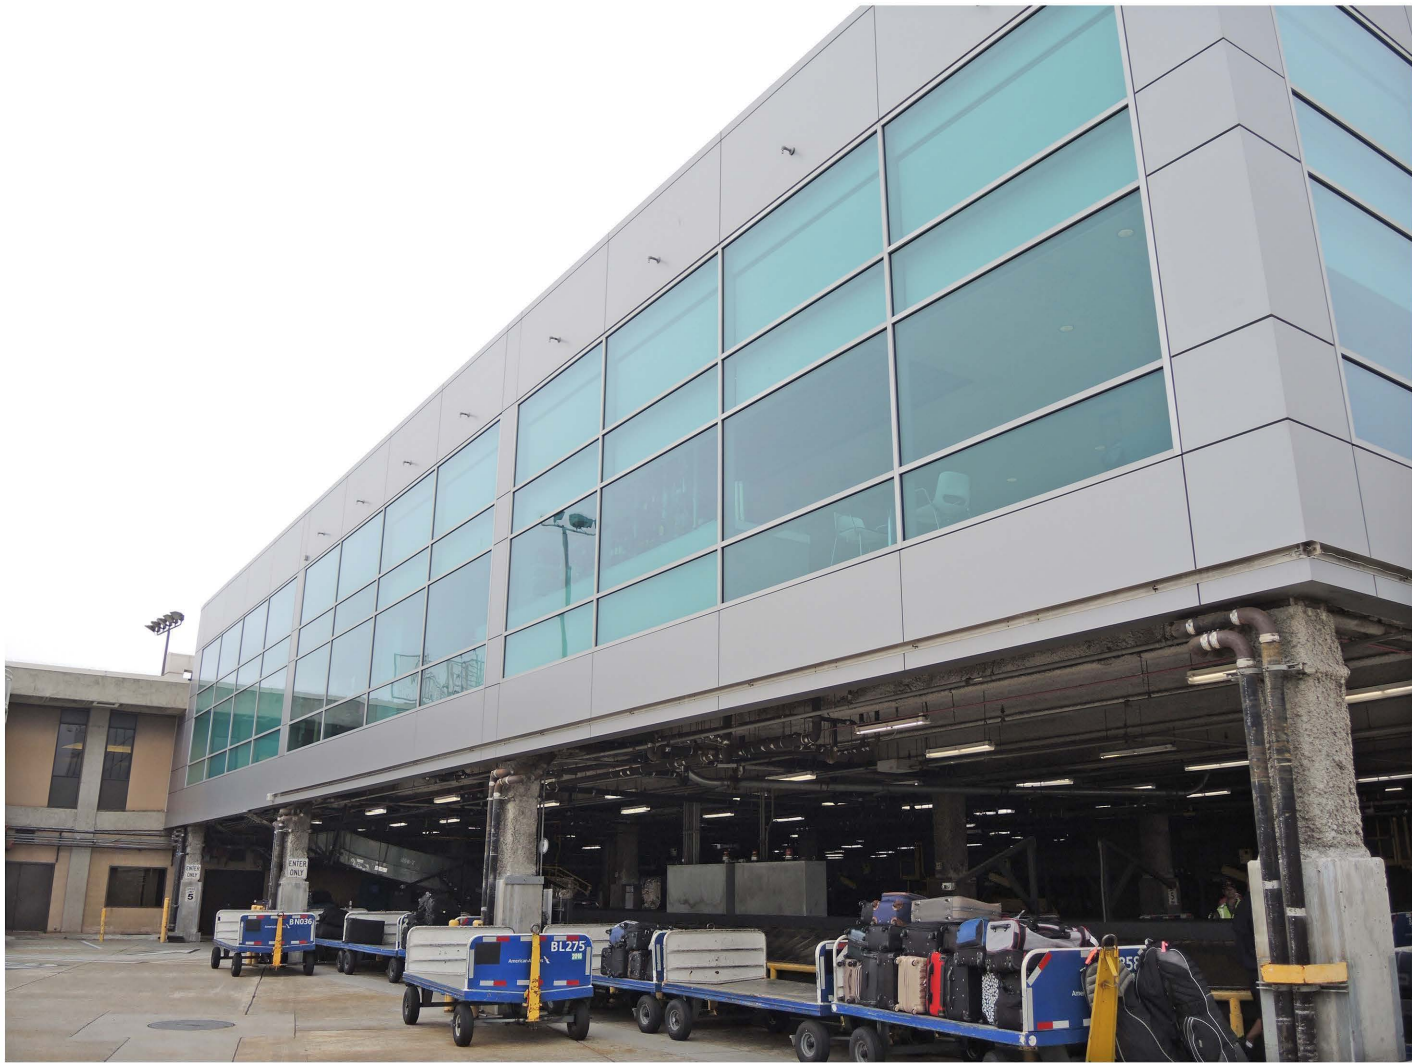
**Plate 6.2-14**

**View of the North Façade of Section D, Facing Southeast**

The north façade of Section A has been heavily altered. Section D comprises the westernmost section of the north façade of Section A (Plate 6.2–14). East of Section D is an original two-story section of the Section A concourse wing, with a concrete band separating the first and second stories (Plate 6.2–15). The first floor is primarily comprised of concrete brick, simple metal doors, and fixed-pane windows; the second story is comprised of smooth stucco, fixed-pane windows, and a coffered concrete overhang (see Plate 6.2–15). Just north is Section E, a trapezoidal-shaped addition that was constructed between 1991 and 1994 and is divided horizontally and vertically by concrete bands. The first floor is comprised of concrete block, fixed-pane windows, and simple metal entrance doors; the second story is comprised of smooth stucco and fixed-pane windows with a coffered concrete overhang (Plates 6.2–16 and 6.2–17).

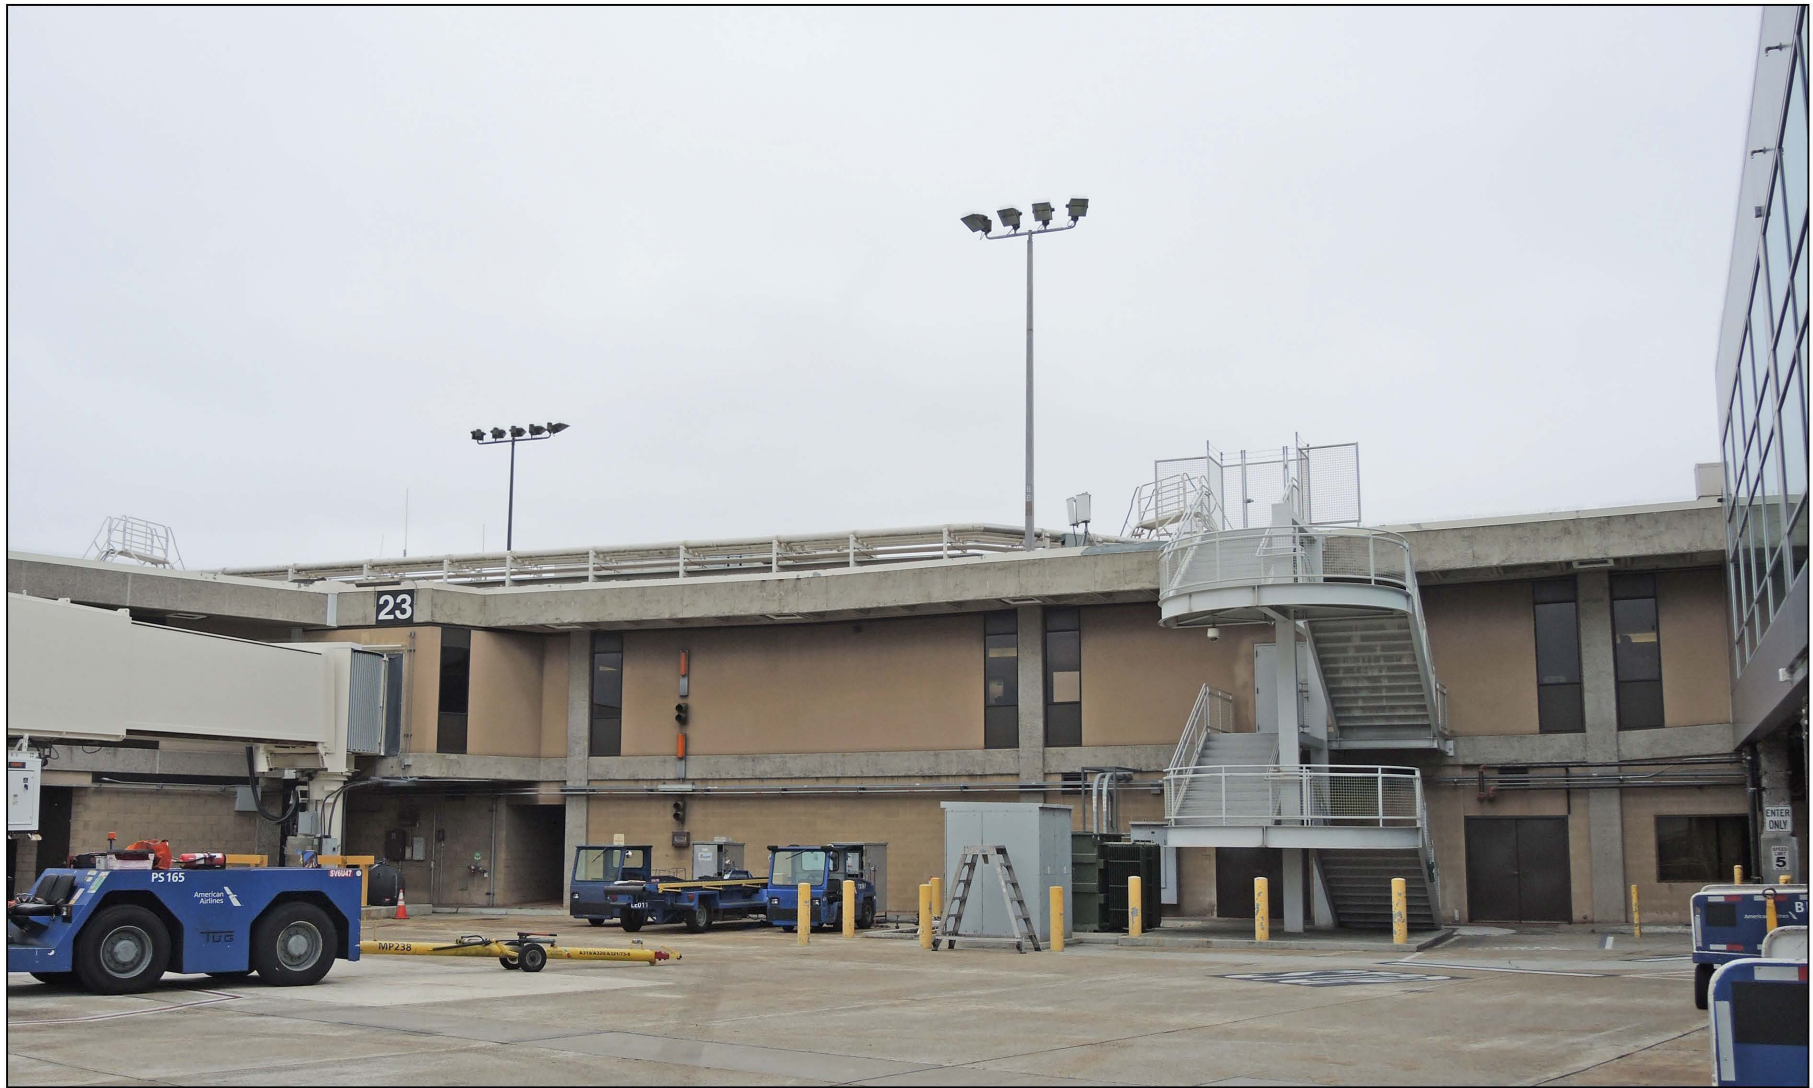
**Plate 6.2-15**

**View of the West Façade of the Section A Concourse Wing at  
the Connection With the Main Terminal Building, Facing East**

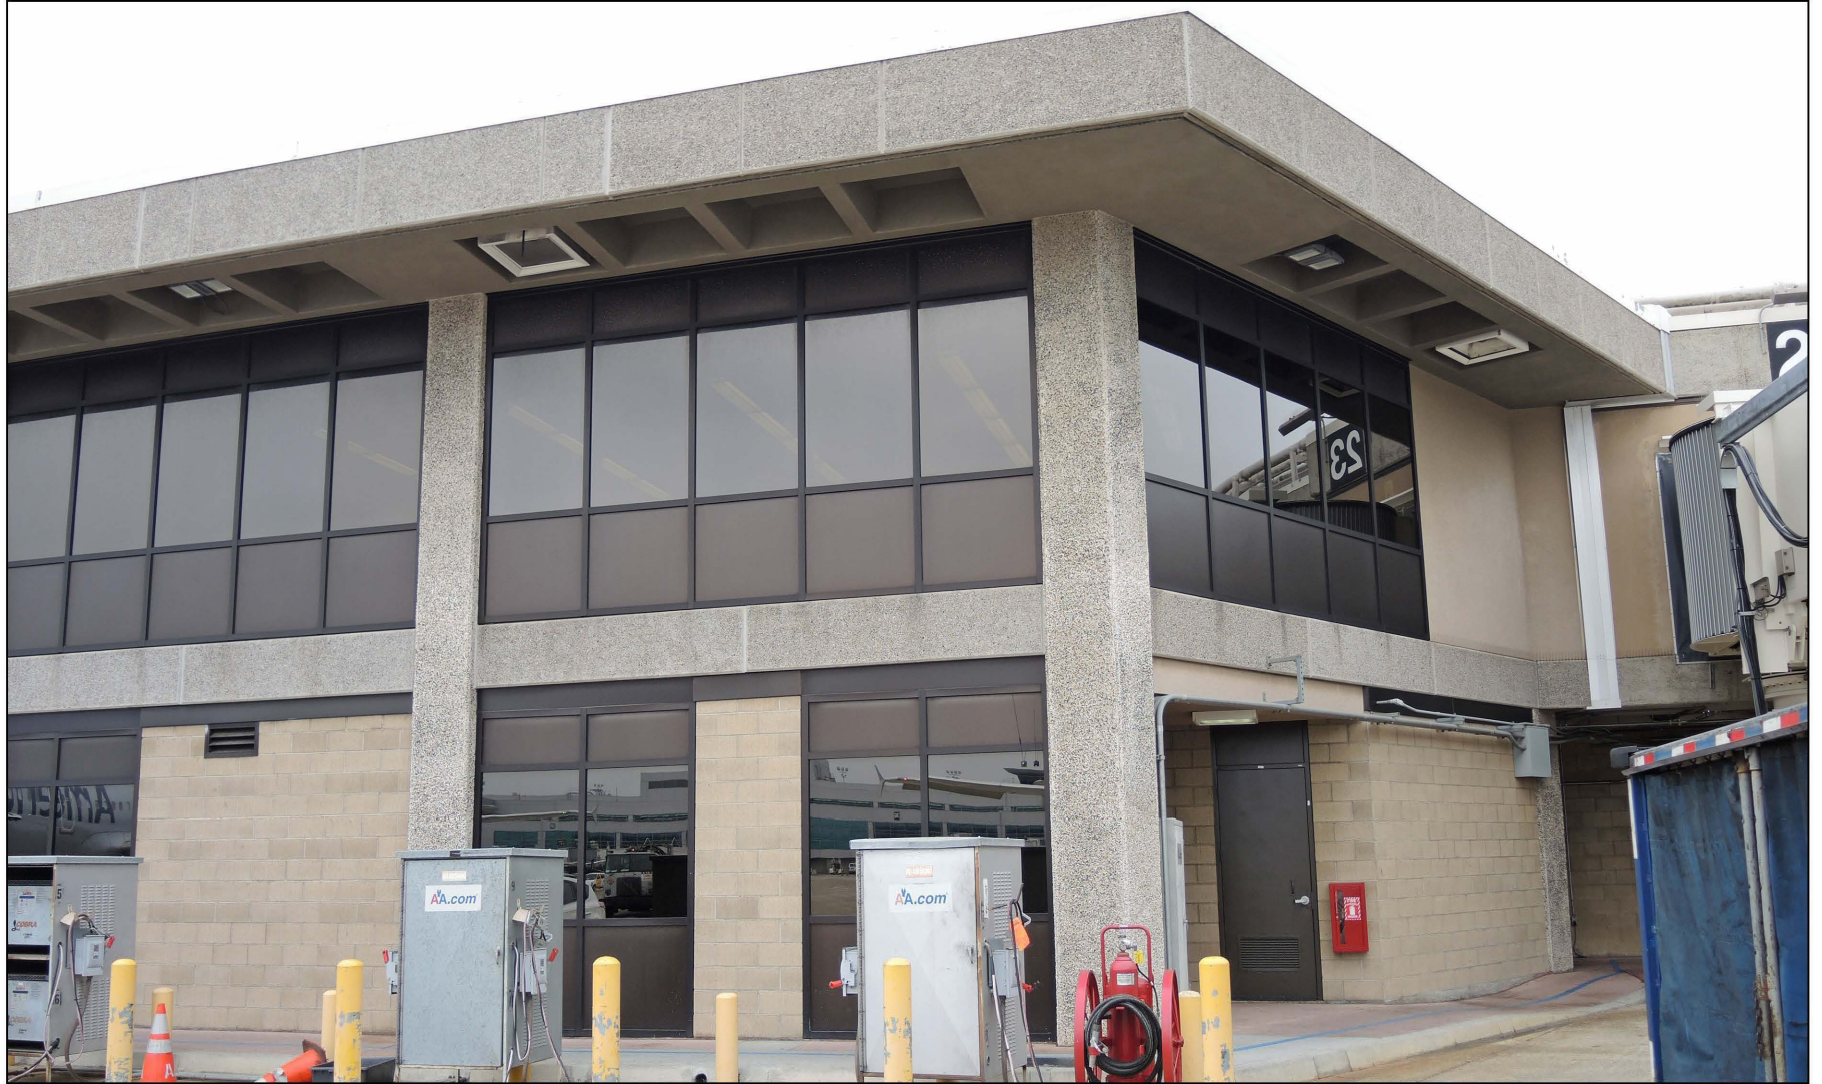
**Plate 6.2-16**

**View of the Southern Portion of Section E, Facing Northeast**

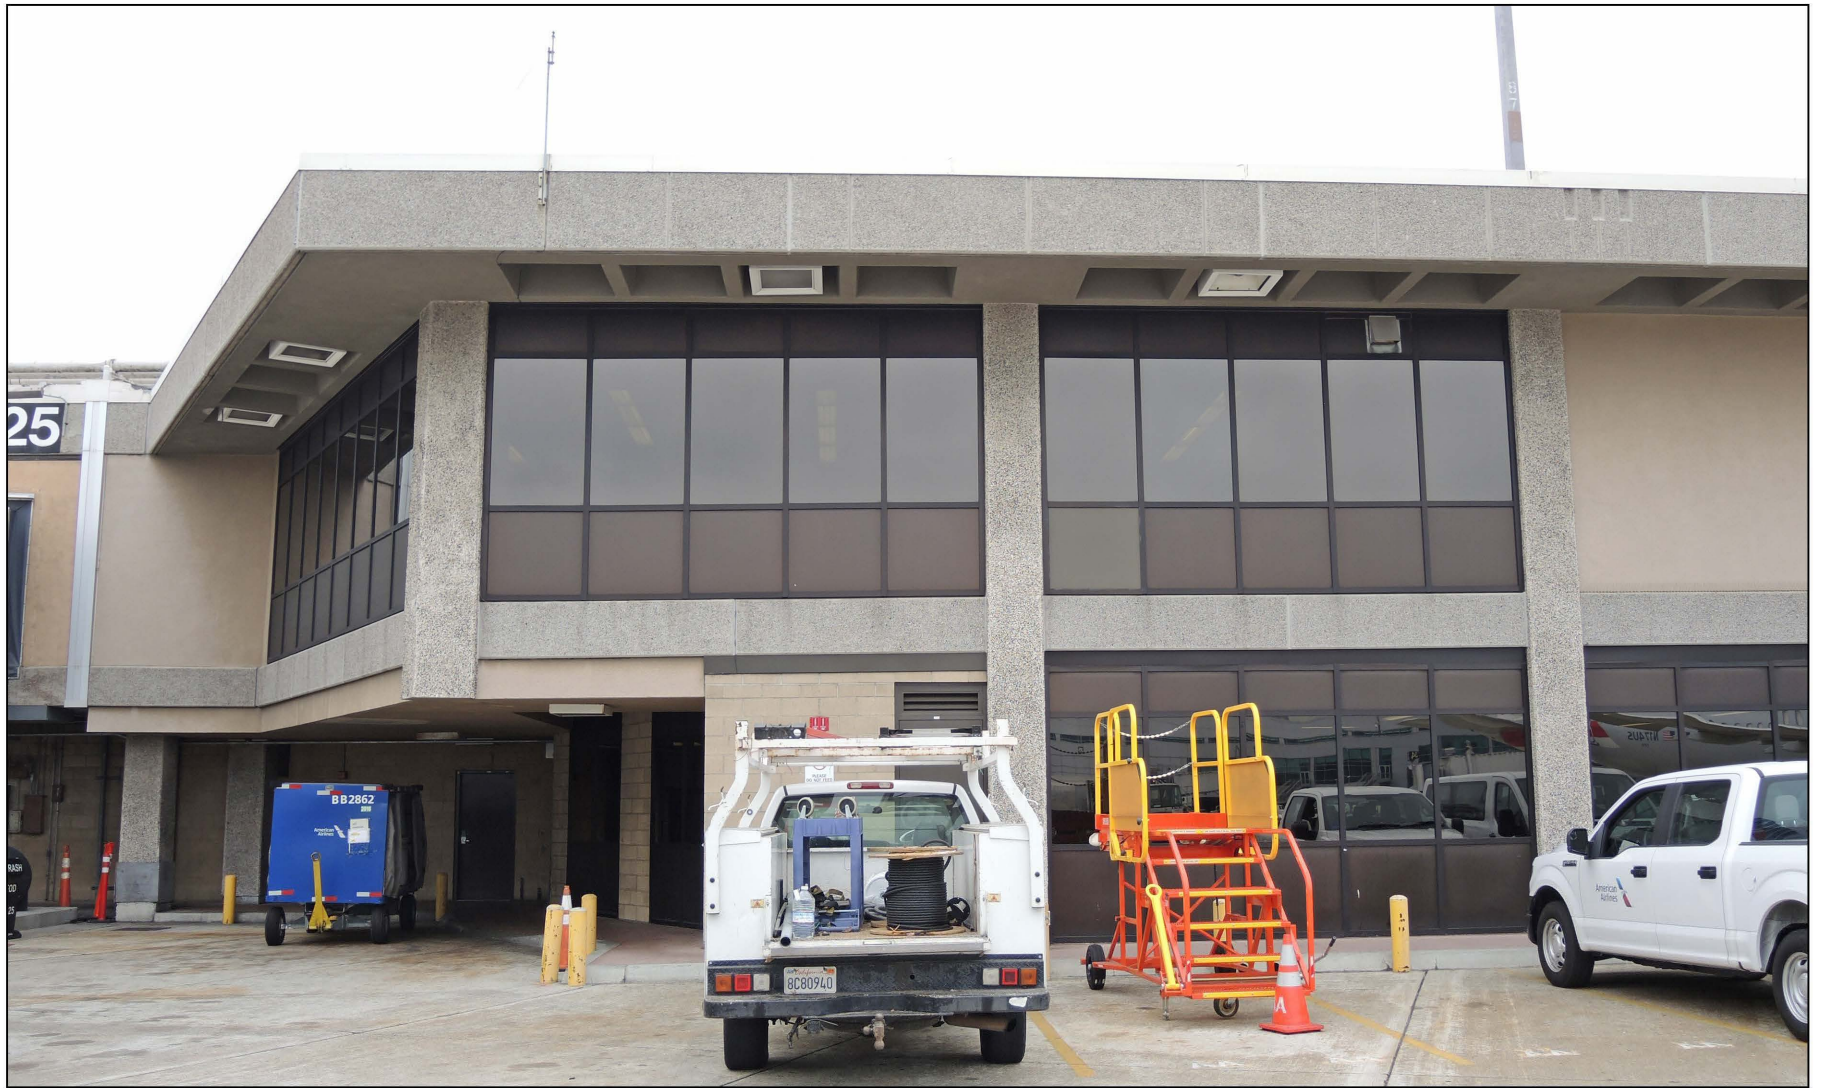
**Plate 6.2-17**

**View of the Northern Portion of Section E, Facing East**  
**The SAN Airfield Improvements and Terminal 1 Replacement Project**

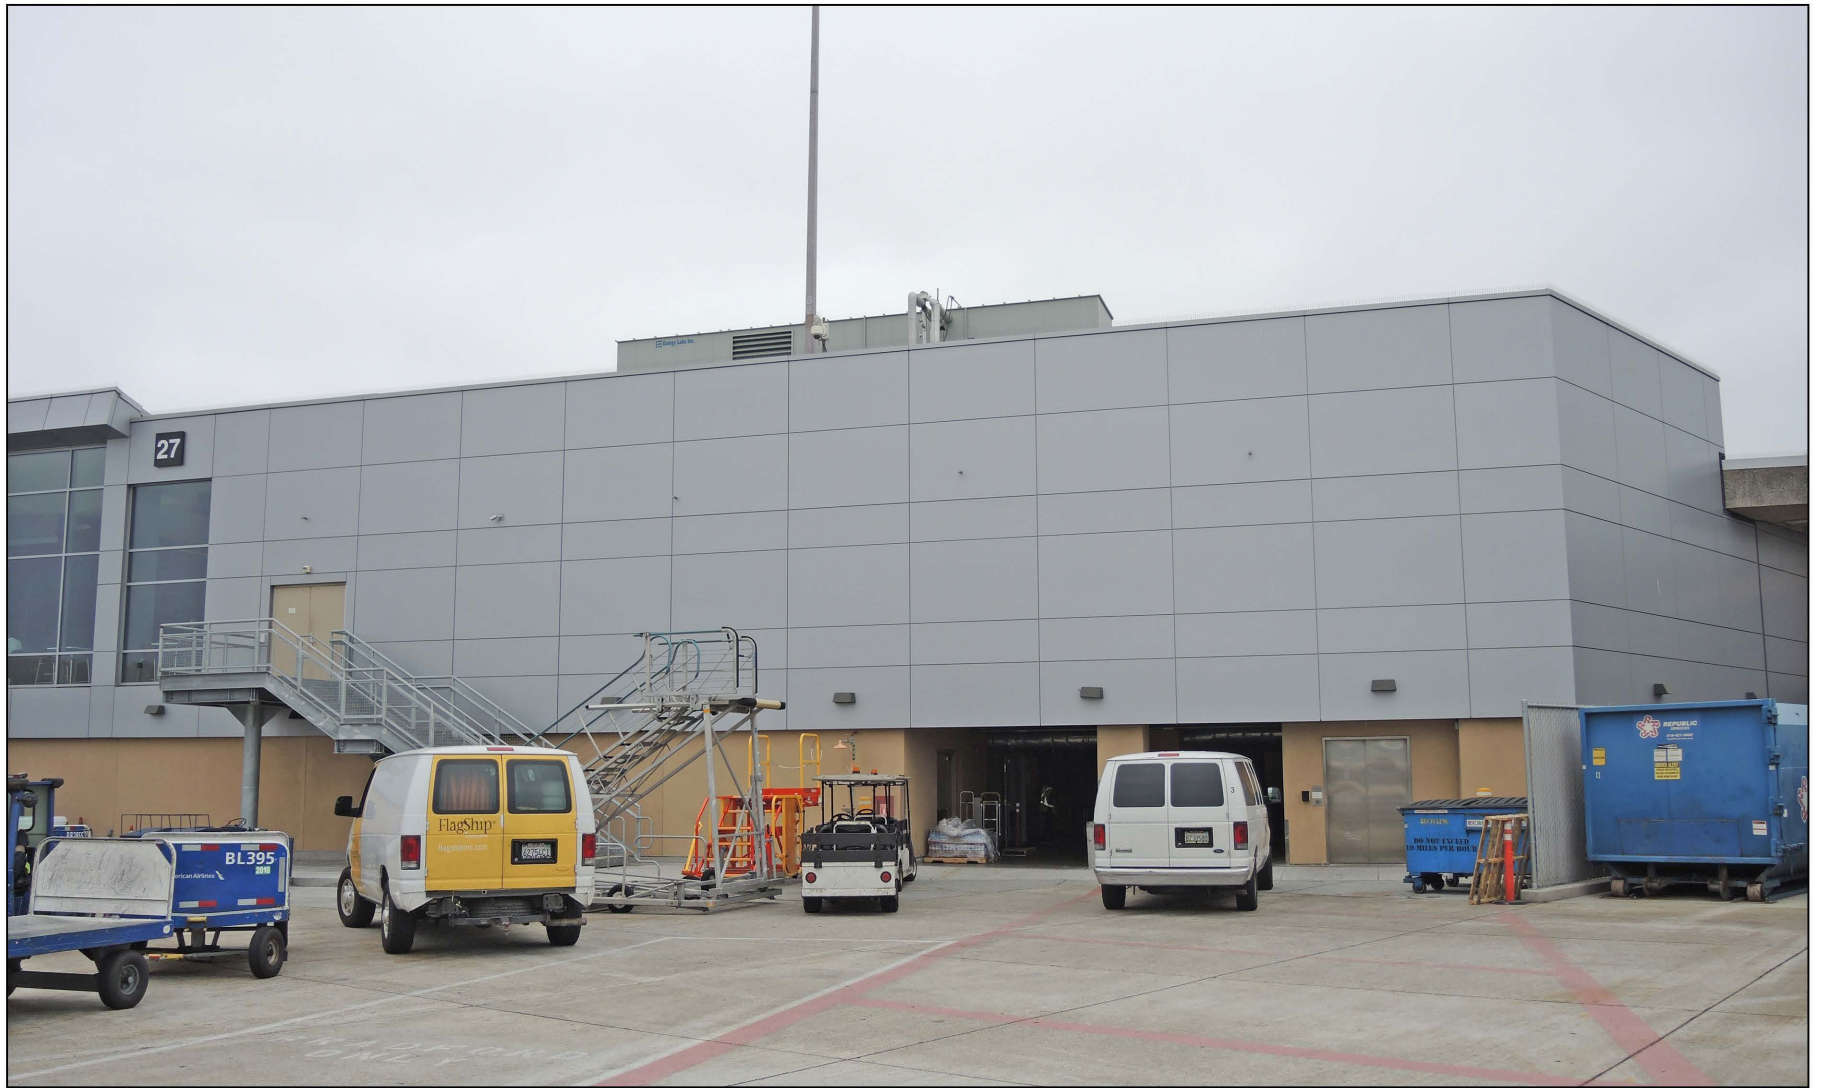
**Plate 6.2-19**

**View of the West Façade of Section G, Facing East**

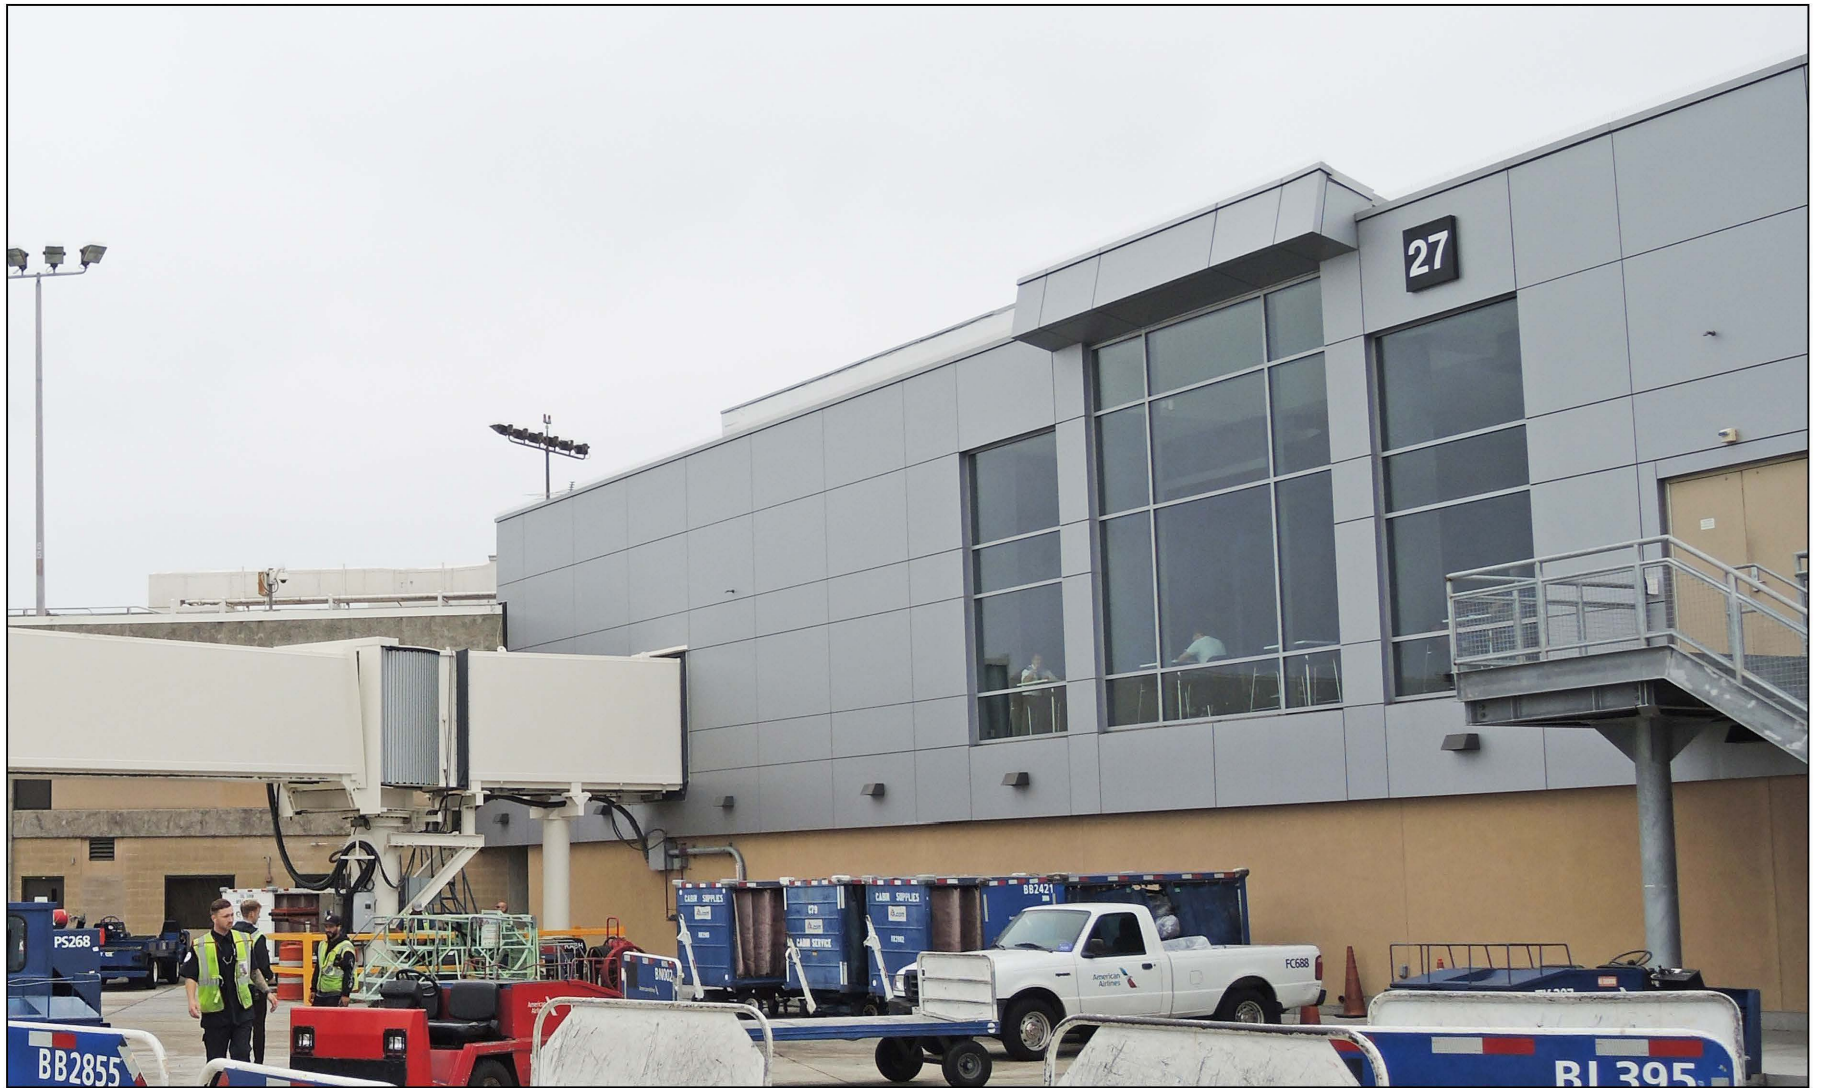
**Plate 6.2-20**

**View of the Fixed-Pane Windows on the West Façade of Section G, Facing Northeast**

Immediately north of Section E is a small, two-story, original portion of the Section A concourse wing. Immediately north is Section F, an irregularly-shaped, two-story addition that was constructed between 1994 and 1997. The first story of Section F is concrete block and the second story is comprised of modern metal with a coffered concrete overhang (Plate 6.2–18). In 2013, Section F was enlarged, expanding to the north and west. The first story of the 2013 Section G is stucco and the second story is the same modern metal as the second story of Section F (Plate 6.2–19). Fixed-pane windows are located on the northern end of the second story of Section G at Gate 27 (Plate 6.2–20).

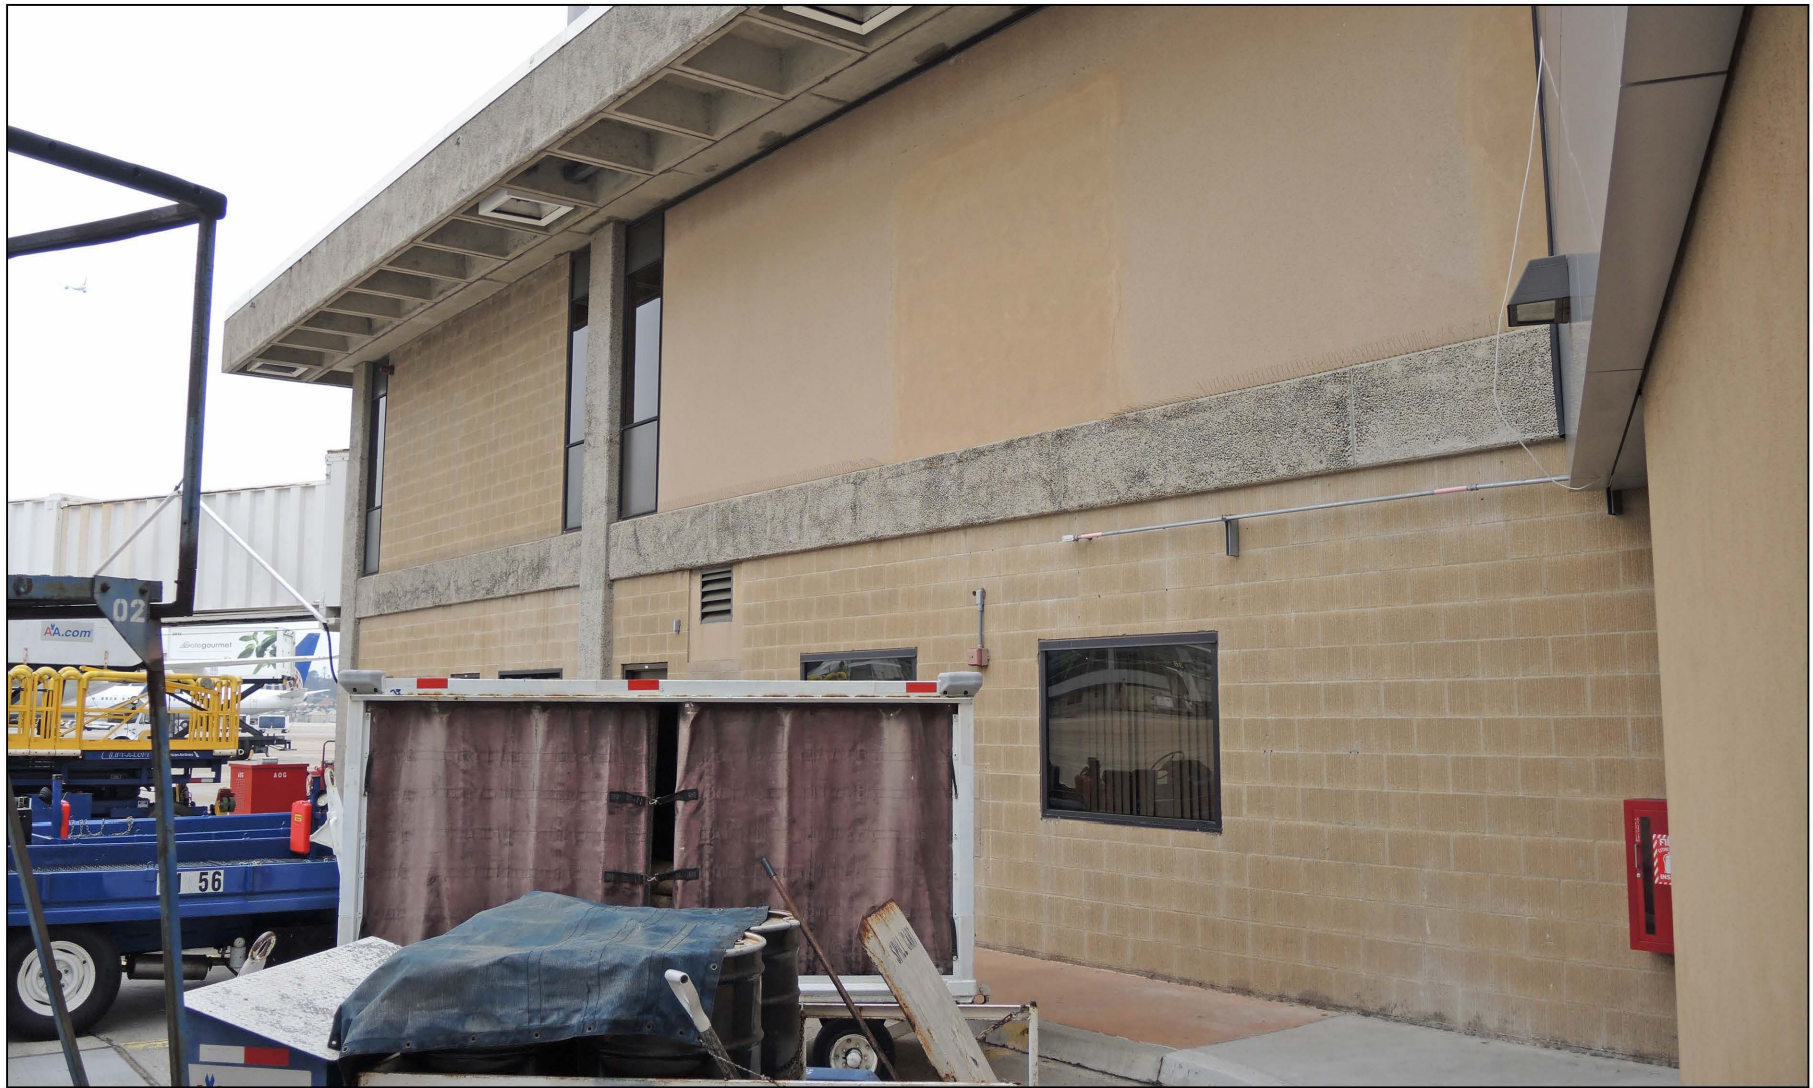
**Plate 6.2-21**

**View of the Original 1979 Westward Projection of  
the Section A Concourse Wing, Facing Northwest**

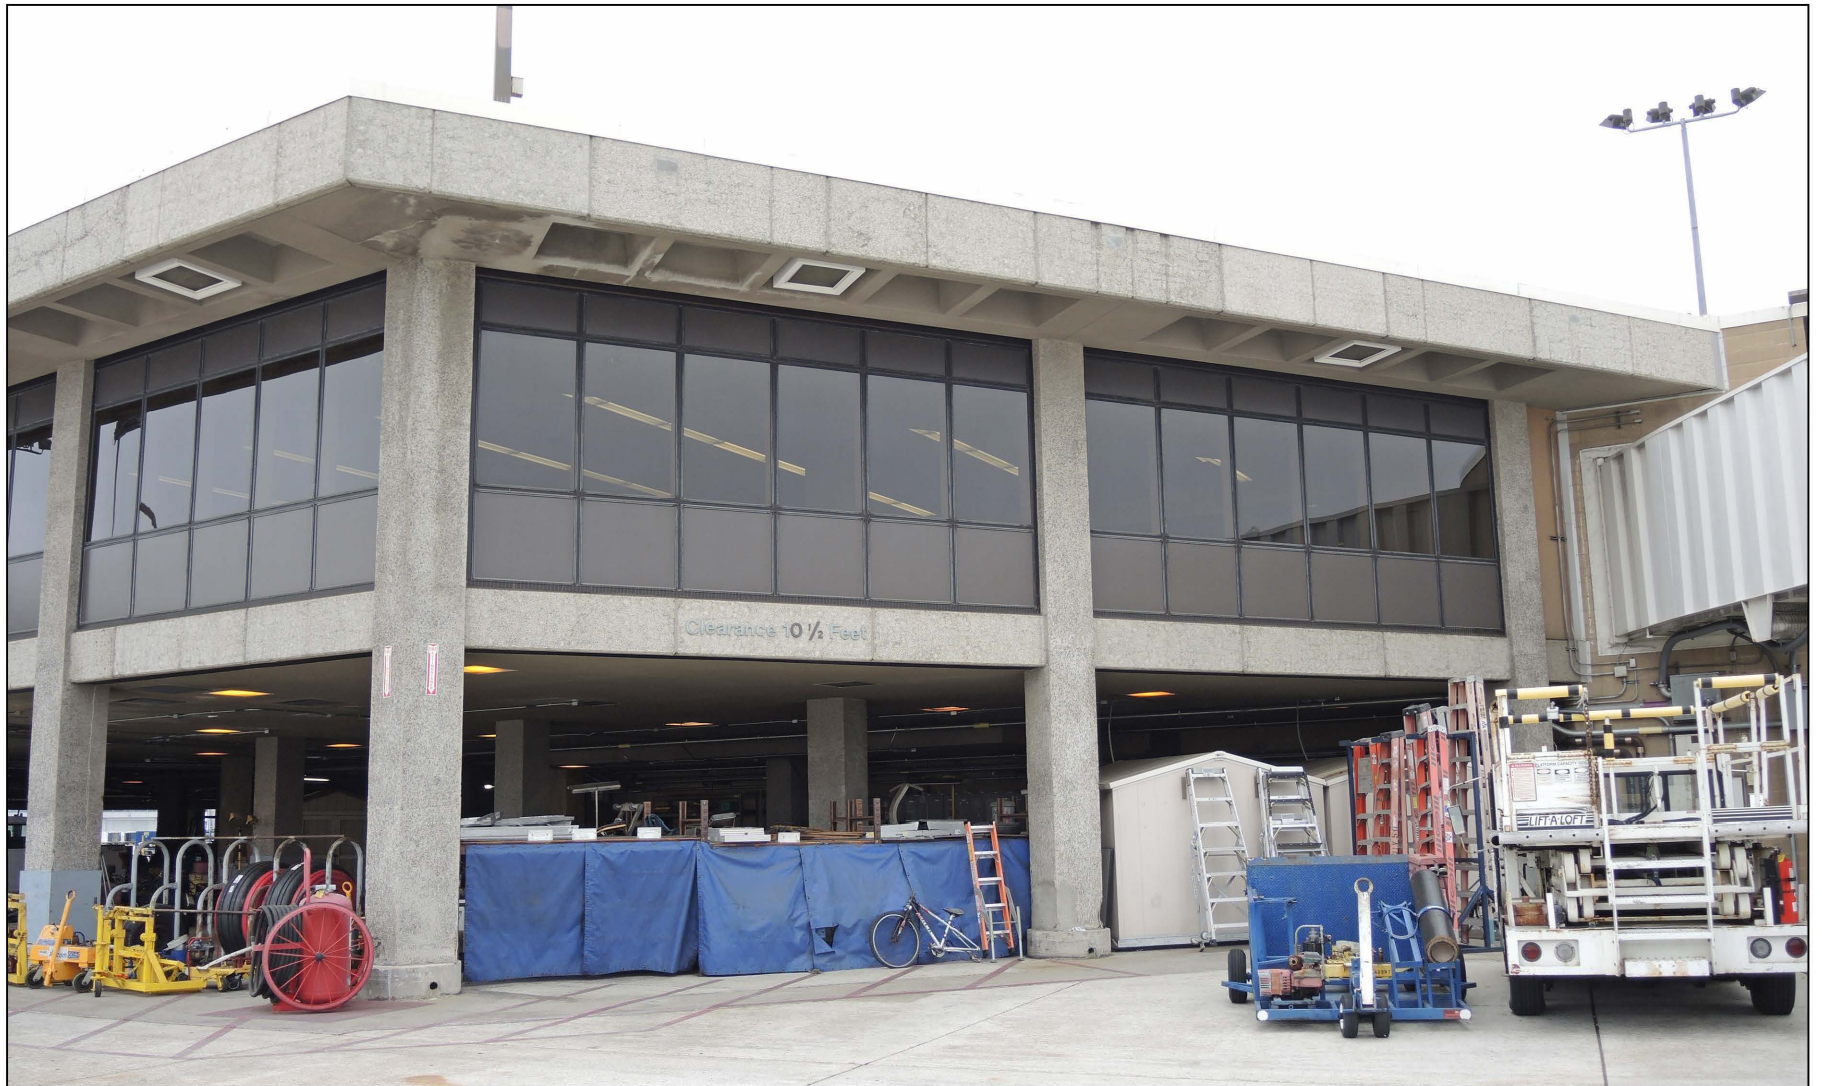
**Plate 6.2-22**

**View of the West Side of Section H, Facing South**
