**Section 106 Assessment for the San Diego International Airport Airfield  
Improvements and Terminal 1 Replacement Project**

**SECTION 106 ASSESSMENT FOR THE  
SAN DIEGO INTERNATIONAL AIRPORT  
AIRFIELD IMPROVEMENTS AND  
TERMINAL 1 REPLACEMENT PROJECT**

**CITY OF SAN DIEGO, CALIFORNIA**

***November 10, 2020; Revised January 8, 2021; Revised February 19, 2021;  
Revised March 12, 2021; Revised April 27, 2021; Revised May 7, 2021***

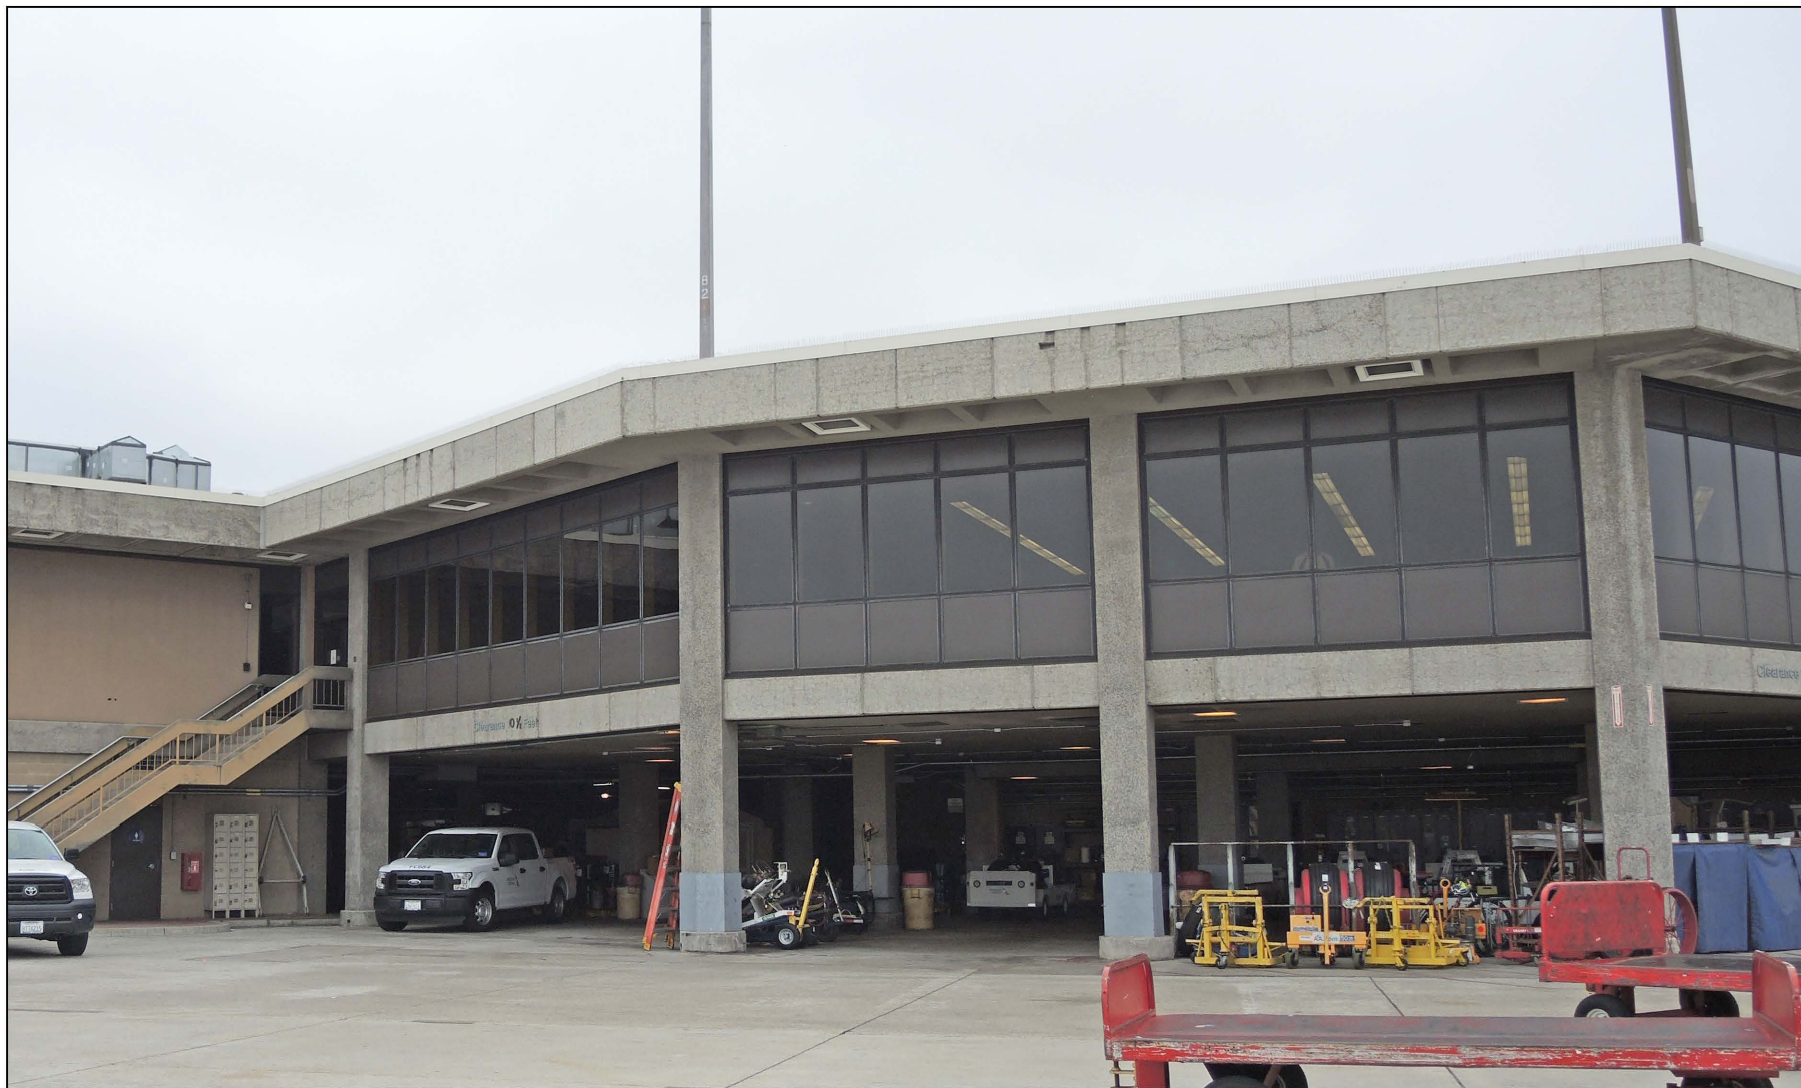
**Plate 6.2-23**

**View of the East Side of Section H, Facing South**

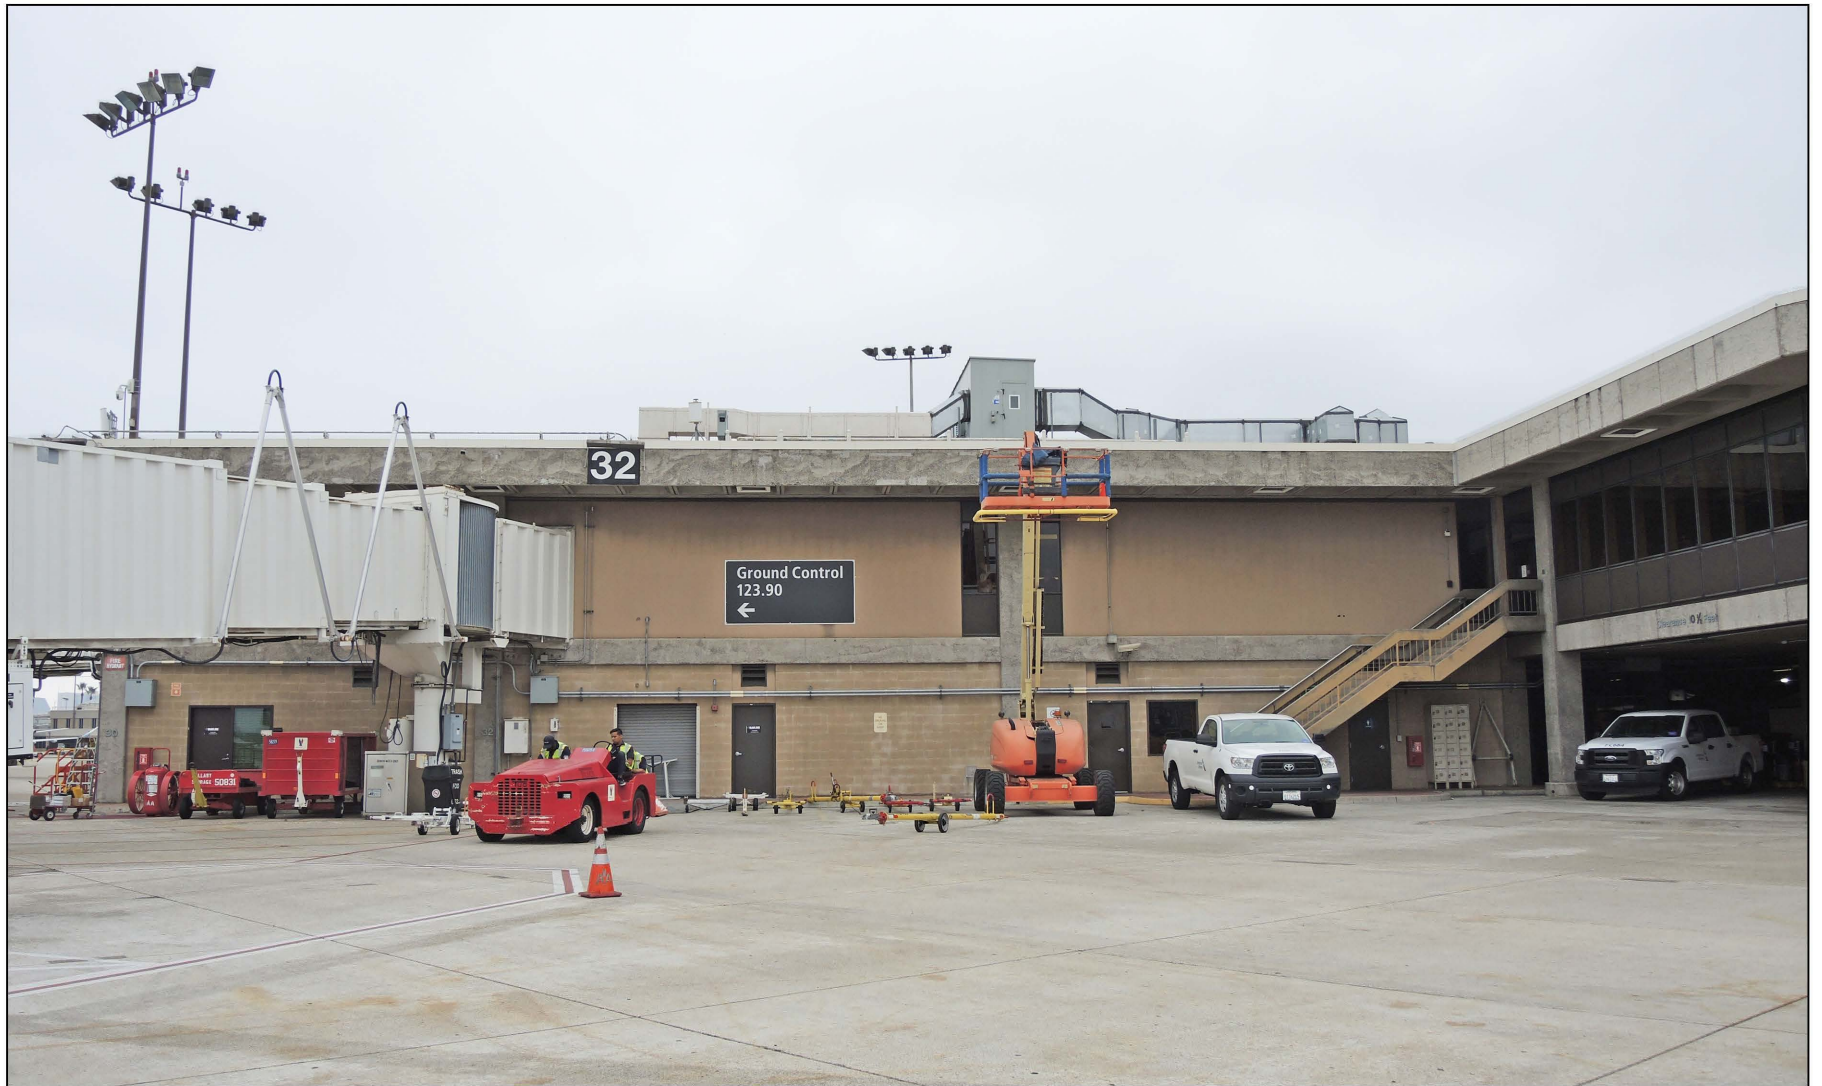
**Plate 6.2-24**

**View of the Original 1979 Eastward Projection  
of the Section A Concourse Wing, Facing South**

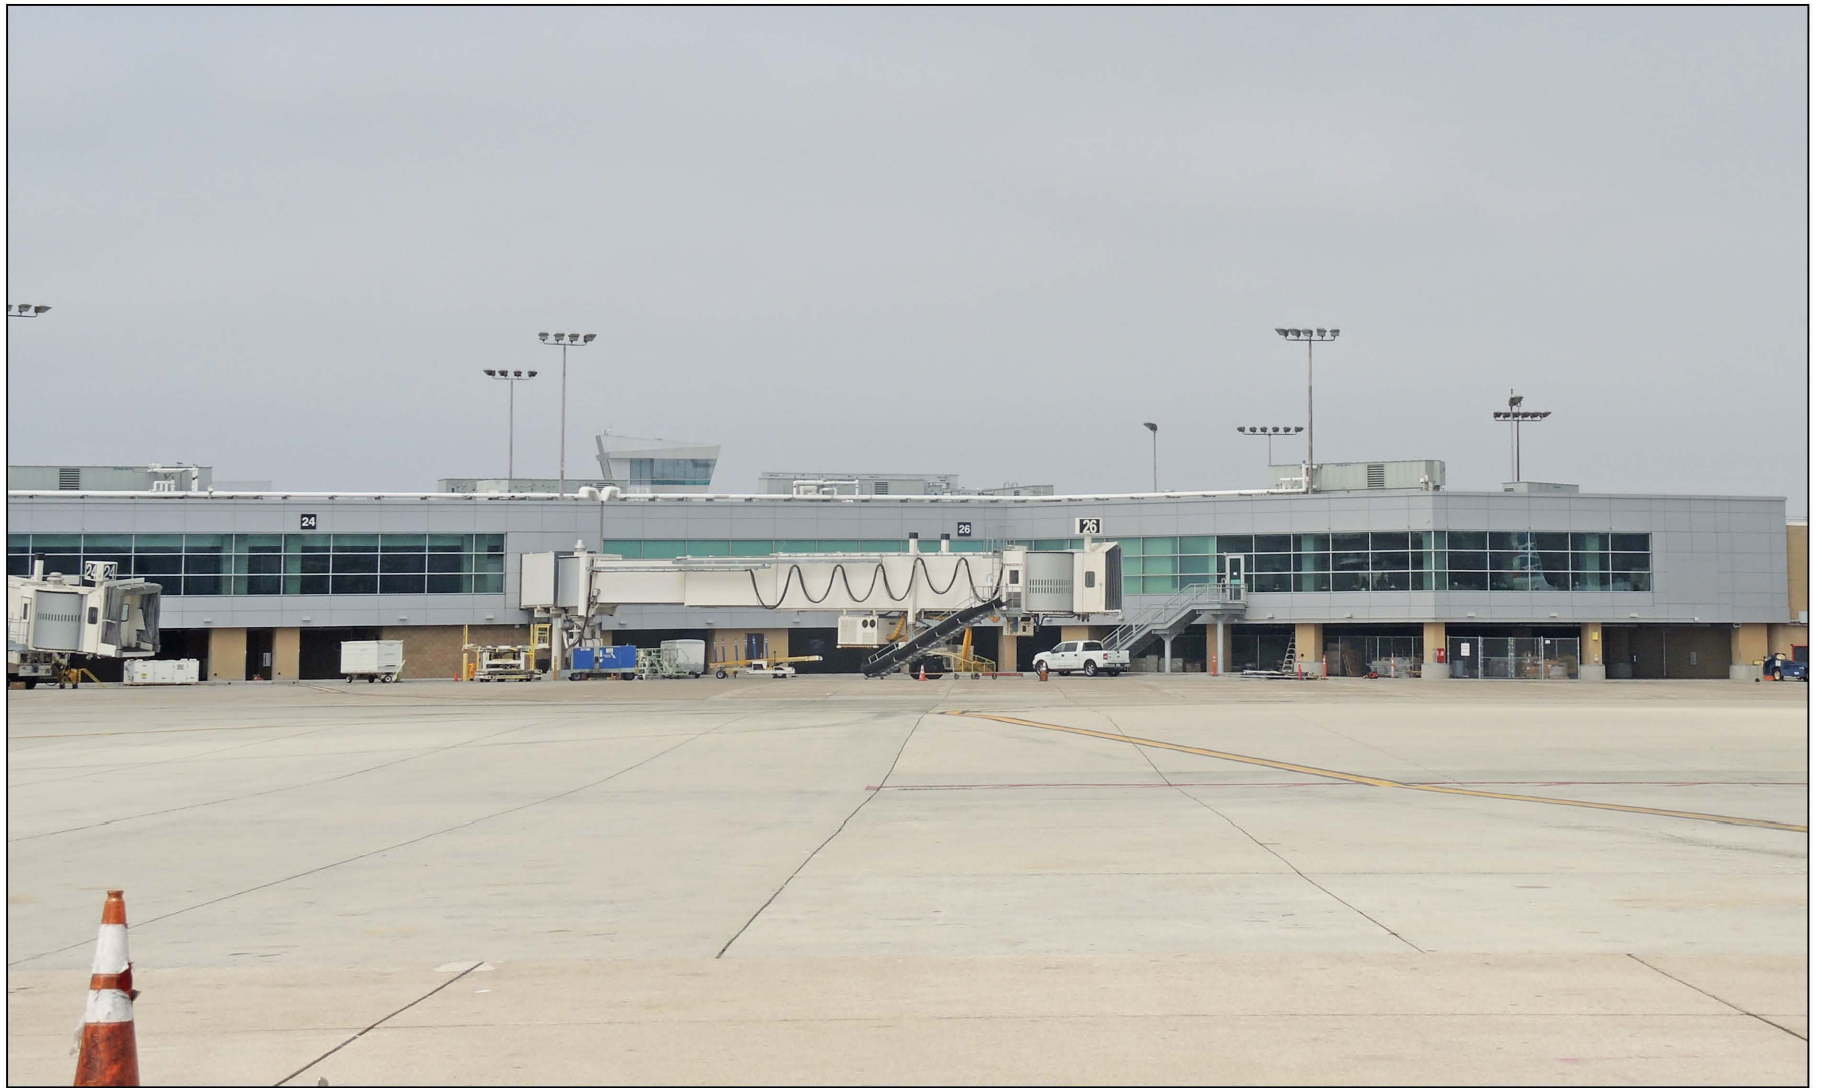
**Plate 6.2-25**

**View of the East Façade of Section I, Facing West**

Immediately south of the original eastward projection of the Section A concourse wing is Section I, a two-story addition that was constructed in 2013 and runs alongside roughly half of the Section A concourse (Plate 6.2–25). The first story is open and supported by stucco-clad concrete columns; the second story is comprised of modern metal and fixed-pane windows. With the exception of Section J, an addition built in 2000 in the northeast corner of the Section A terminal building, at its connection with the concourse wing, the remainder of the east façade of the Section A concourse wing is original (Plate 6.2–26). The original east façade of Section A is two stories and is horizontally and vertically divided by concrete bands. The first floor is comprised of concrete block, simple metal doors, and fixed-pane windows; the second story is comprised of smooth stucco, fixed-pane windows, and a coffered concrete overhang. A two-story trapezoidal projection near the center of Section A is constructed of concrete block (Plate 6.2–27).

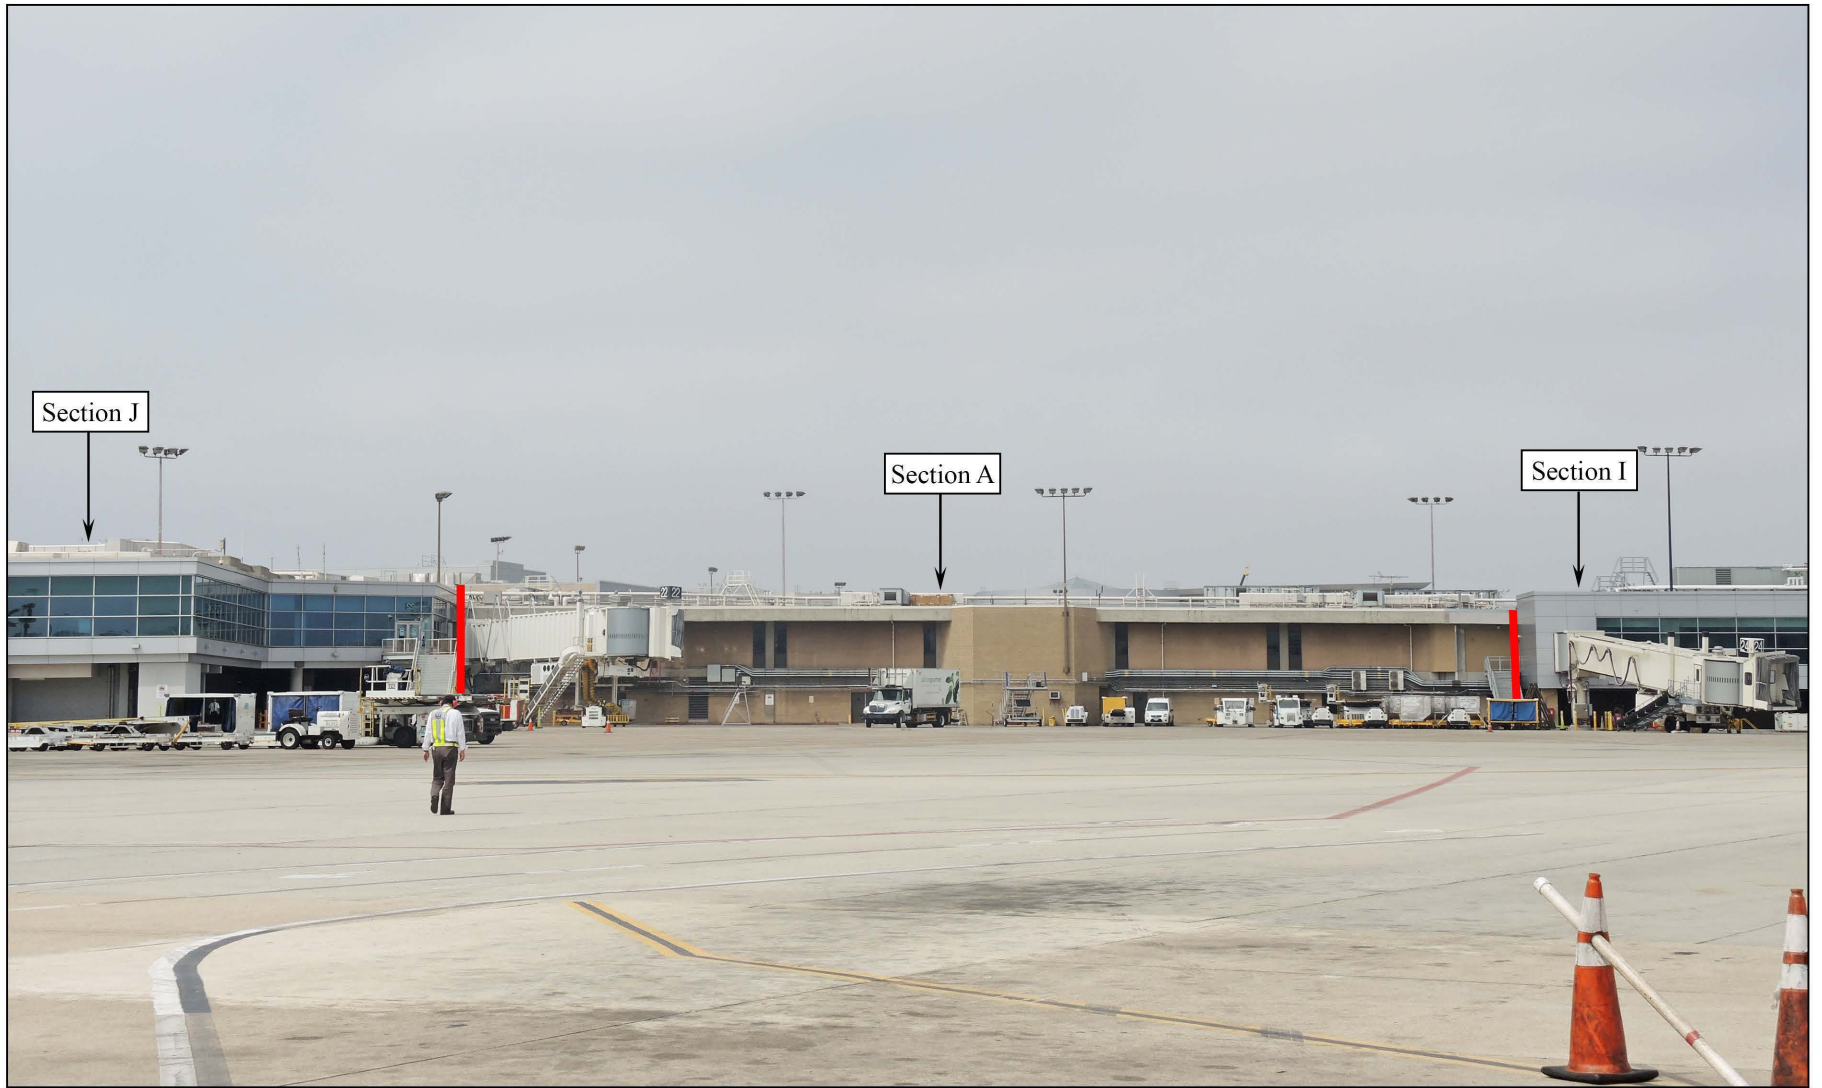
**Plate 6.2-26**  
**View of the East Façade of the Section A Concourse Wing**  
**Between Section I (Right) and Section J (Left), Facing West**  
The SAN Airfield Improvements and Terminal 1 Replacement Project

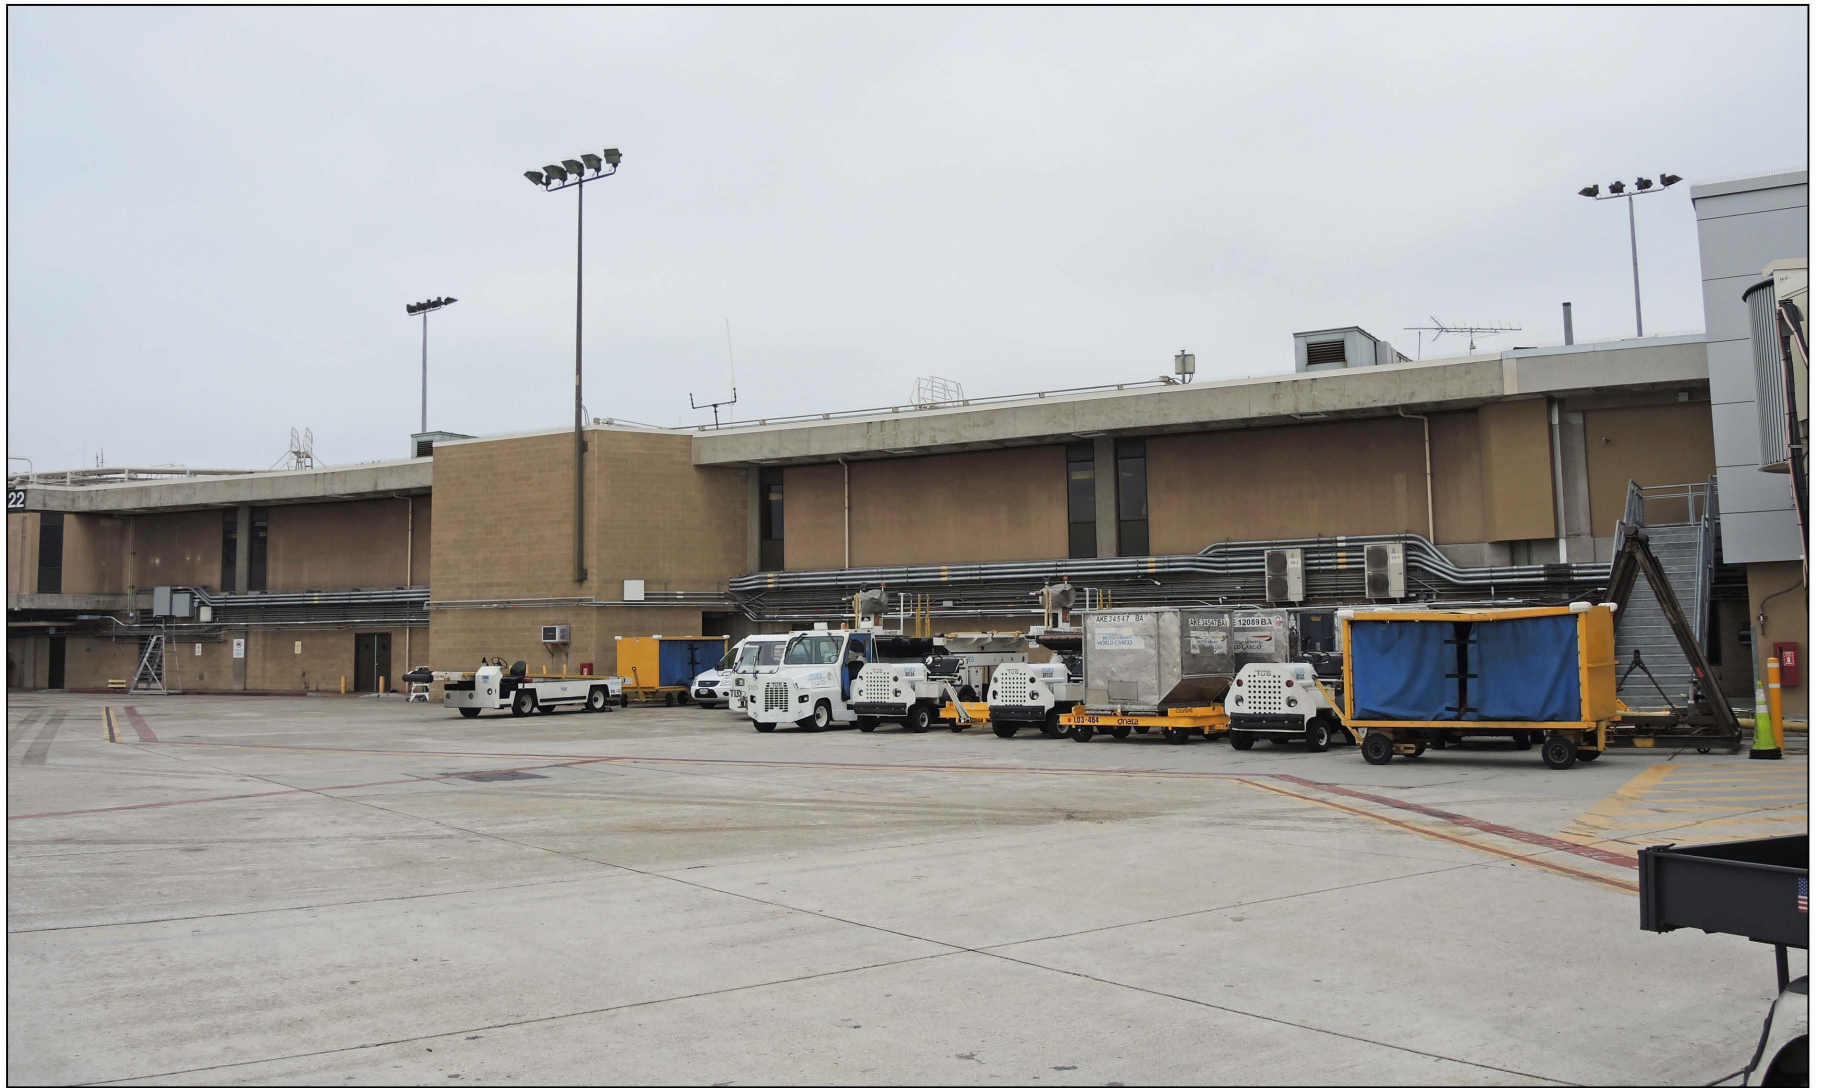
**Plate 6.2-27**

**View of the East Façade of the Original 1979 Portion  
of the Section A Concourse Wing, Facing Southwest**

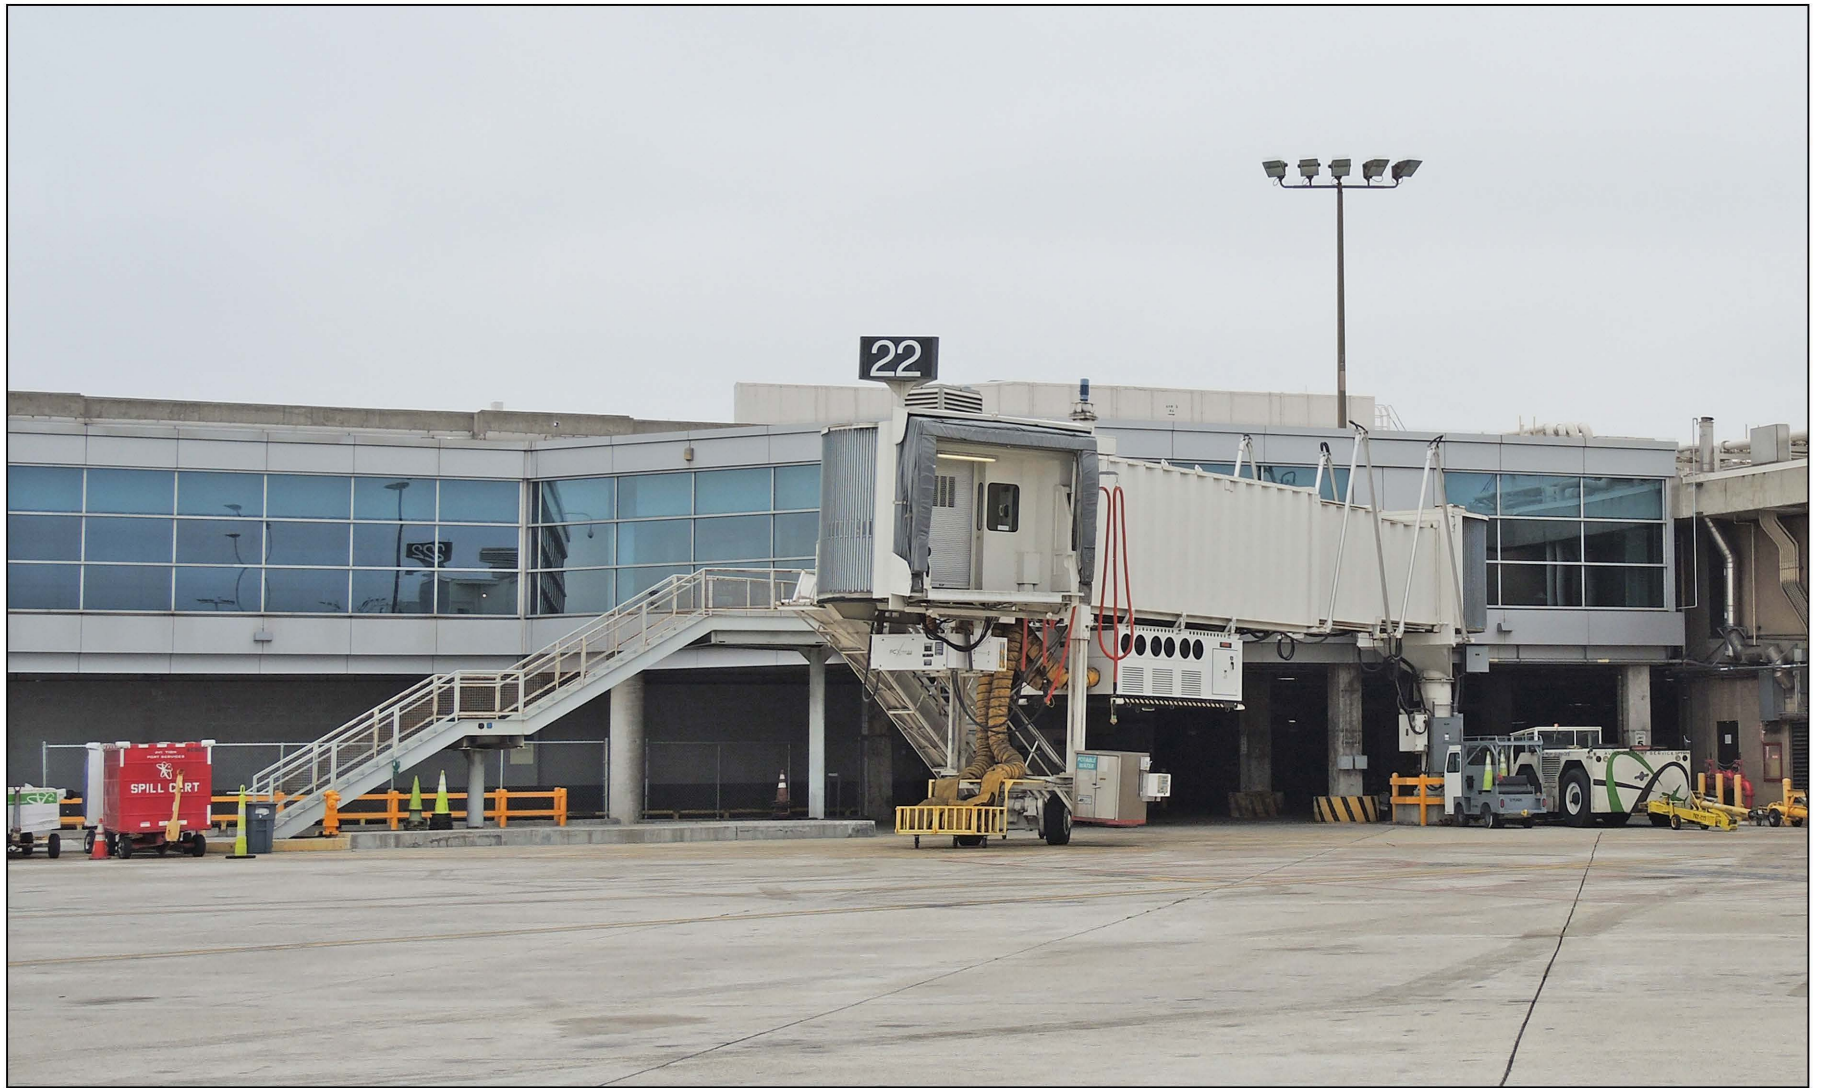
**Plate 6.2-28**

**View of the North Façade of Section J, Facing South**

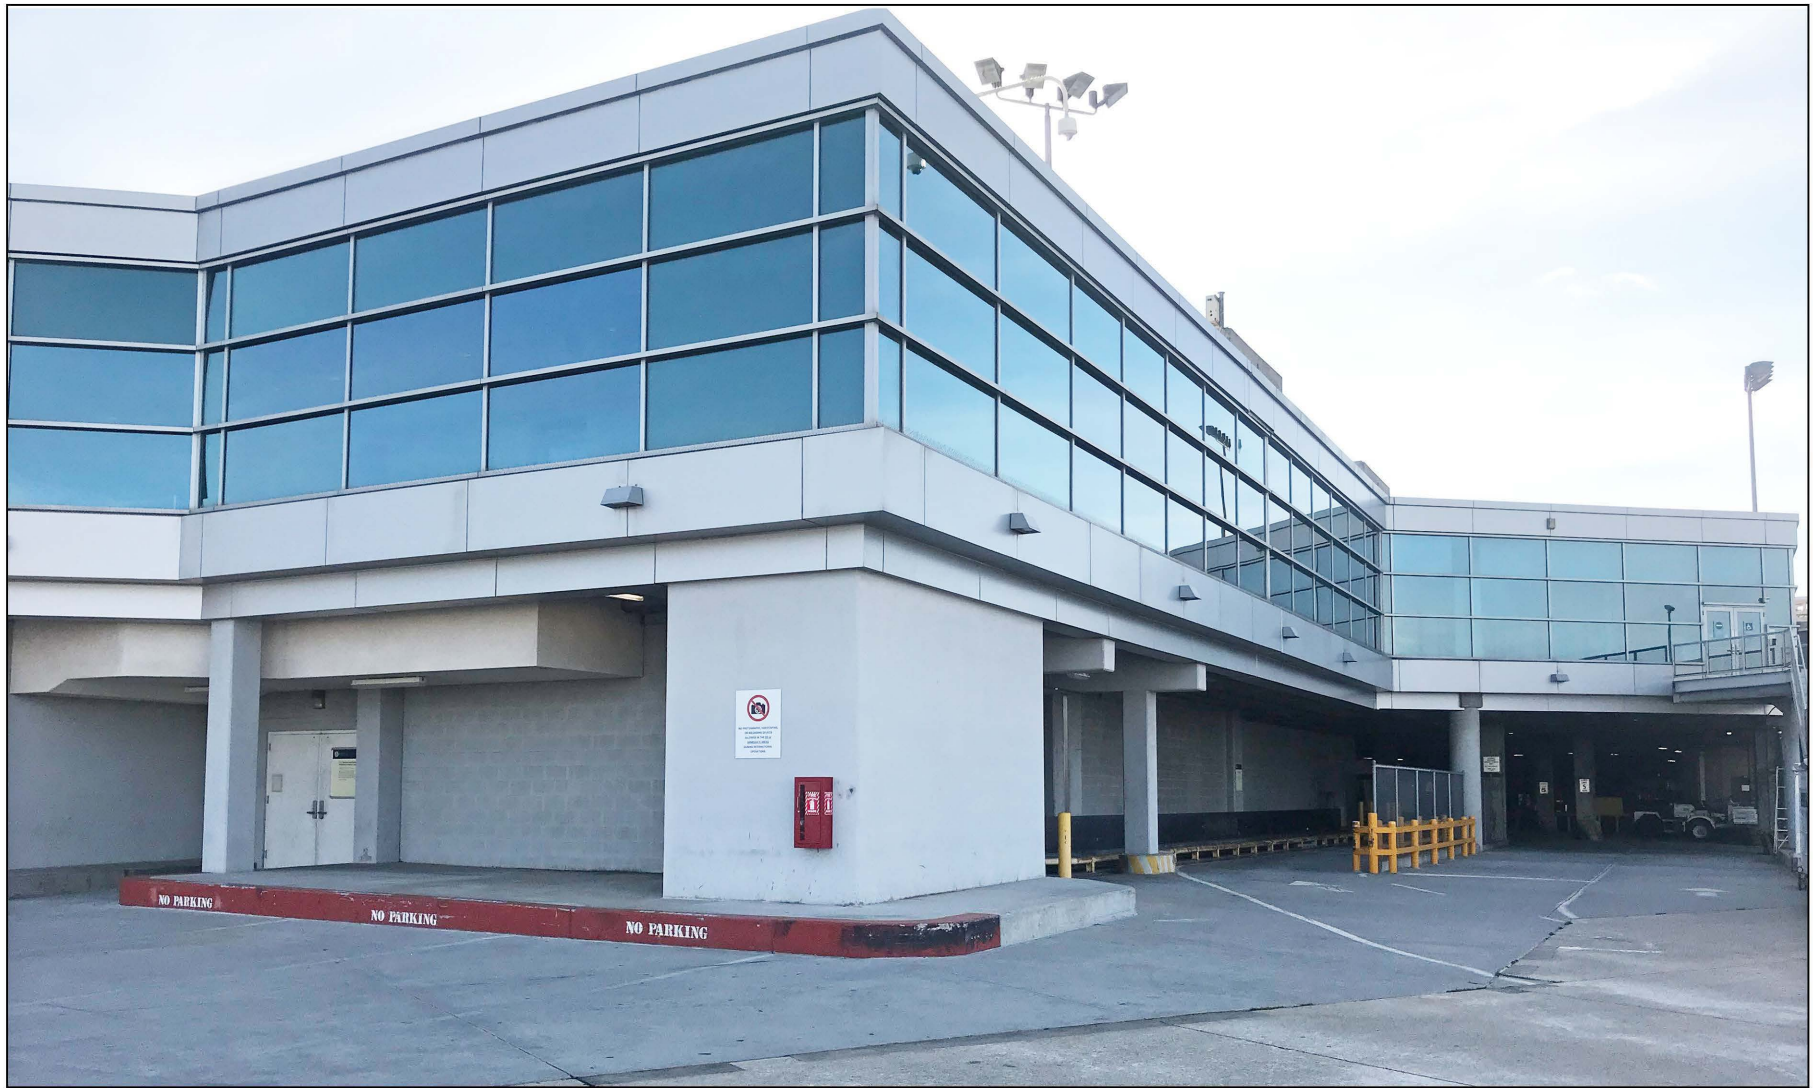
**Plate 6.2-29**  
**View of the North and East Façades of Section J, Facing Southwest**  
The SAN Airfield Improvements and Terminal 1 Replacement Project

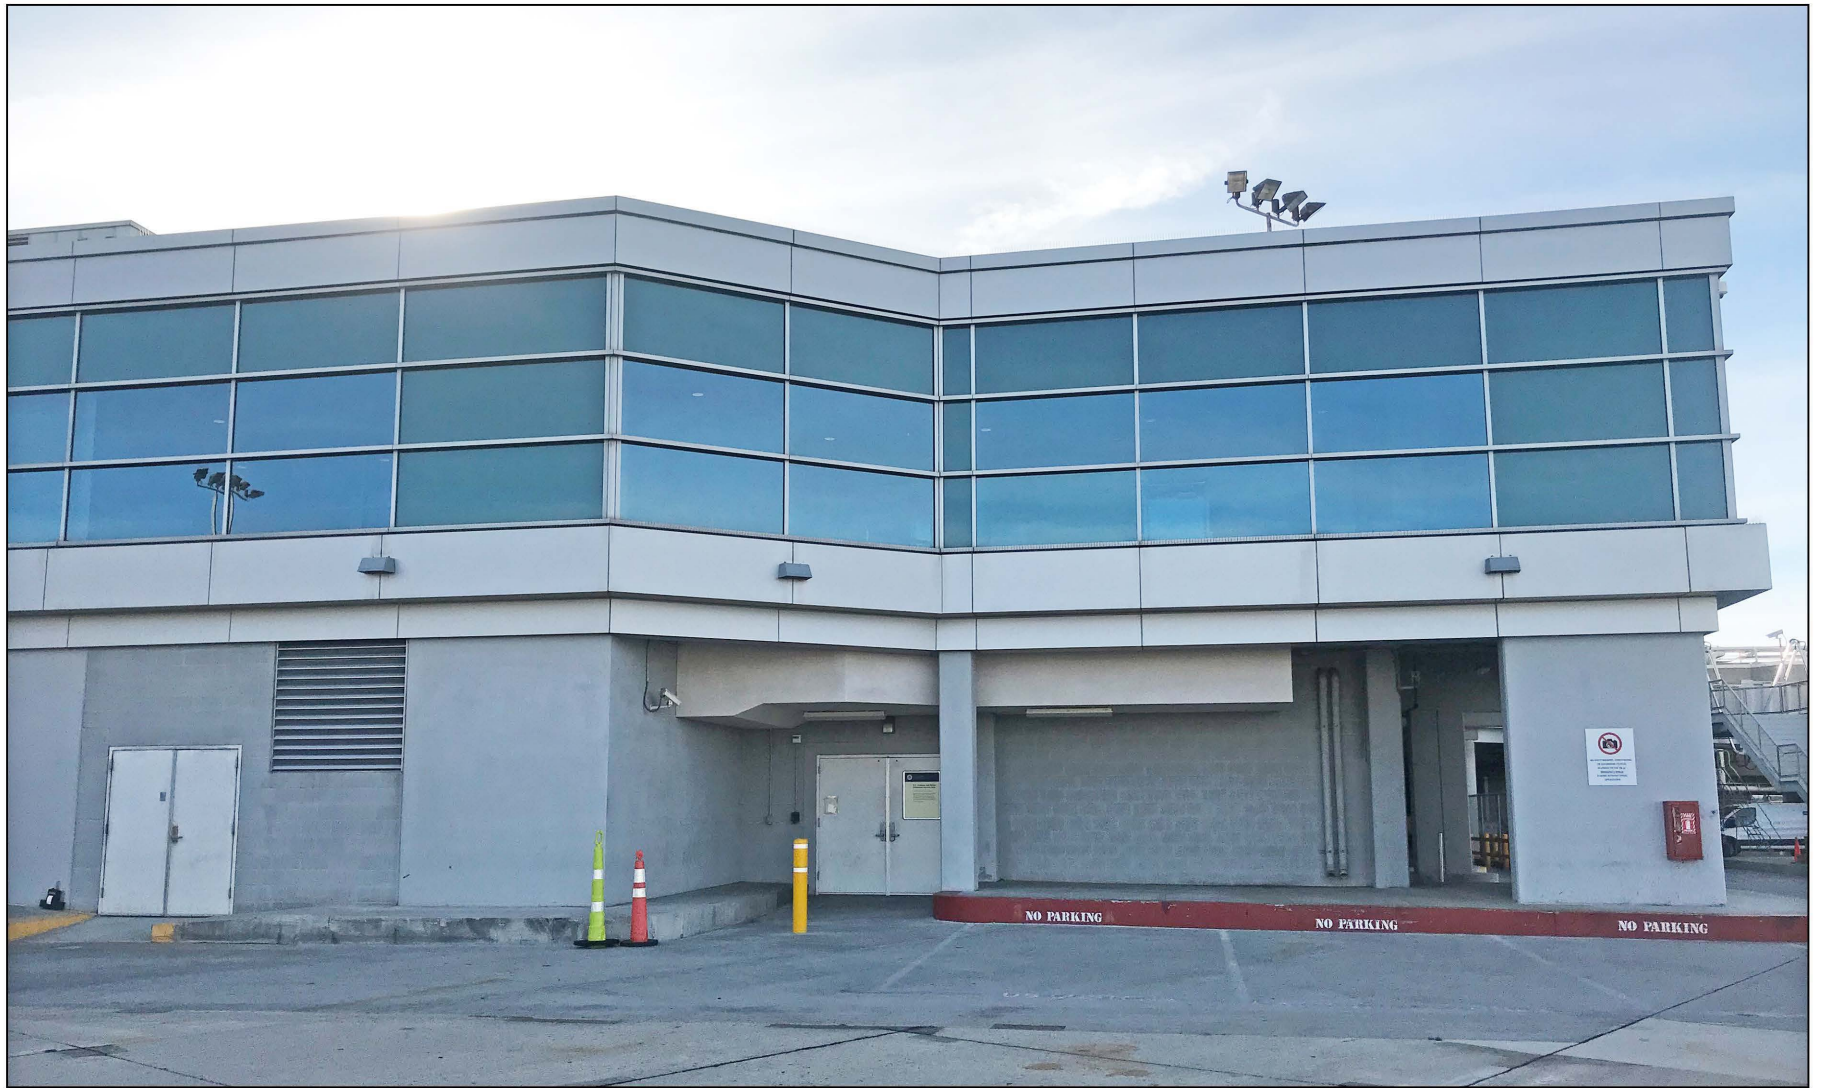
**Plate 6.2-30**

**View of the East Façade of Section J, Facing West**

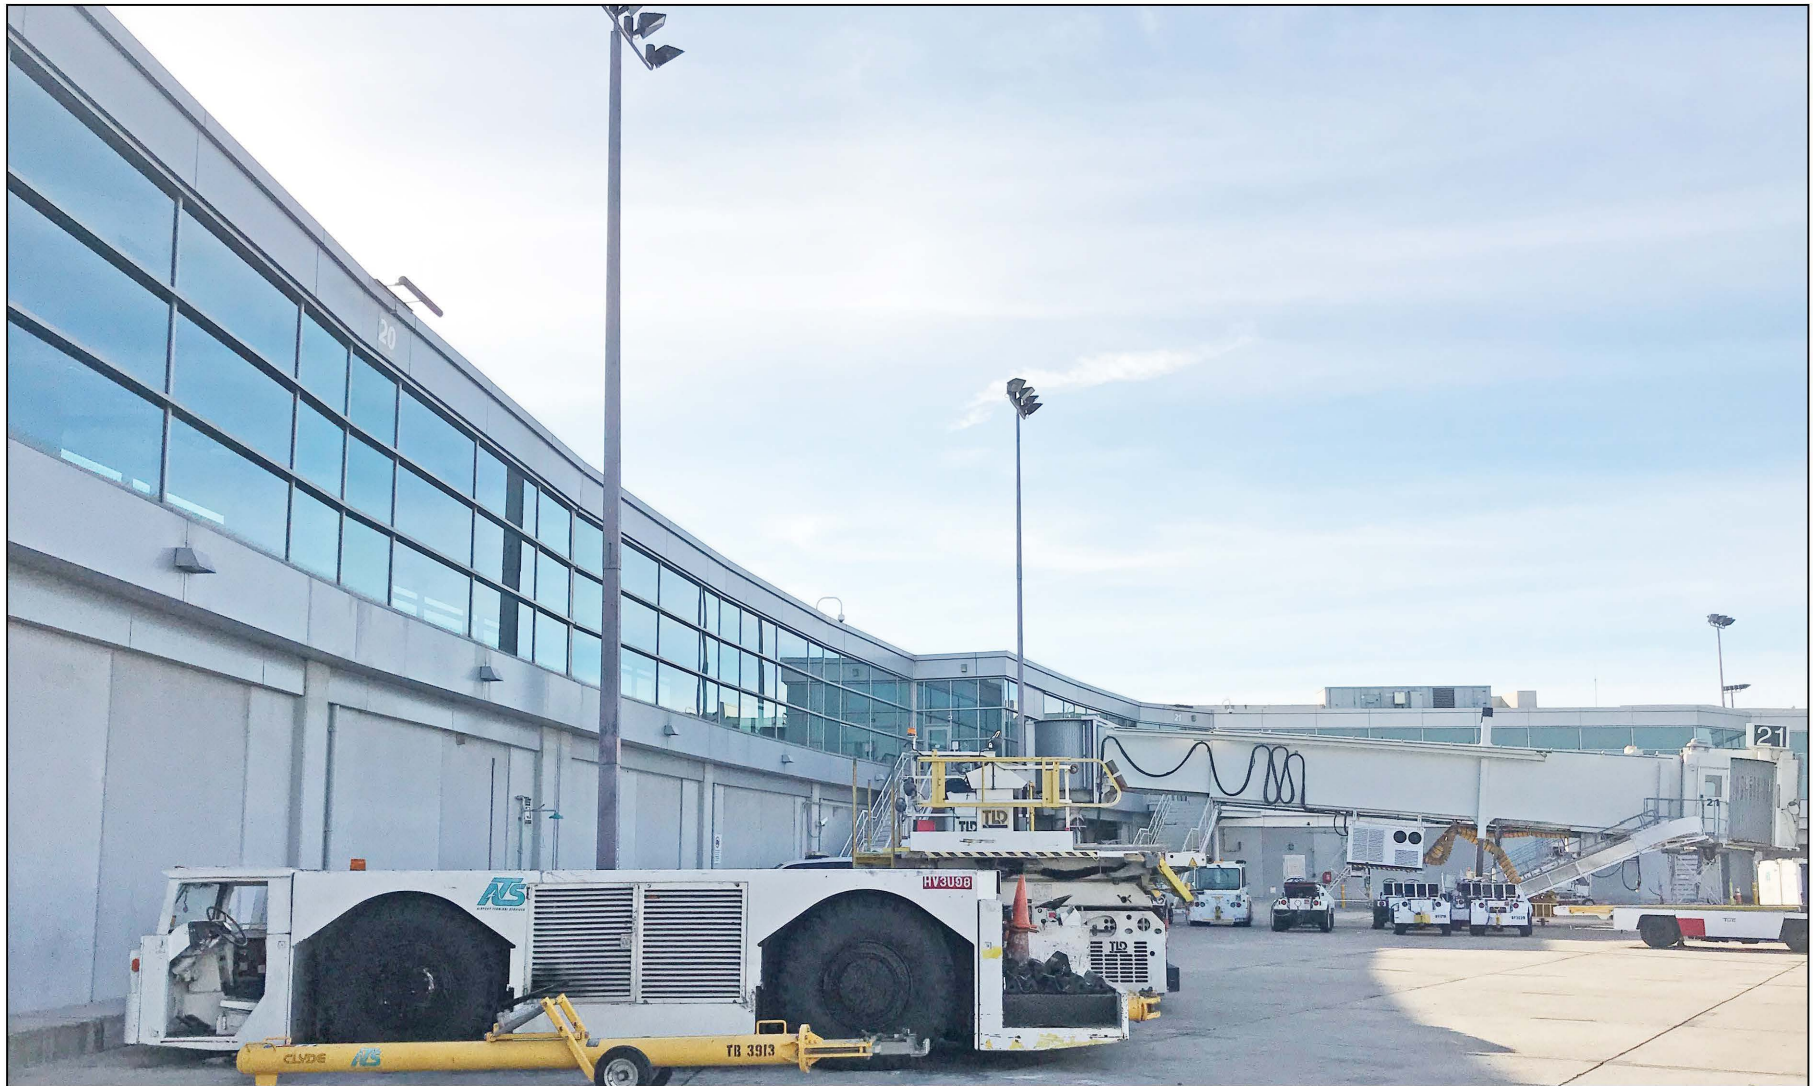
**Plate 6.2-31**

**View of the North Façade the Connector Wing Portion of Section J (Left), Facing West**

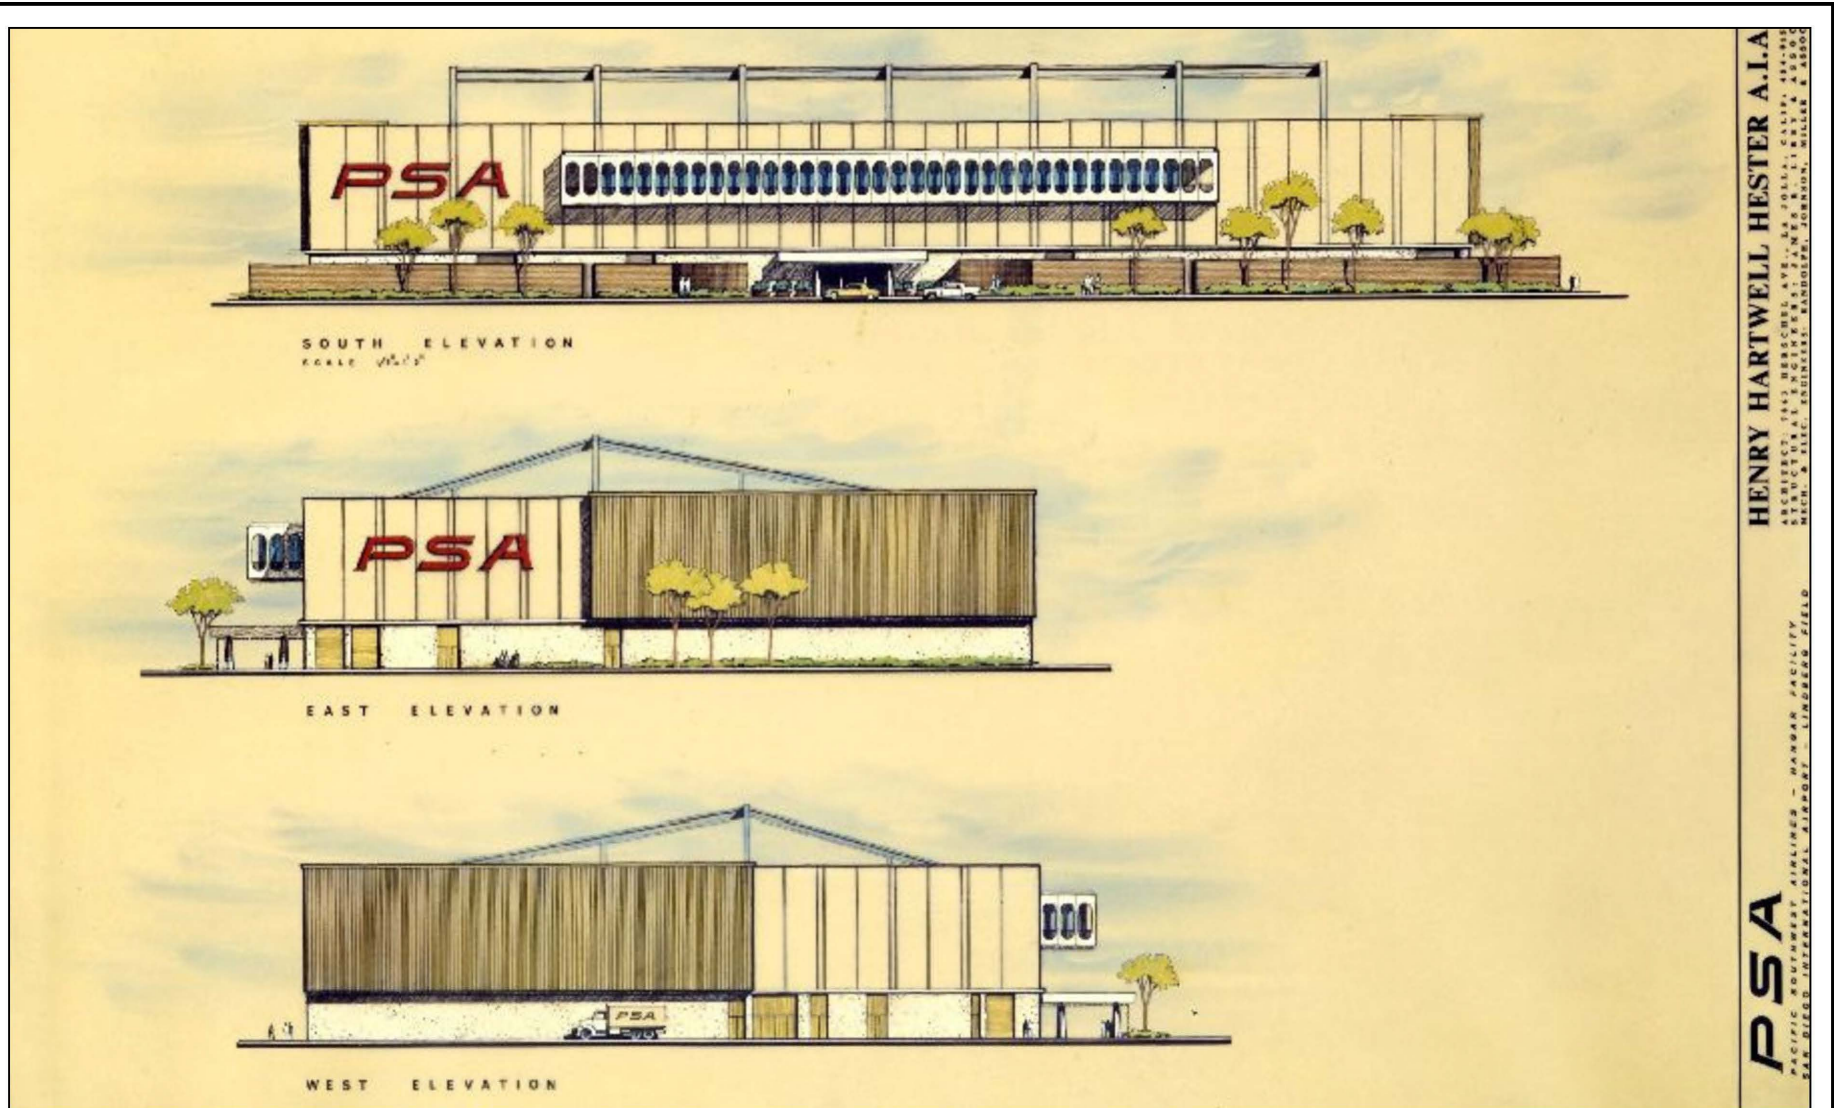
Construction on the building began in February of 1967 (*San Diego Union* 1967h) and it was completed in July of 1968 (*San Diego Union* 1968). *The San Diego Union* (1966, 1967h) described the building as “a three story structure 400 feet long by 150 feet wide” consisting of an “administrative office structure adjacent to new hangars.” Some of the administration offices were described as being “cantilevered out from the third floor” (*San Diego Union* 1966). When originally constructed in 1968, the building only had windows in the cantilevered portion of the third floor (Plate 6.3–2). The north façade of the new hangar was left open to allow for the entrance and exit of large aircraft (Plate 6.3–3); a solid concrete wall separated the hangar from the administrative office. All other exterior walls of the administration and hangar portions of the building were also solid concrete. Large, triangular, projecting roof beams connected the hangar with the administrative office. The PSA AMF building had a small, flat-roofed entrance supported by concrete columns that tapered at the top. A concrete block retaining wall was also located at the entrance and ran the entire length of the south façade, curving inward at the entrance. The wall separated the parking lot from the sidewalk immediately adjacent to the building. Large, integrated, stylized signage reading “PSA” was present on the upper left portion of the south and east façades.

**Figure 6.3-1**  
**Original 1966 Architectural Rendering of the PSA AMF Building**  
 The SAN Airfield Improvements and Terminal 1 Replacement Project

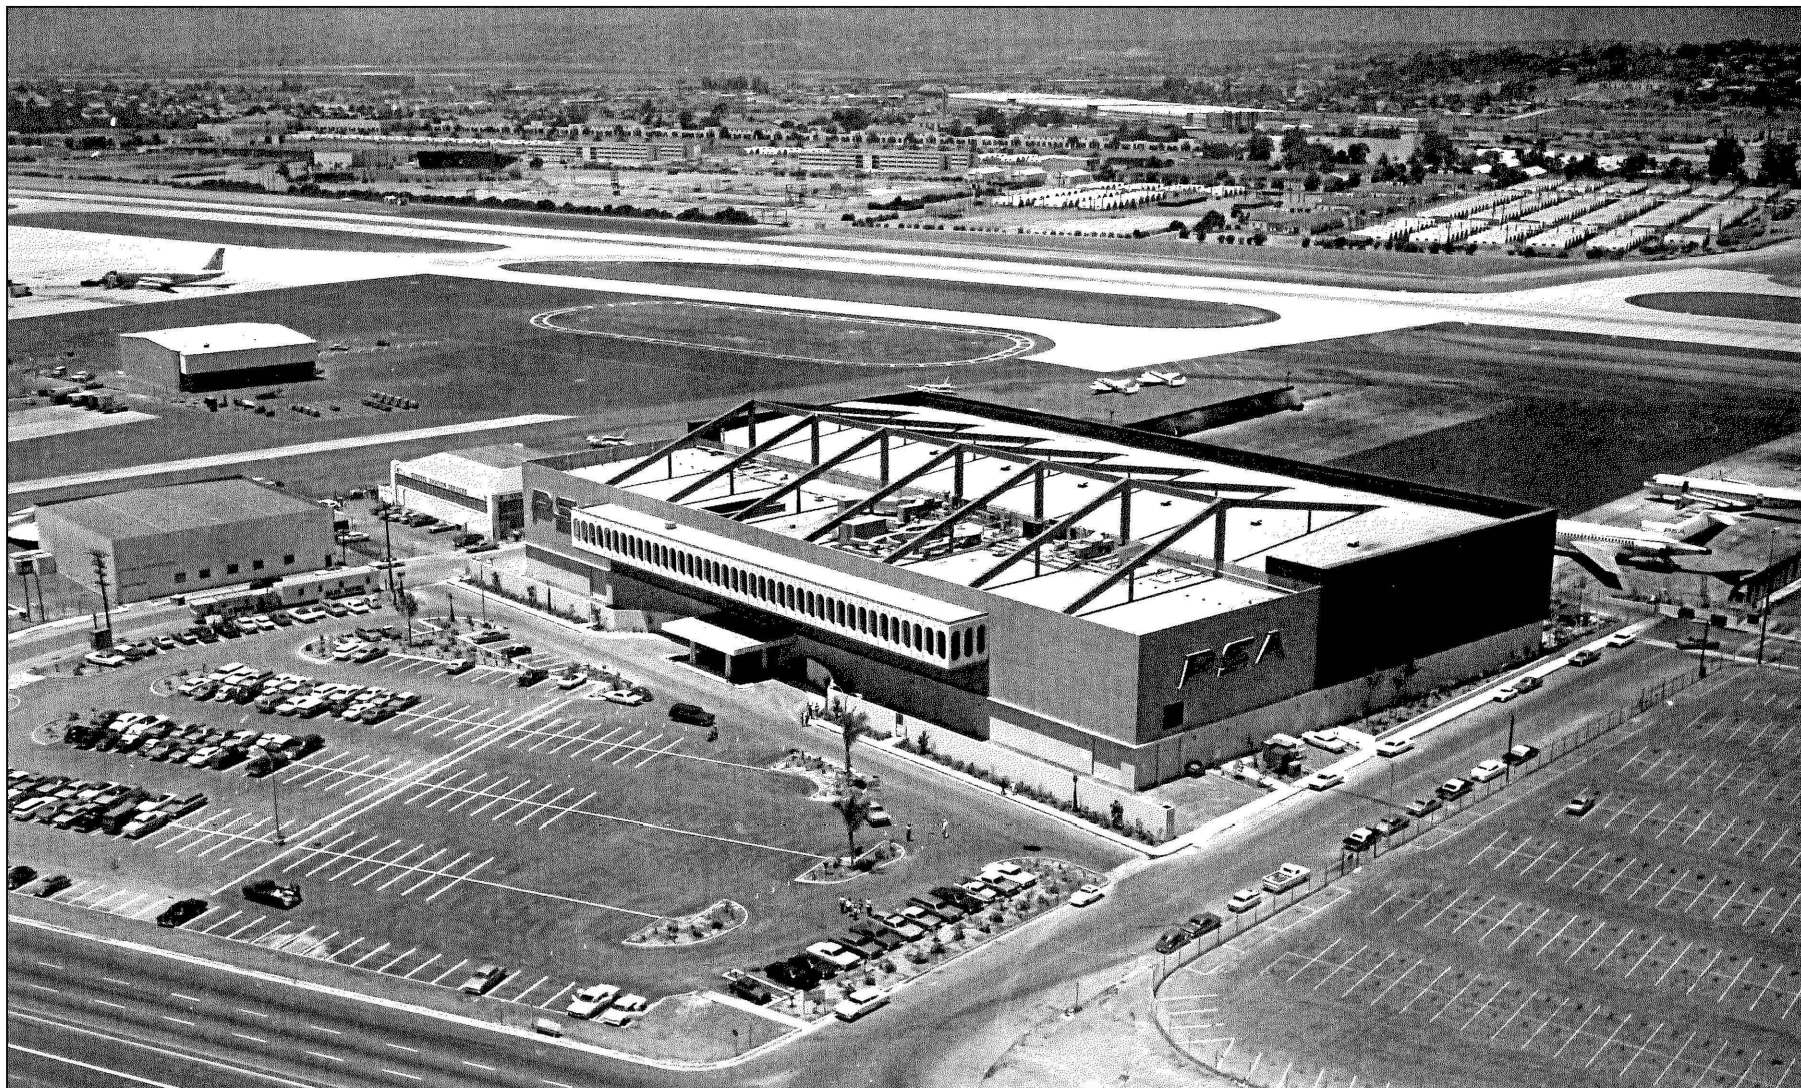
## Plate 6.3-2

### 1968 Aerial Photograph of the PSA AMF Building
