**Section 106 Assessment for the San Diego International Airport Airfield  
Improvements and Terminal 1 Replacement Project**

**SECTION 106 ASSESSMENT FOR THE  
SAN DIEGO INTERNATIONAL AIRPORT  
AIRFIELD IMPROVEMENTS AND  
TERMINAL 1 REPLACEMENT PROJECT**

**CITY OF SAN DIEGO, CALIFORNIA**

***November 10, 2020; Revised January 8, 2021; Revised February 19, 2021;  
Revised March 12, 2021; Revised April 27, 2021; Revised May 7, 2021***

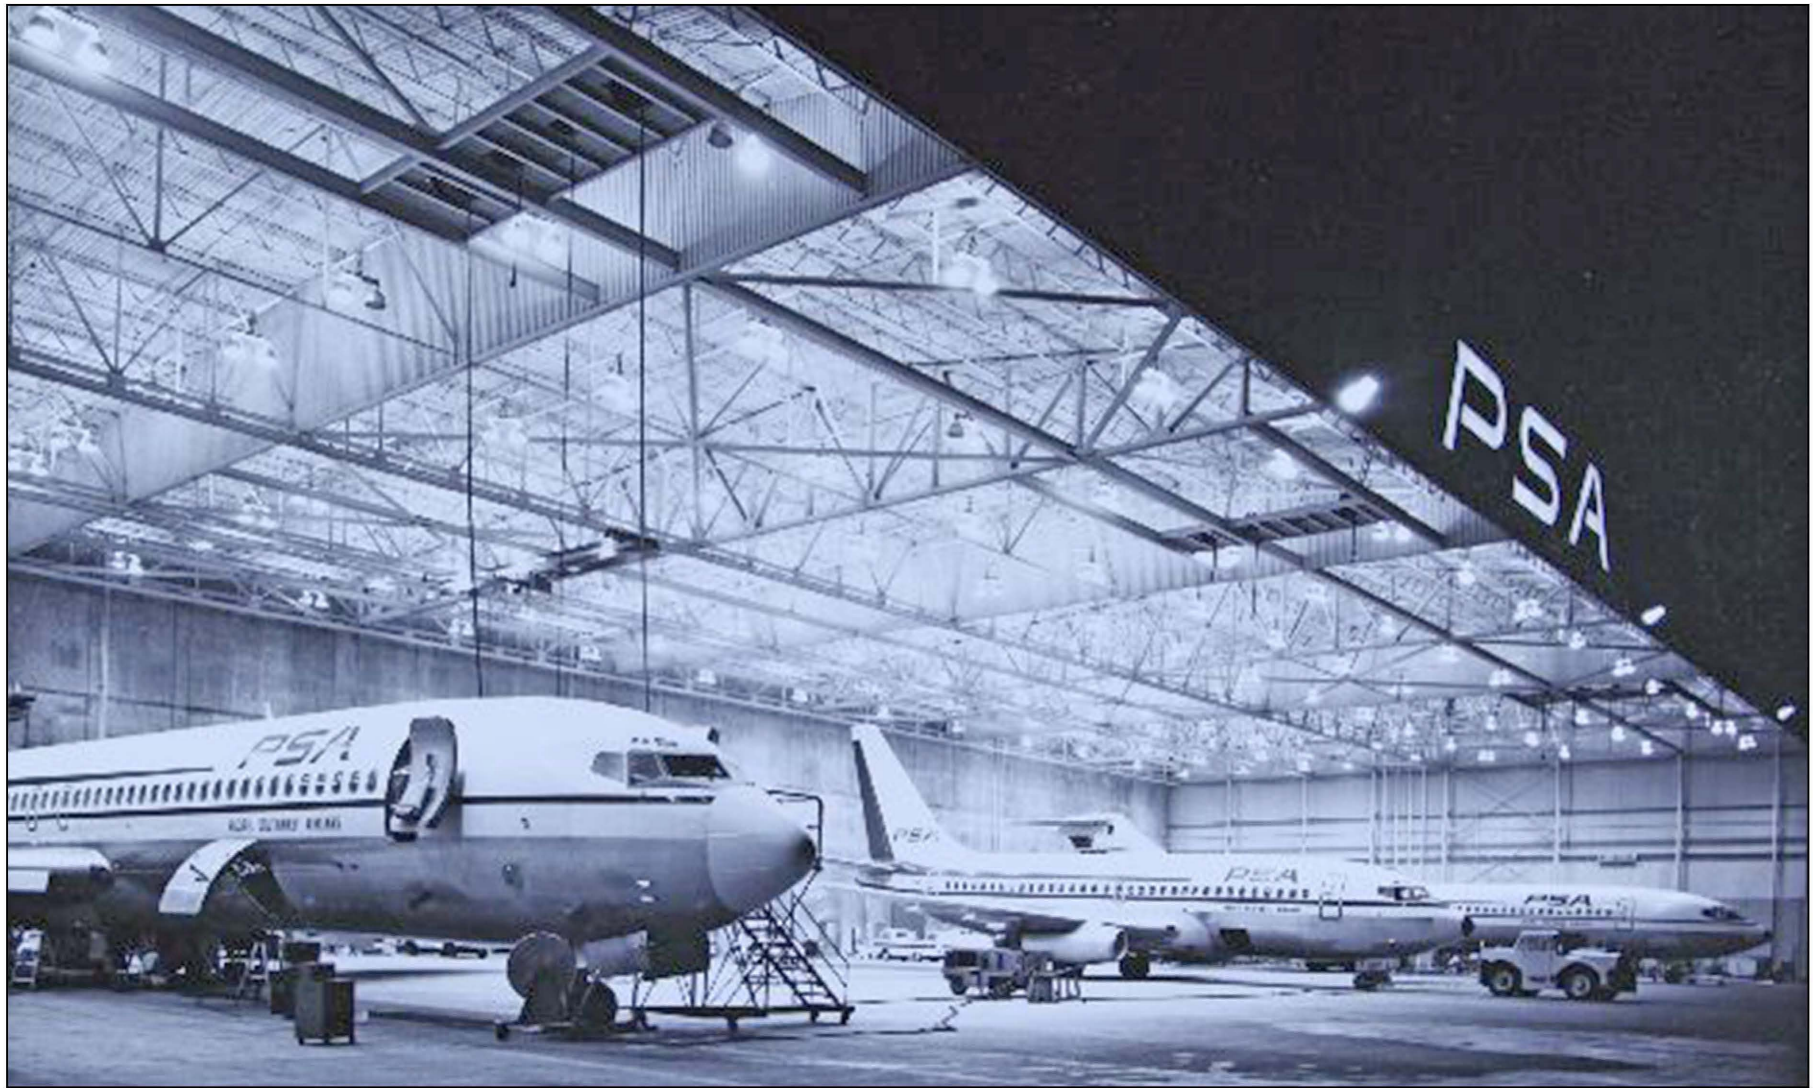
### Plate 6.3-3

#### View of the PSA AMF Hangar

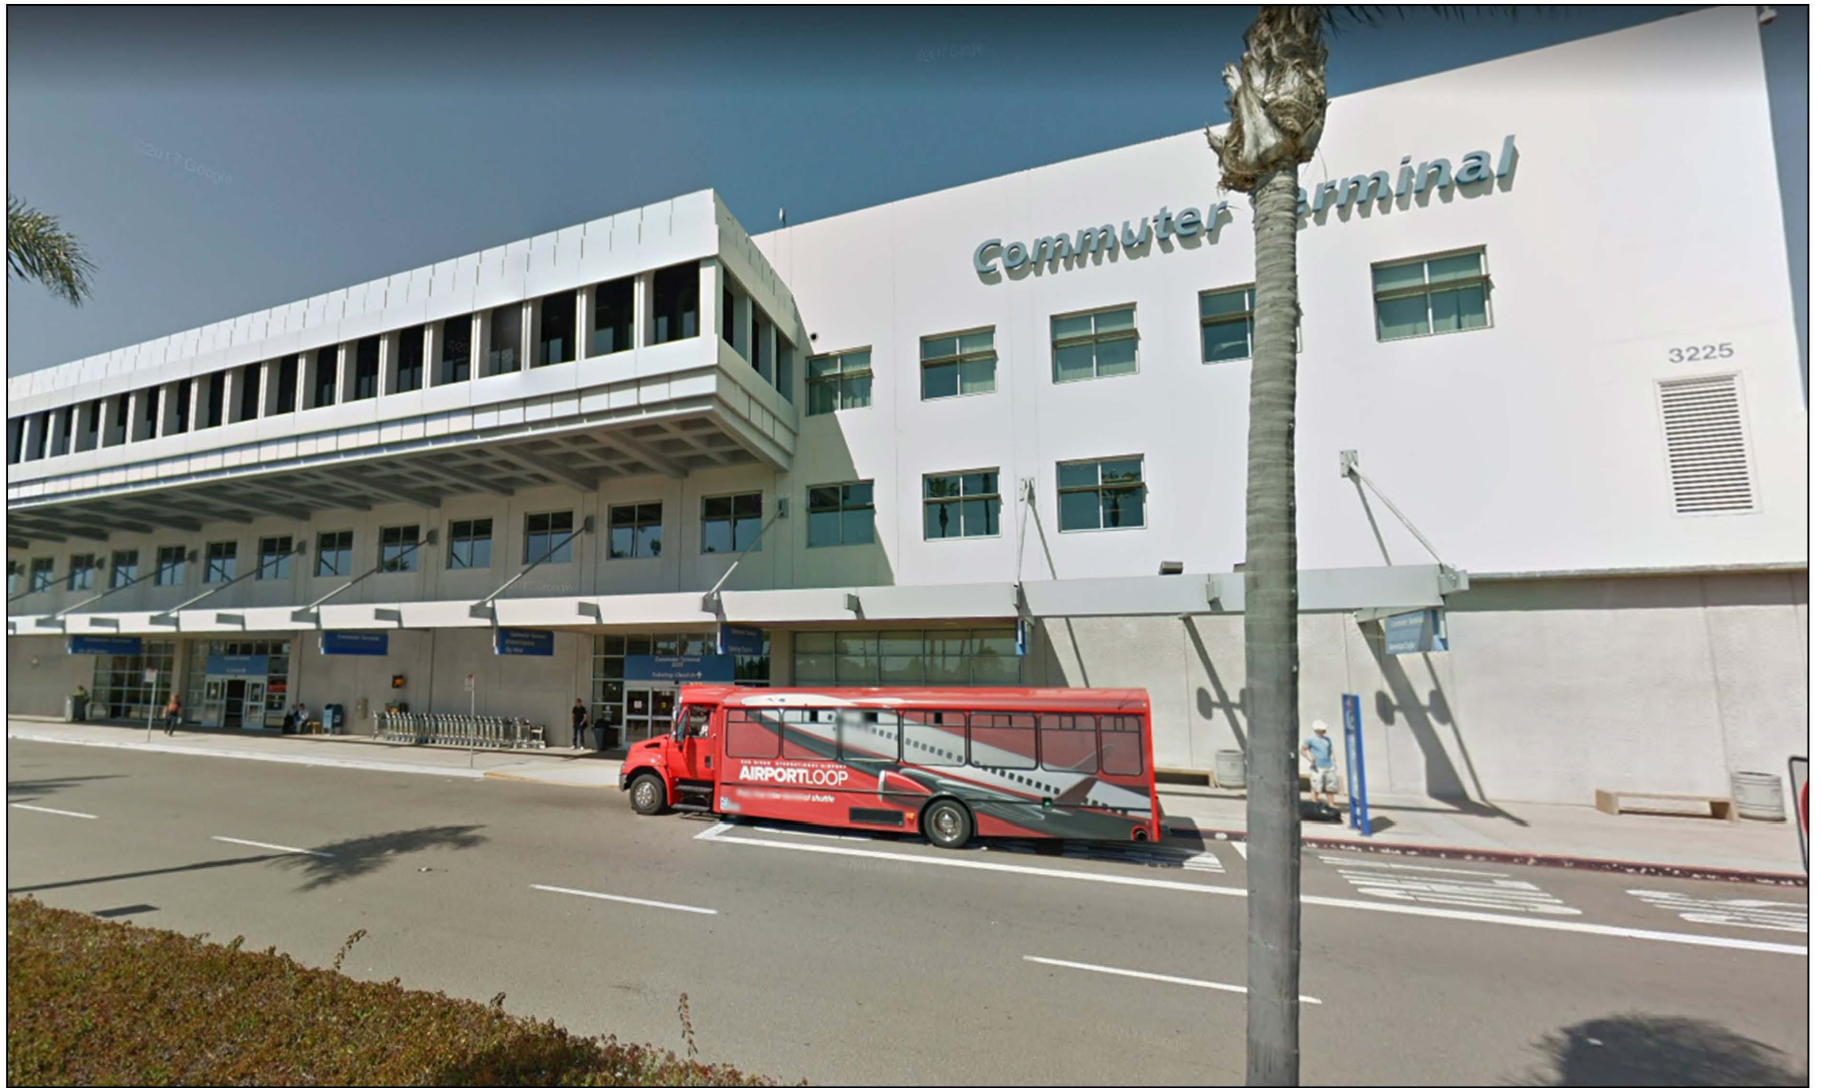
**Plate 6.3-4**

**2011 View of the South Façade of the PSA AMF  
Building Turned Commuter Terminal, Facing North**

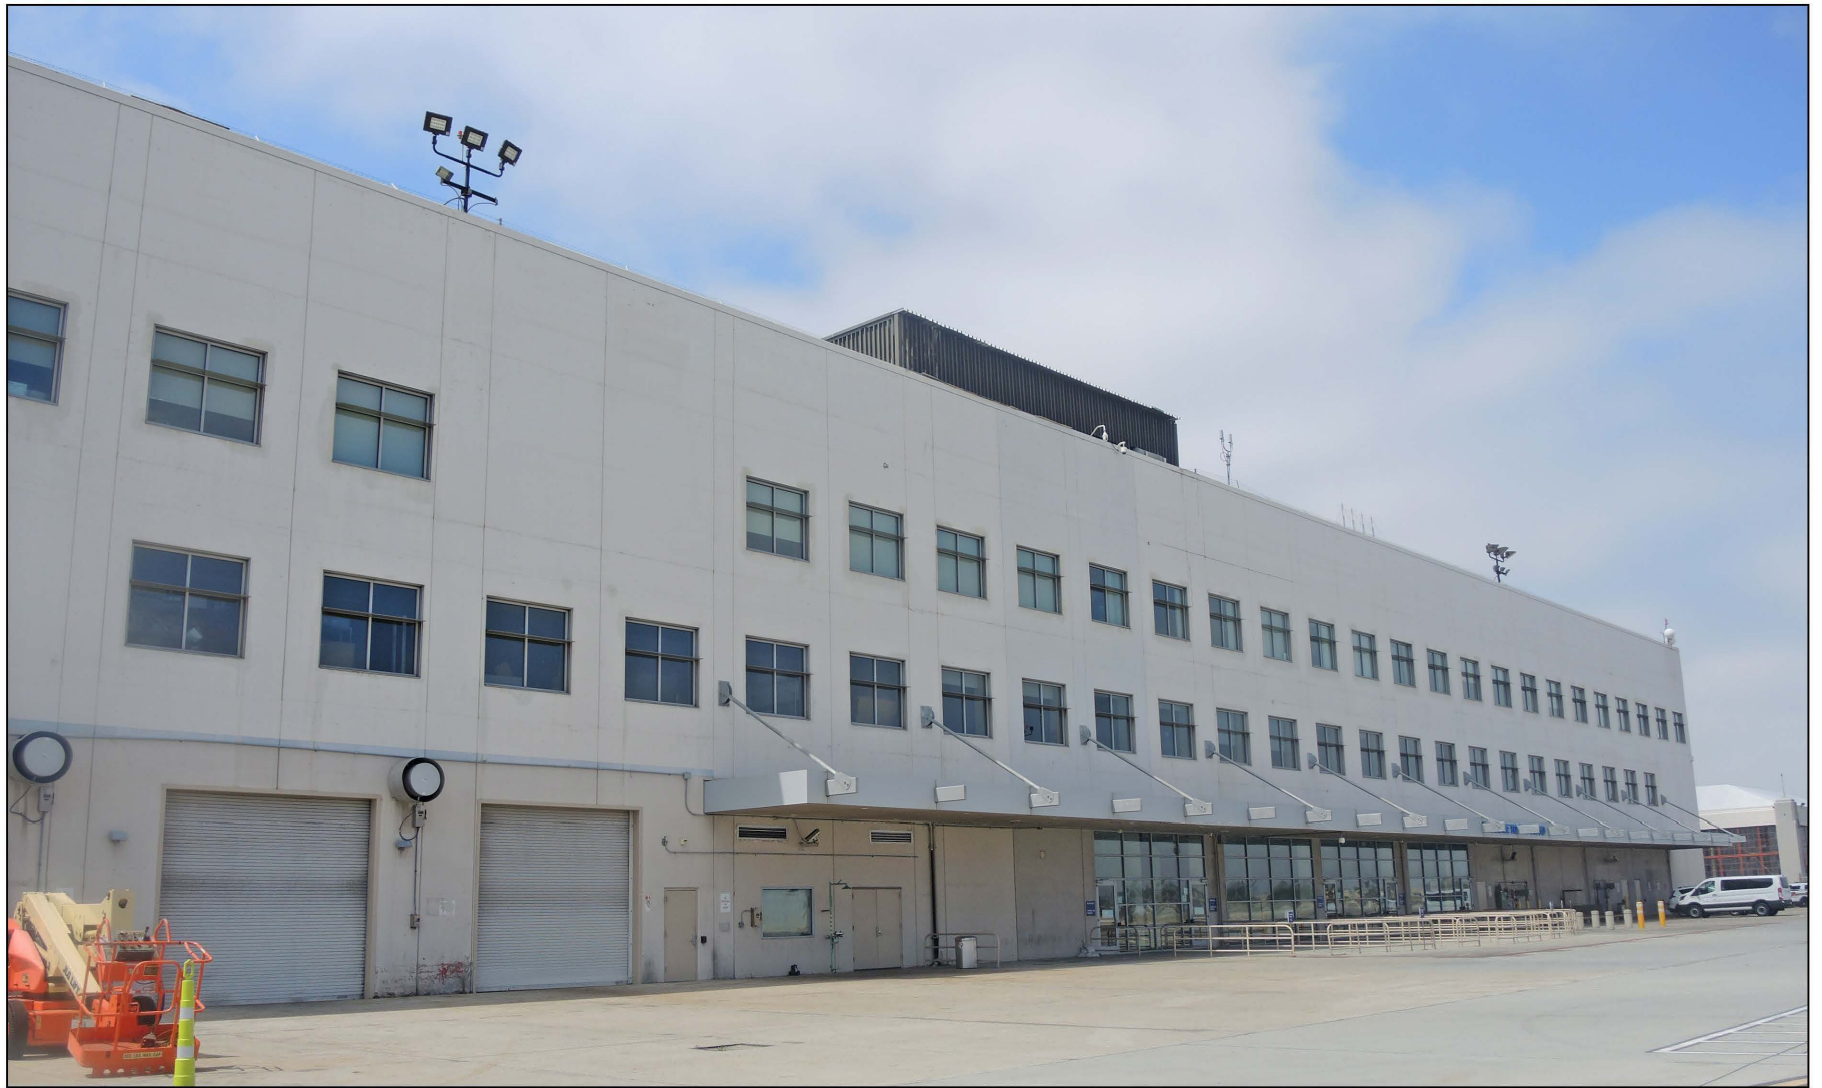
**Plate 6.3-5**

**View of the North Façade of the PSA AMF Building  
With the 1968 Hangar Removed, Facing Southwest**

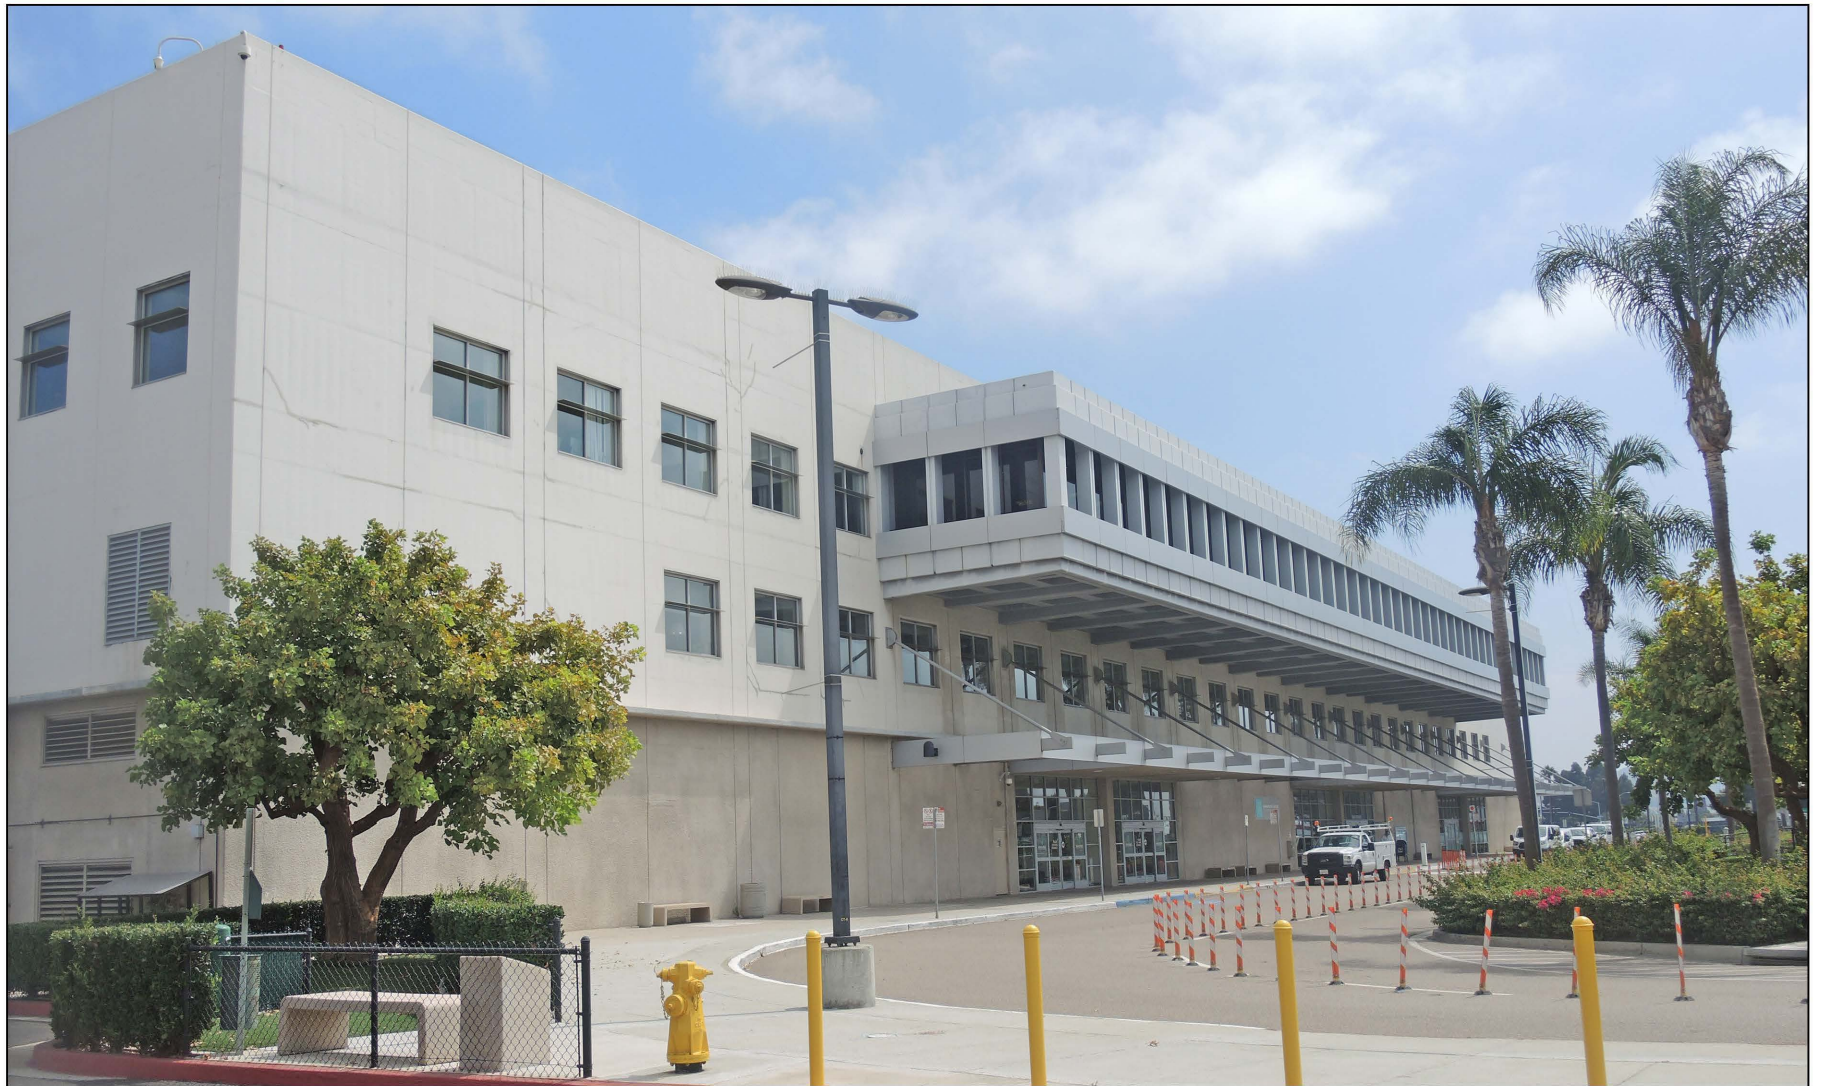
**Plate 6.3-6**

**View of the South Façade of the PSA AMF  
Building Showing the 1996 Awning, Facing East**

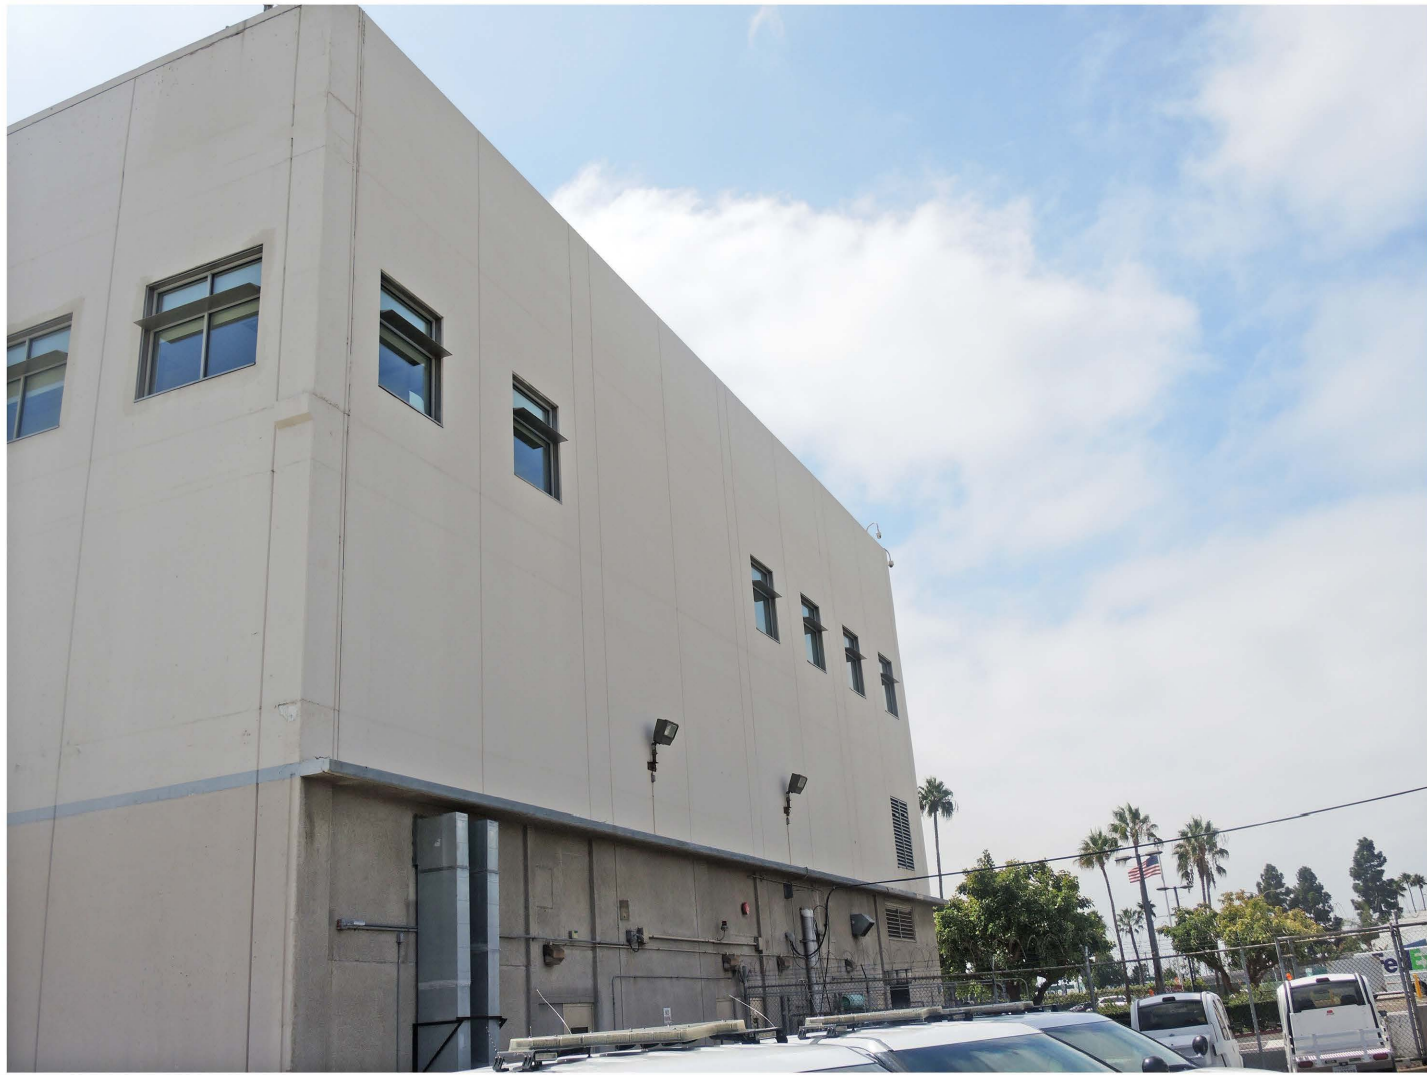
**Plate 6.3-7**

**View of the Northwest Corner of the PSA AMF  
Building Showing the 1996 Windows, Facing South**

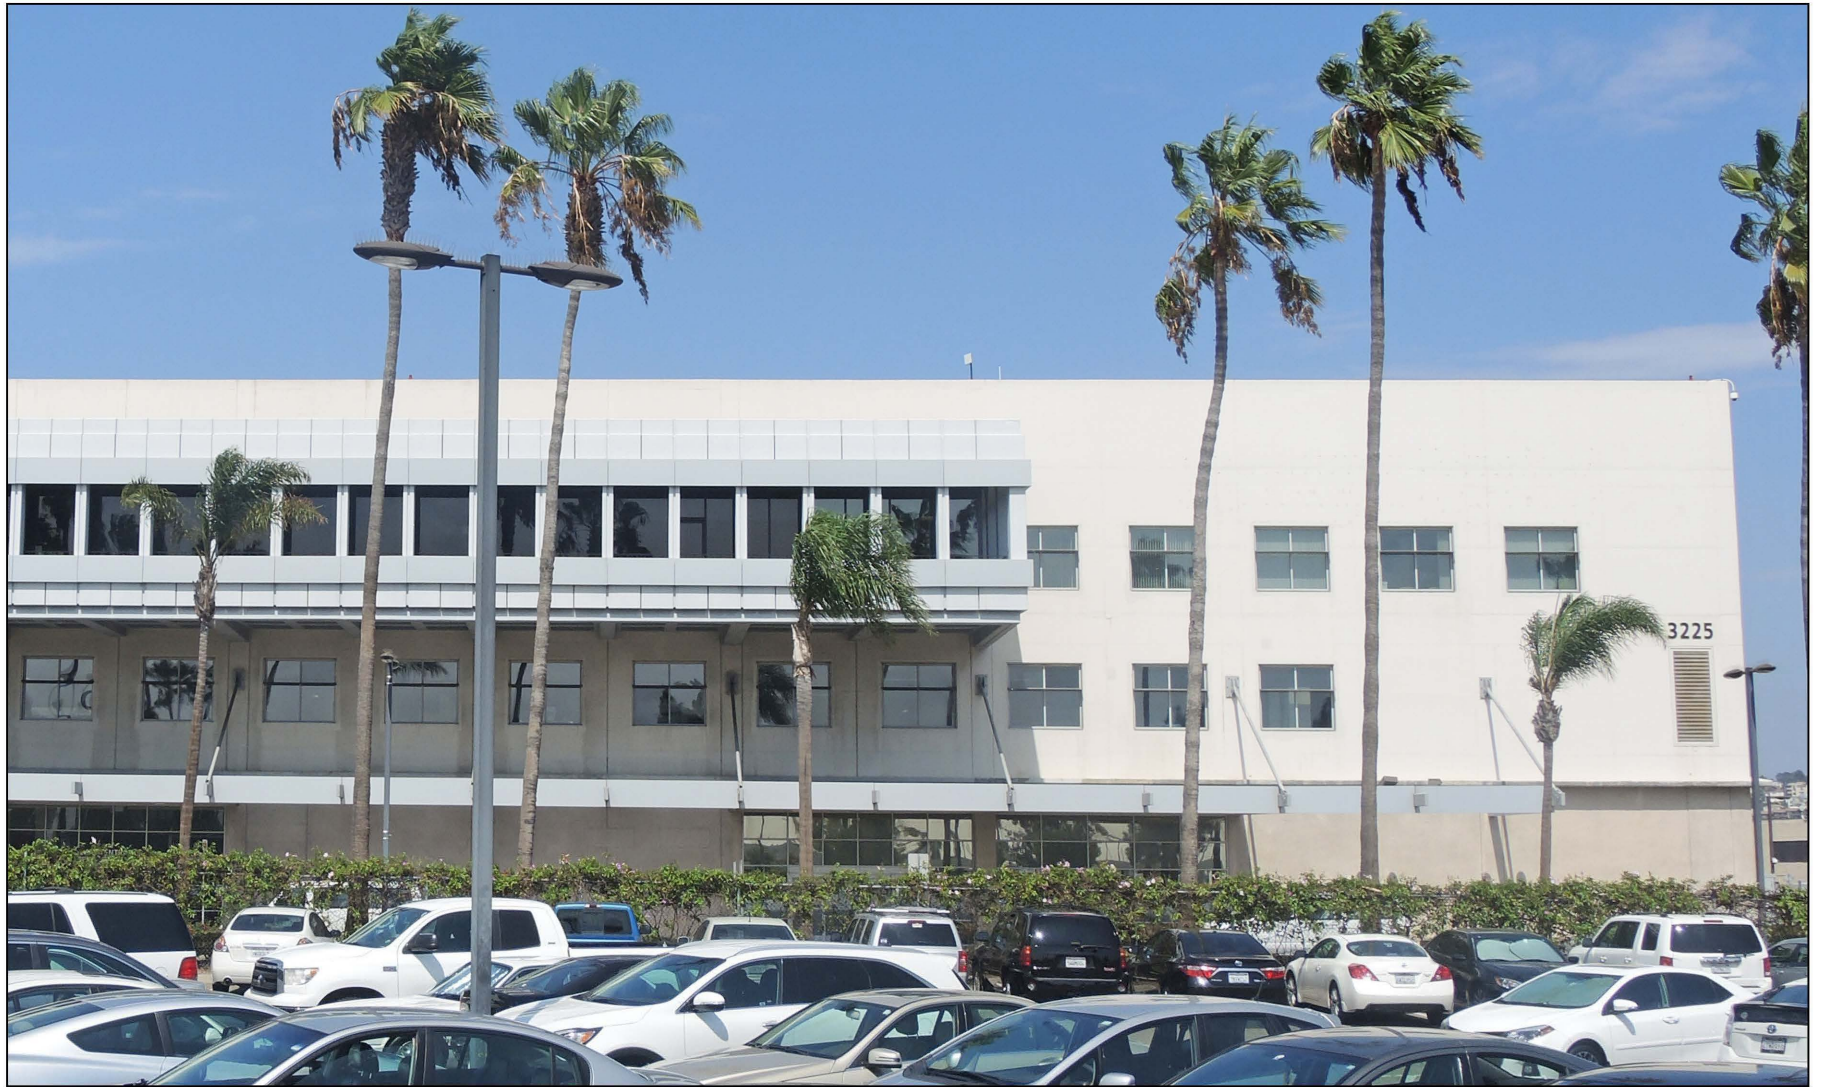
**Plate 6.3-8**

**View of the South Façade of the PSA AMF  
Building Showing the 1996 Windows, Facing Northeast**  
The SAN Airfield Improvements and Terminal 1 Replacement Project

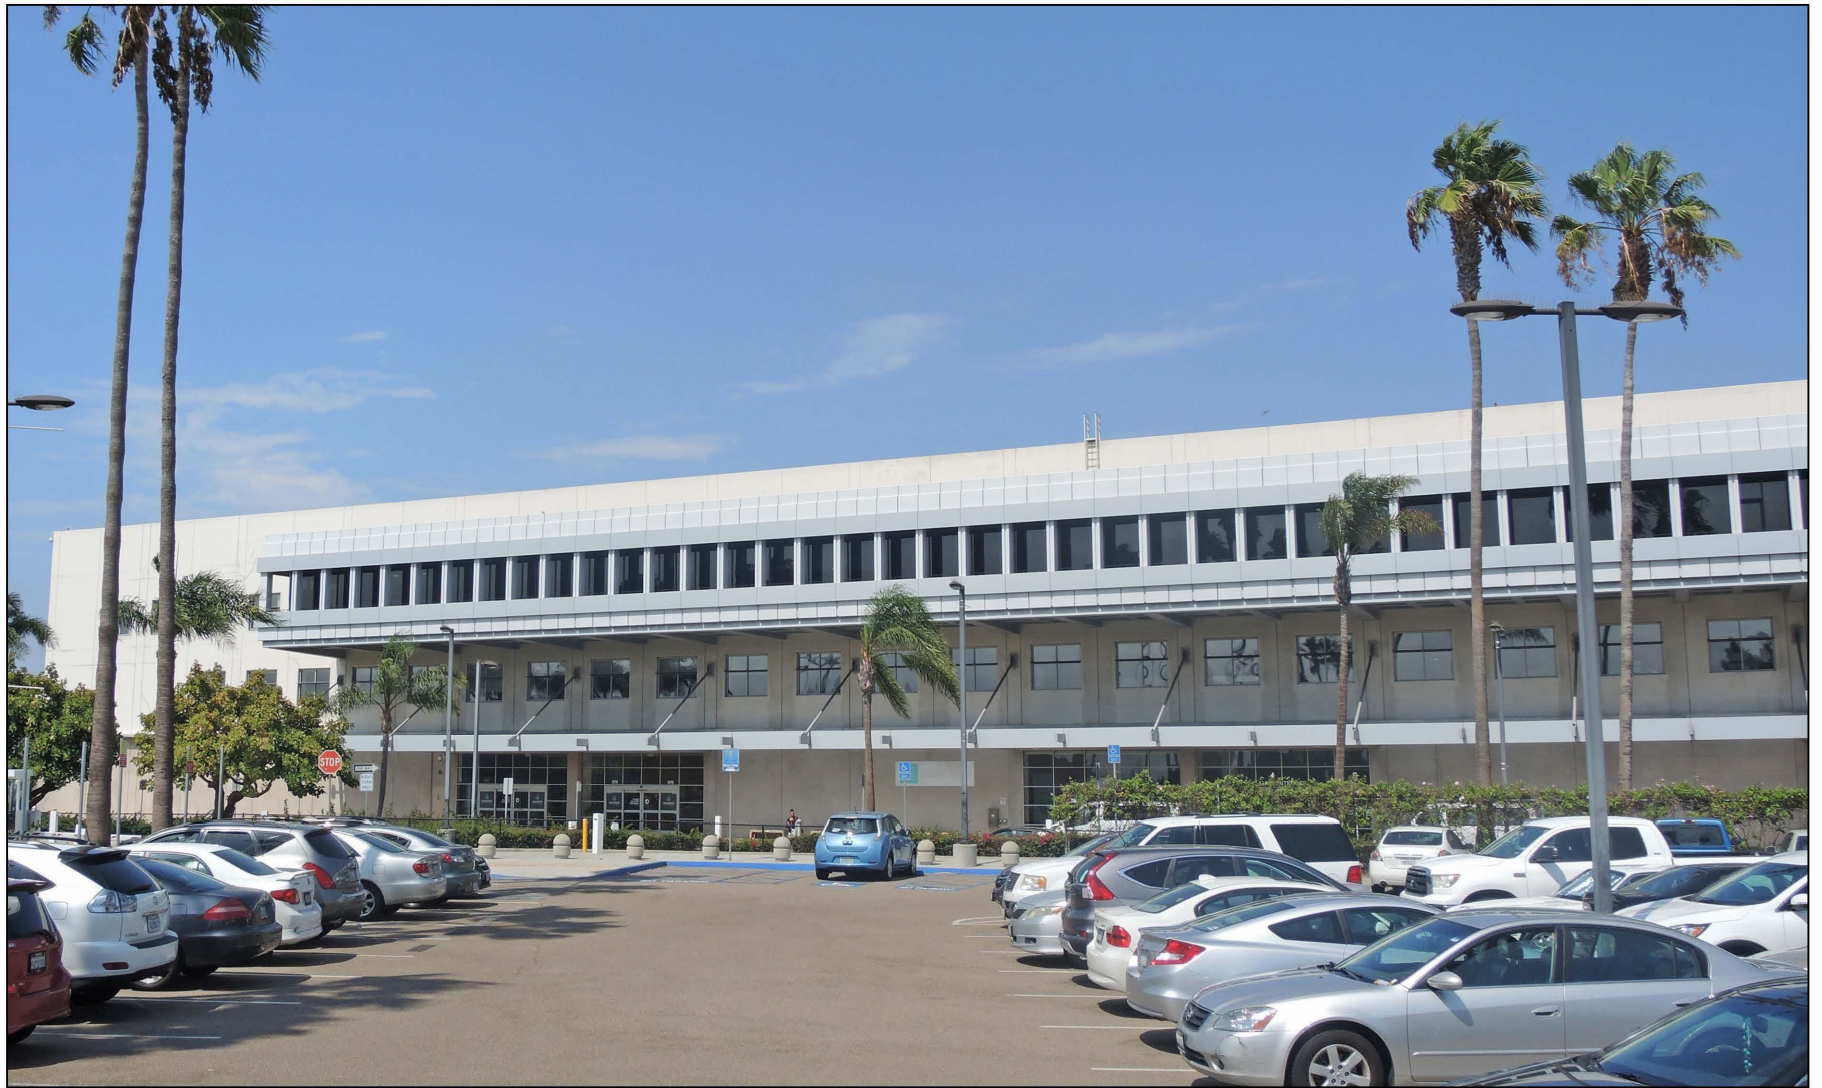
**Plate 6.3-9**

**View of the South Façade of the PSA AMF Building  
Showing the 1996 Windows and Doors, Facing North**

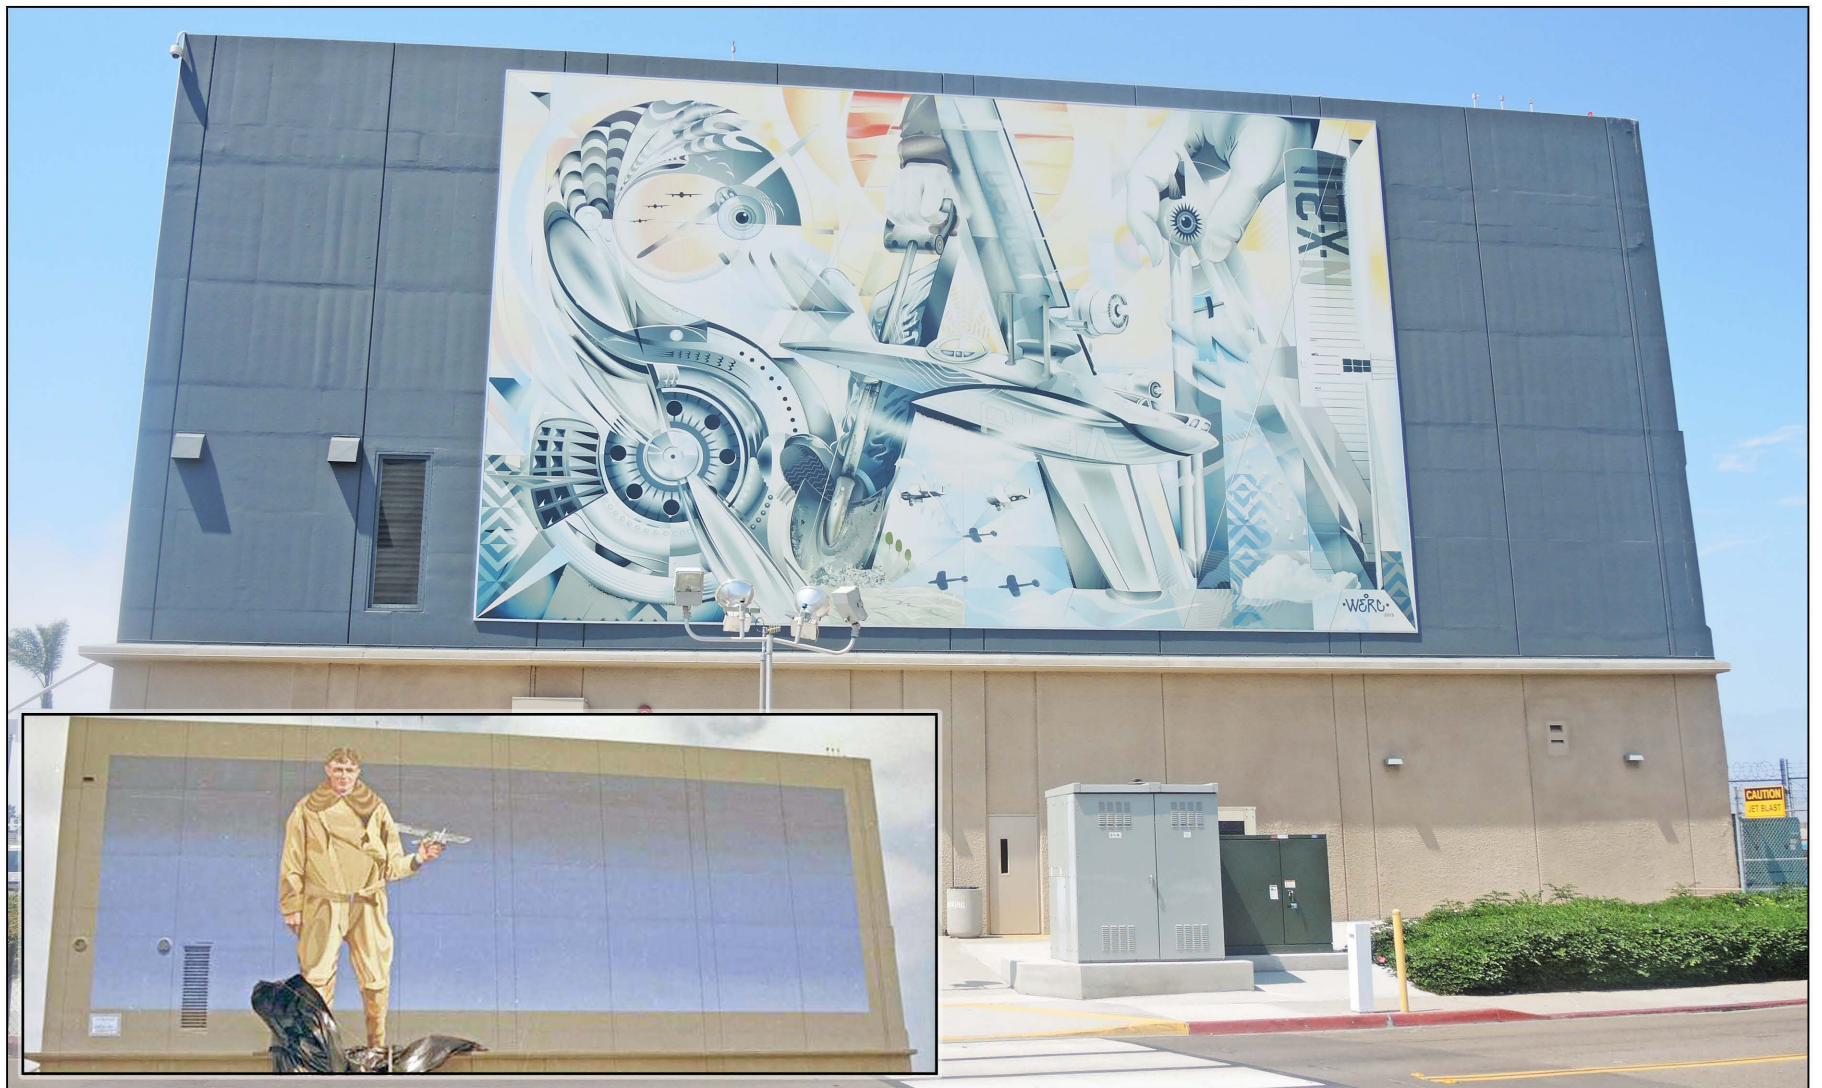
**Plate 6.3-10**  
**View of the East Façade of the PSA AMF Building, Facing Northwest**  
The SAN Airfield Improvements and Terminal 1 Replacement Project

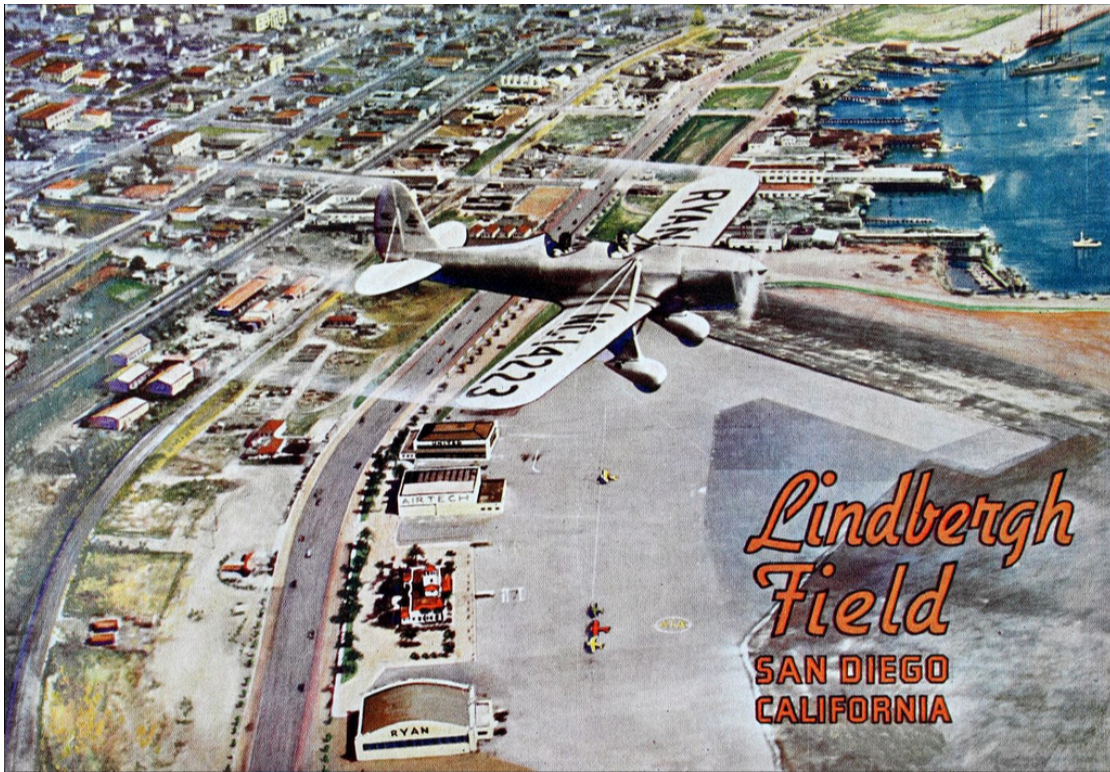
**Plate 6.4–1: 1930s Lindbergh Field postcard showing the UAHT building on Pacific Highway just under the wing of the Ryan aircraft.**  
*(Courtesy of the San Diego Air and Space Museum)*

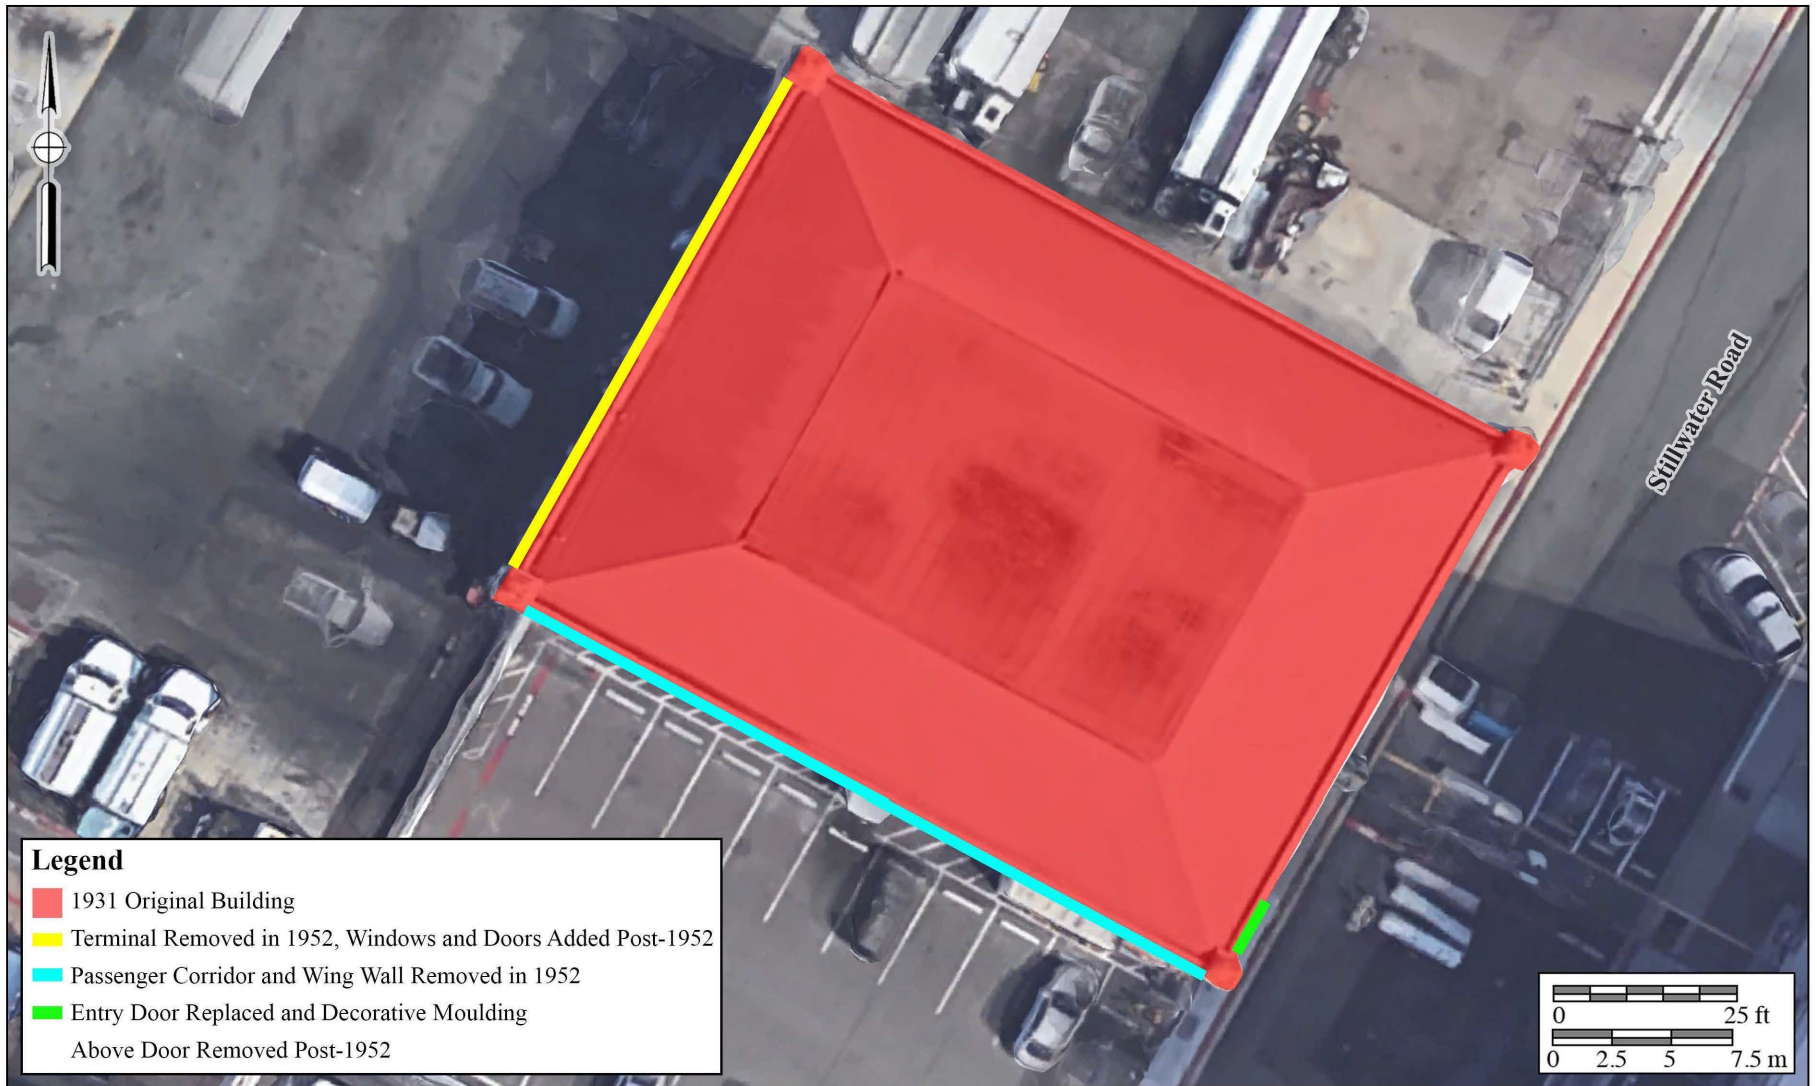
In 2005, Van Wormer recorded the UAHT building as being representative of an “Industrial – commercial aircraft hangar” with “modest Art Deco pillars at corners.” However, the current evaluation found that the original UAHT building is more representative of a mixture of the Spanish Revival and Modernistic architectural styles. When constructed in 1931, the UAHT building consisted of an approximately 5,625-square-foot hangar, a covered passenger corridor, and a rectangular terminal. The hangar portion of the UAHT building was moved to its current location at 2340 Stillwater Road in 1952 (Morn 1952). At that time, it was rotated approximately 180 degrees so that the large hangar doors now face north rather than south. The following were removed from the building: the wing wall and passenger loading corridor; the terminal; and the decorative moulding around the entry door. After its relocation, the building functioned as an aircraft maintenance hangar. Currently, the building serves as a storage and maintenance facility for Menzies Aviation. The remaining hangar portion currently appears much as it did when constructed in 1931 (Plate 6.4–3).

**Figure 6.4-2**  
**Site Plan for the UAHT Building**  
**Site P-37-028620**

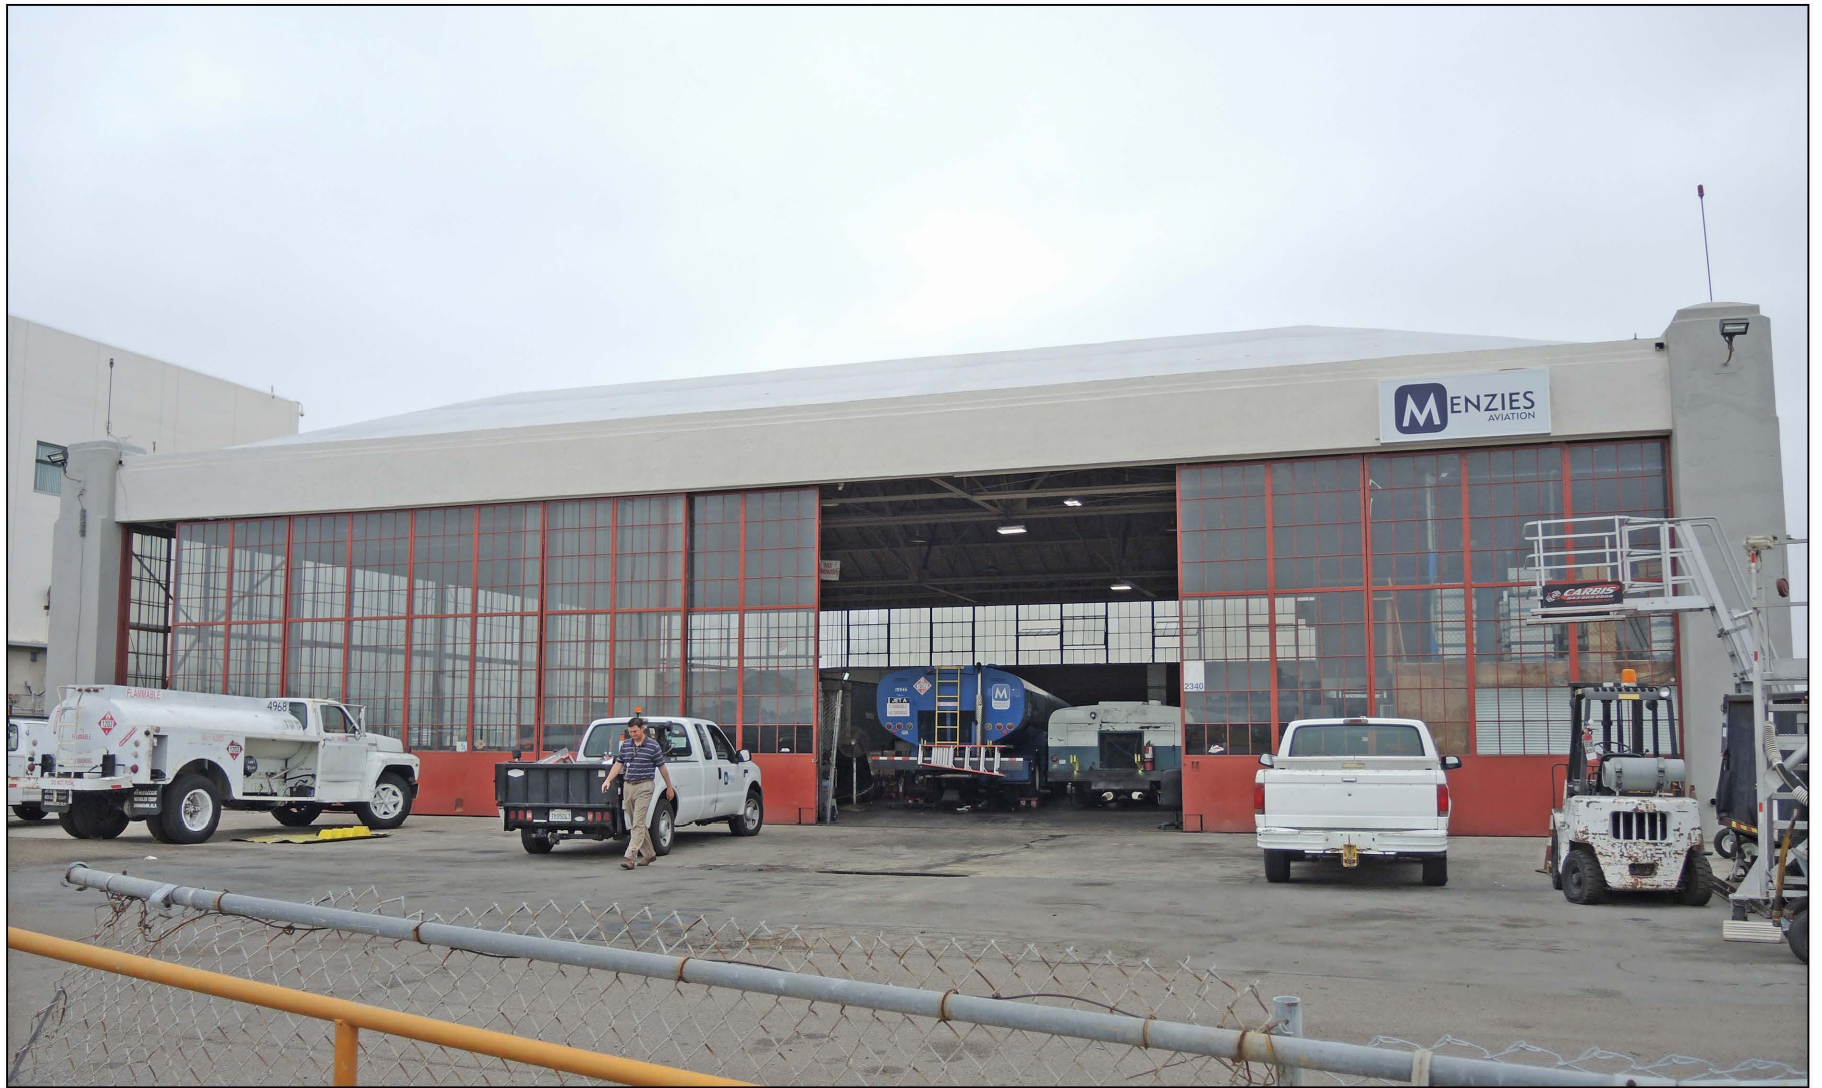
### Plate 6.4-4

### View of the North Façade of the UAHT Building, Facing South

The hangar was constructed with a steel frame and wood and steel trusses that form a low, flat, pyramidal roof (Plate 6.4–4). The roof itself was constructed using wood planks (Plate 6.4–5) covered in an asphalt roofing material. Square, stepped, concrete, Art Deco-style pillars clad in stucco support the four corners of the hangar building. The pillars are connected on the north, south, and east façades via a thick, stucco-clad architrave with stepped horizontal grooves at the cornice line. The stepped horizontal grooves on the west façade are interrupted in the center by a curved parapet. The north façade of the building exhibits 12 multi-paned, steel-framed, sliding hangar doors. The doors are installed on tracks (upper and lower) that allow all of the doors to slide to the inside of the west façade so as to all be open at the same time (Plates 6.4–6 and 6.4–7).
