**Section 106 Assessment for the San Diego International Airport Airfield  
Improvements and Terminal 1 Replacement Project**

**SECTION 106 ASSESSMENT FOR THE  
SAN DIEGO INTERNATIONAL AIRPORT  
AIRFIELD IMPROVEMENTS AND  
TERMINAL 1 REPLACEMENT PROJECT**

**CITY OF SAN DIEGO, CALIFORNIA**

***November 10, 2020; Revised January 8, 2021; Revised February 19, 2021;  
Revised March 12, 2021; Revised April 27, 2021; Revised May 7, 2021***

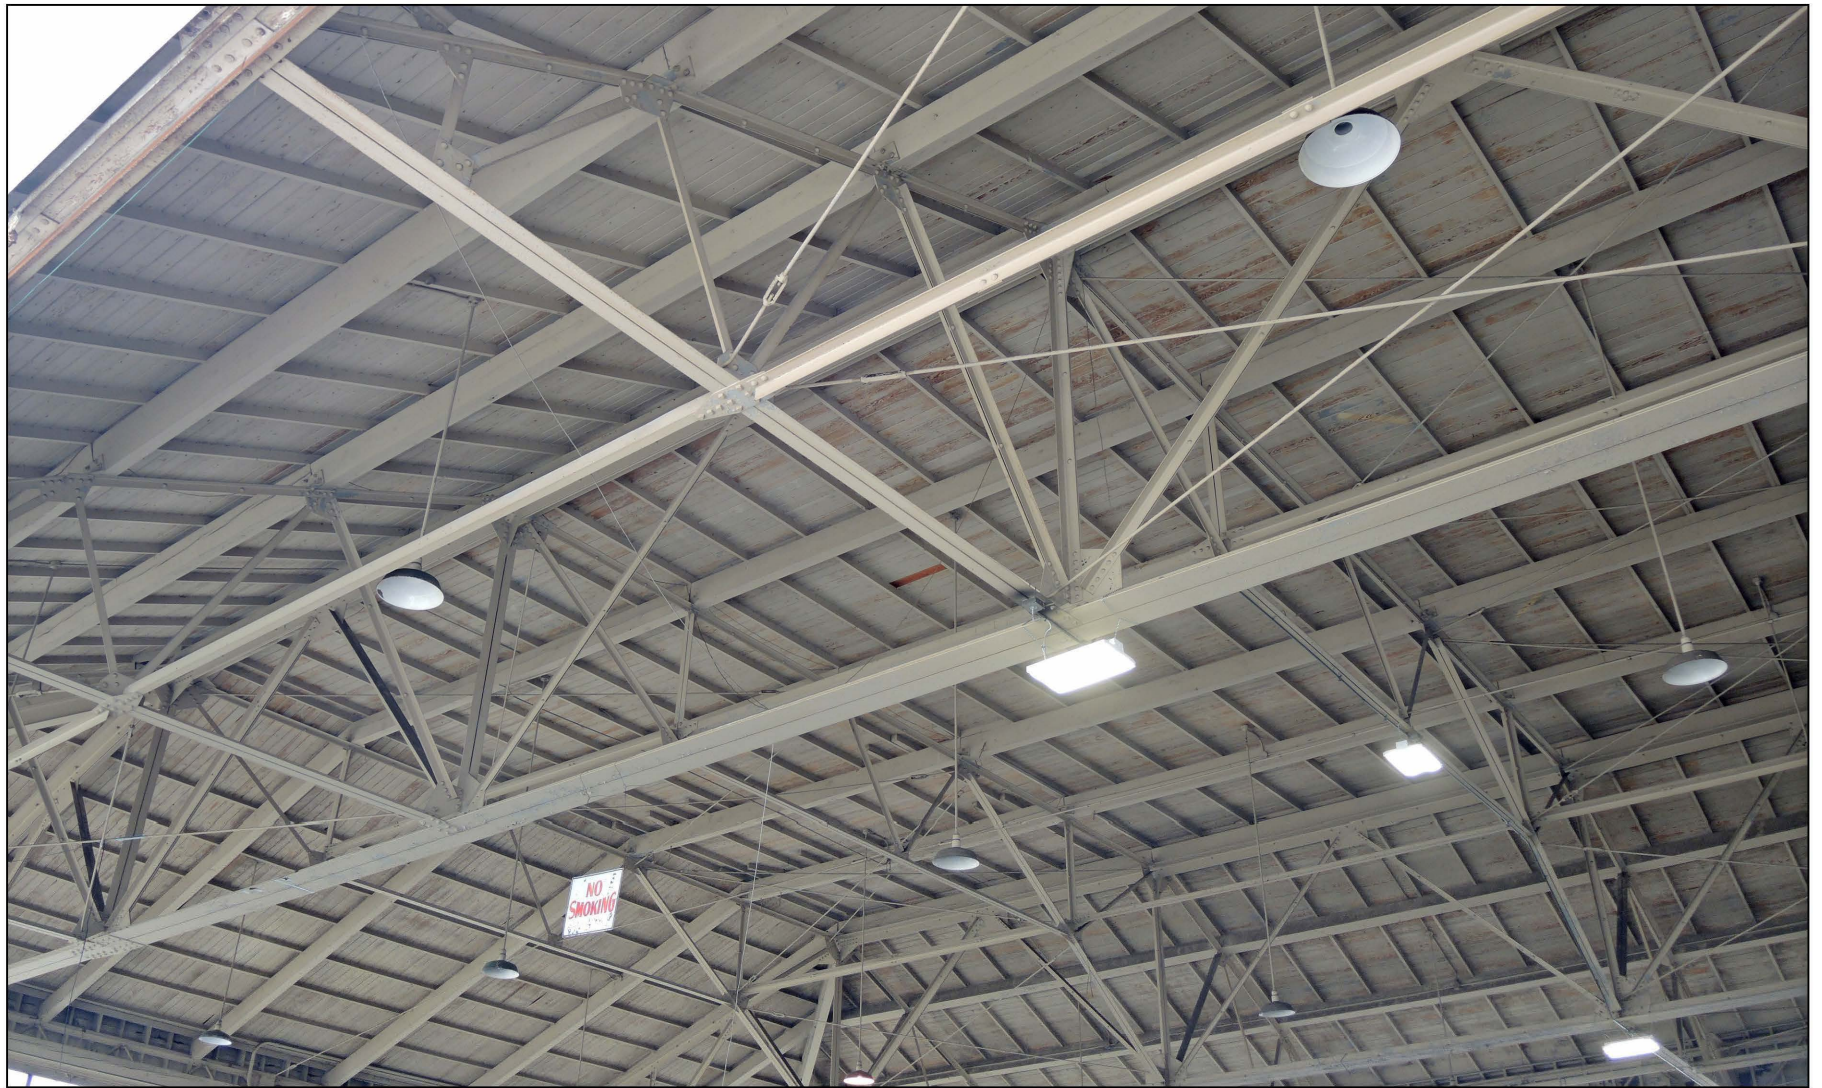
**Plate 6.4-5**

**View of the Wood Plank Ceiling of the UAHT Building, Facing Southeast**

The hangar was constructed with a steel frame and wood and steel trusses that form a low, flat, pyramidal roof (Plate 6.4–4). The roof itself was constructed using wood planks (Plate 6.4–5) covered in an asphalt roofing material. Square, stepped, concrete, Art Deco-style pillars clad in stucco support the four corners of the hangar building. The pillars are connected on the north, south, and east façades via a thick, stucco-clad architrave with stepped horizontal grooves at the cornice line. The stepped horizontal grooves on the west façade are interrupted in the center by a curved parapet. The north façade of the building exhibits 12 multi-paned, steel-framed, sliding hangar doors. The doors are installed on tracks (upper and lower) that allow all of the doors to slide to the inside of the west façade so as to all be open at the same time (Plates 6.4–6 and 6.4–7).

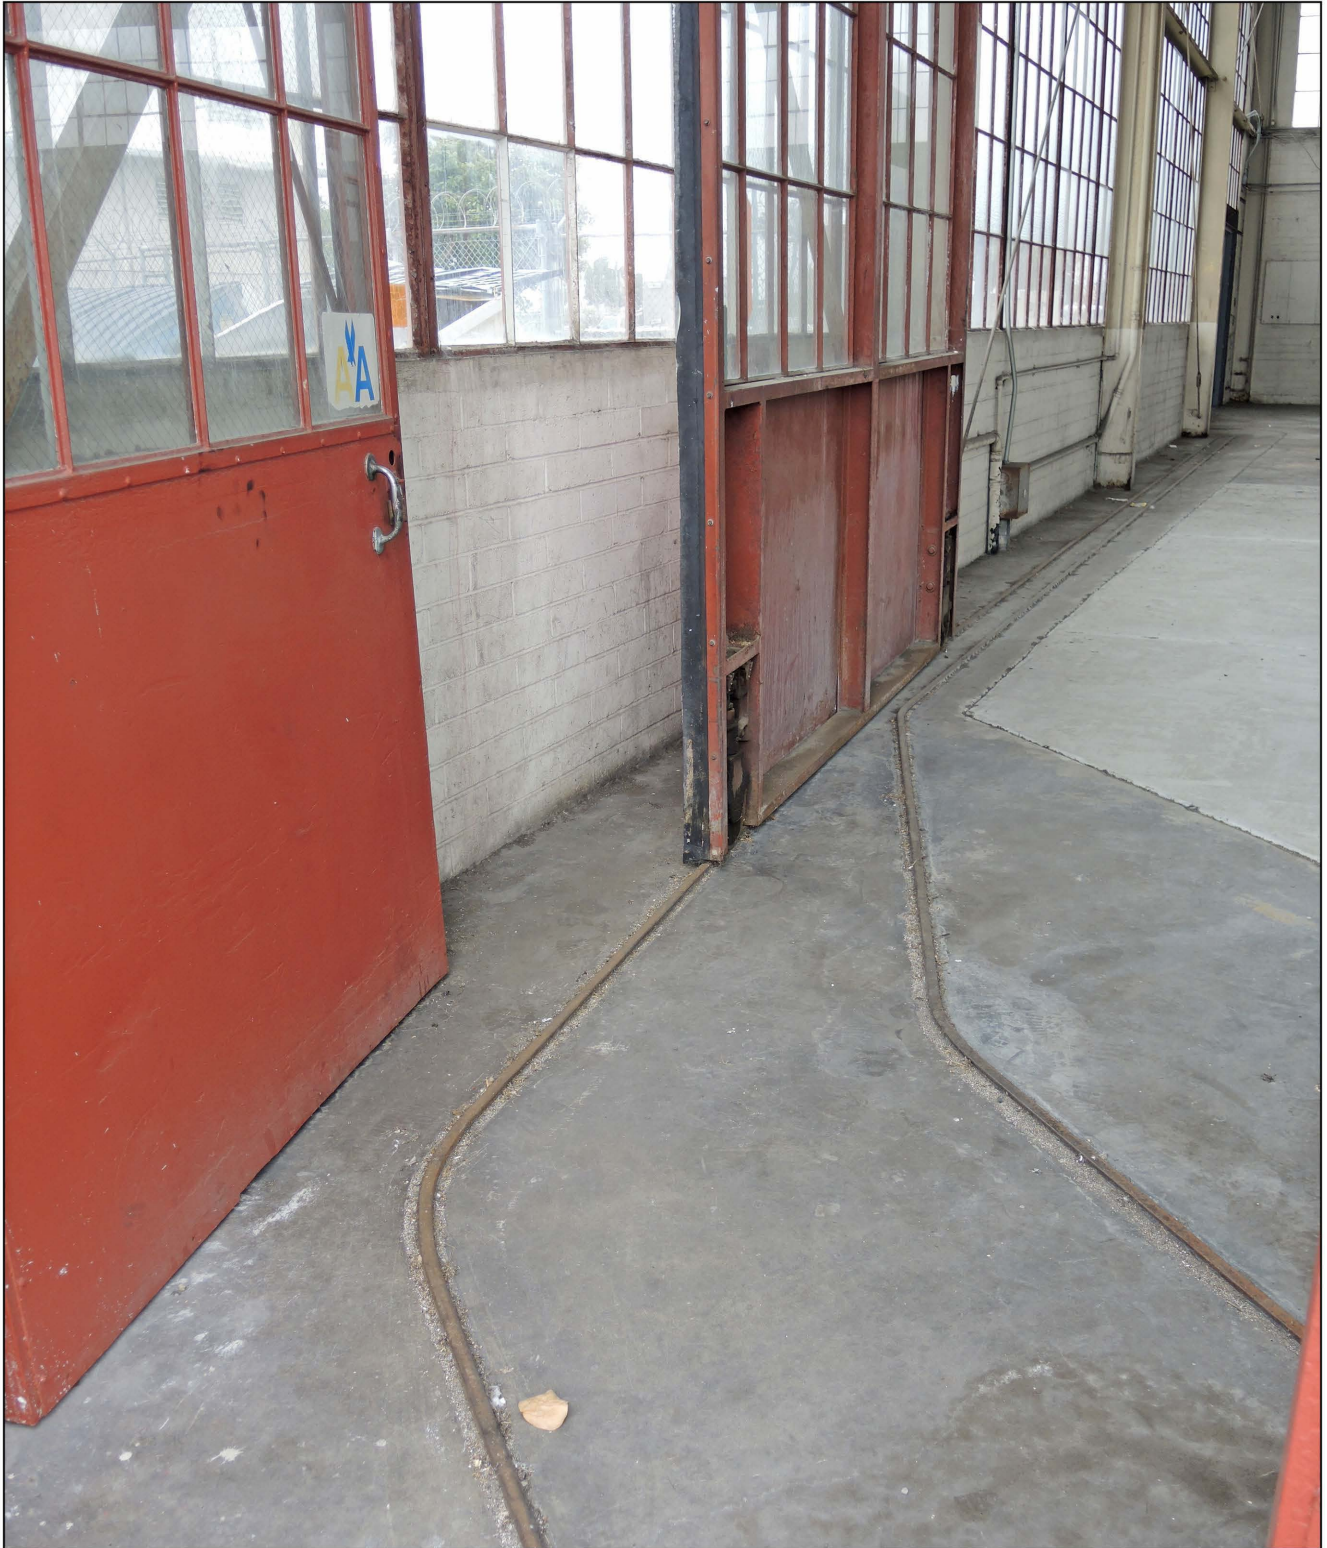
**Plate 6.4-6**

**View of the Tracks for the Sliding Hangar Doors  
on the UAHT Building, Facing Southeast**

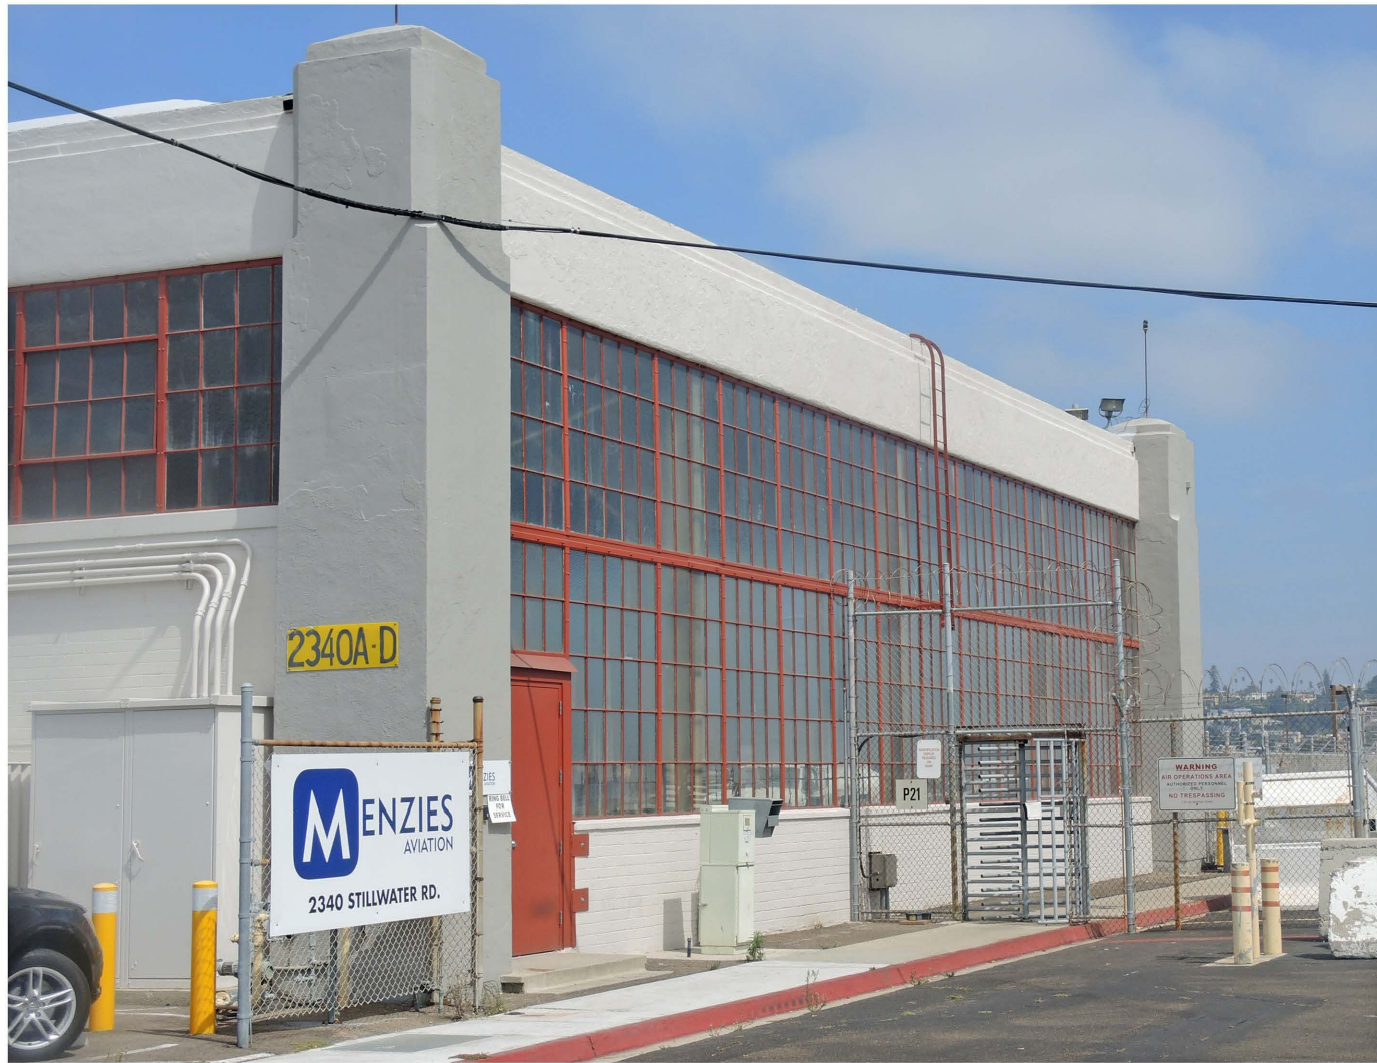
**Plate 6.4-8**  
**View of the East Façade of the UAHT Building, Facing North**  
The SAN Airfield Improvements and Terminal 1 Replacement Project

The east façade of the building exhibits fixed-pane, steel-framed windows (Plate 6.4–8), which are the same size and shape as the panes present in the hangar doors on the north façade. Below the windows on the east façade is an approximately two-foot-tall brick wall with concrete coping between the wall and windows. There is also a single, unadorned, solid metal entry door on the east façade (Plate 6.4–9). This door is not original and was likely replaced around the time that the building was relocated in 1952. As can be seen in Plate 6.4–3, the original entry door on what is now the current east façade exhibited decorative moulding.

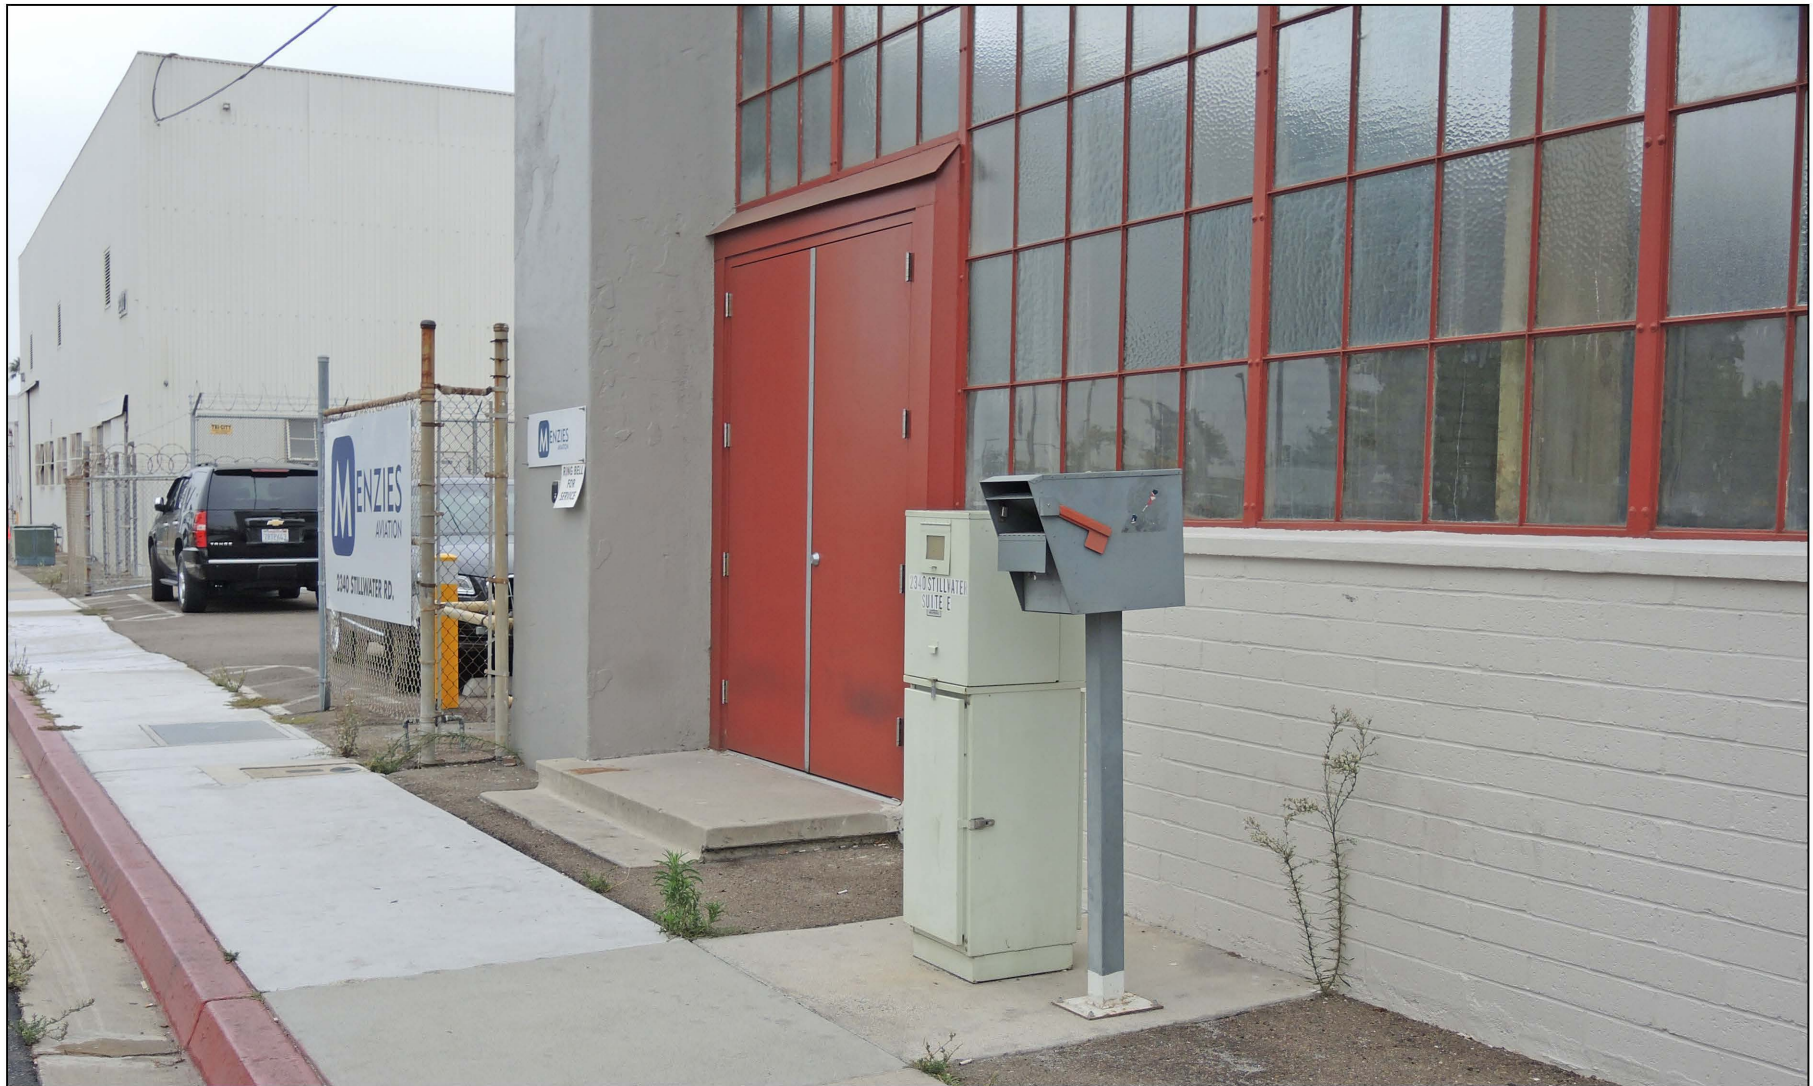
**Plate 6.4-9**

**View of the Post-1952 Entry Door on the East  
Façade of the UAHT Building, Facing Southwest**

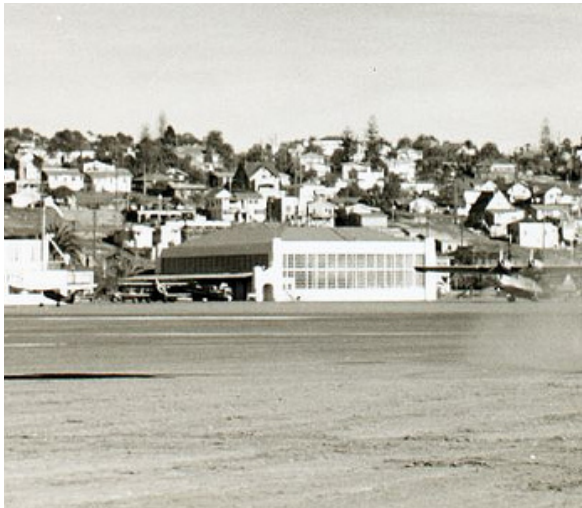
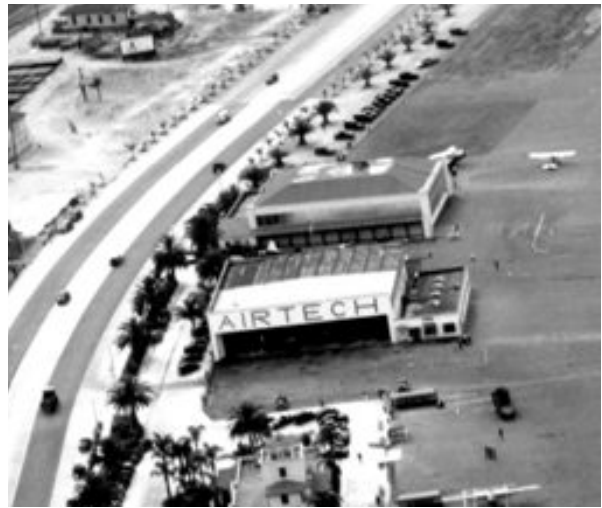
**Plates 6.4–10 and 6.4–11: 1930s (left) and 1936 (right) photographs of the UAHT building, showing the passenger corridor on the left side. (Photographs courtesy of the San Diego Air and Space Museum and the City of San Diego, respectively)**

When completed in 1931, the UAHT building possessed a covered passenger corridor on what is currently the south façade (Plates 6.4–10 and 6.4–11). The passenger corridor resembled a Spanish Revival-style, full-length porch, which extended the entire length of the building and exhibited 10 support posts. The corridor was accented on what is currently the east side by an arcaded, stucco-clad wing wall with a stepped pillar that matched those on the four corners of the building. A description could not be located of the passenger corridor roof material and historic photographs do not show the corridor clearly enough to determine what materials may have been used in its construction. The wall separating the corridor from the interior of the hangar was constructed of brick, as can be seen in a current photograph of the south façade of the building (Plate 6.4–12). Above the brick wall is a band of original steel-framed, fixed-pane and horizontal pivot windows (see Plate 6.4–12).

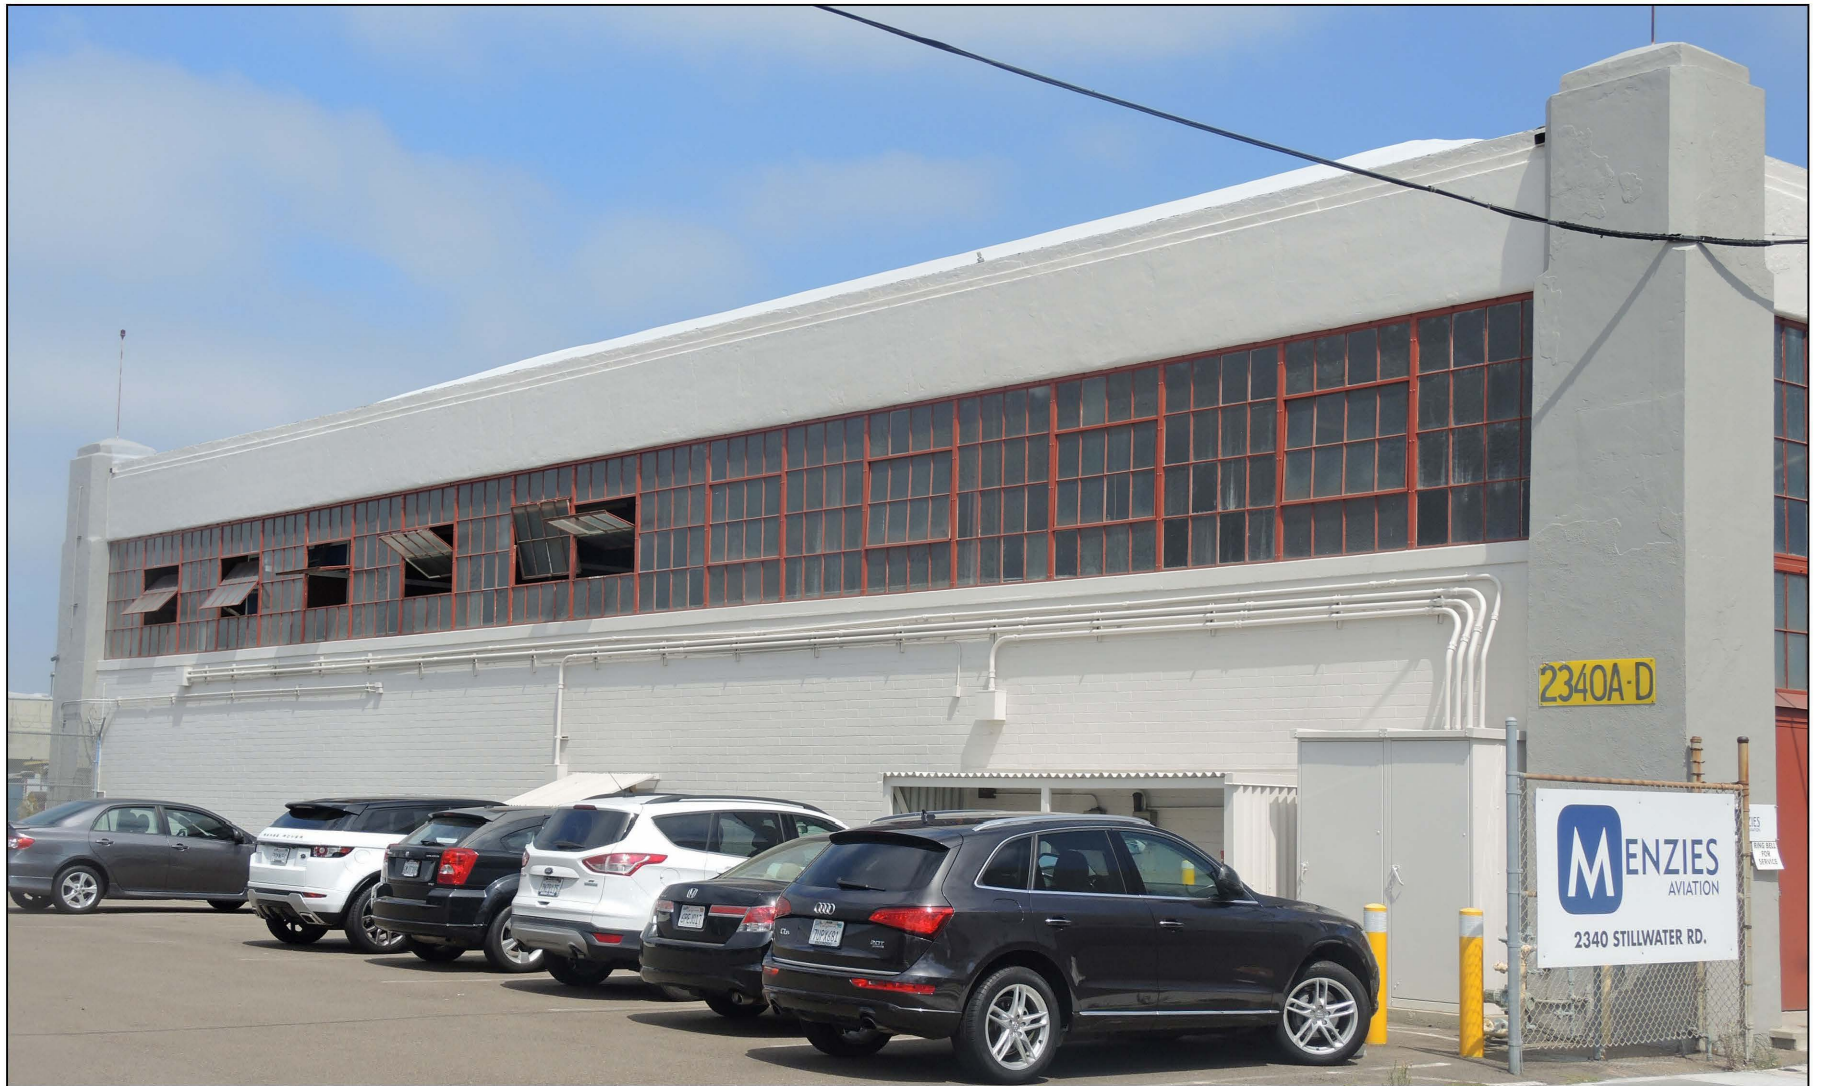
**Plate 6.4-12**  
**View of the South Façade of the UAHT Building, Facing Northwest**  
The SAN Airfield Improvements and Terminal 1 Replacement Project

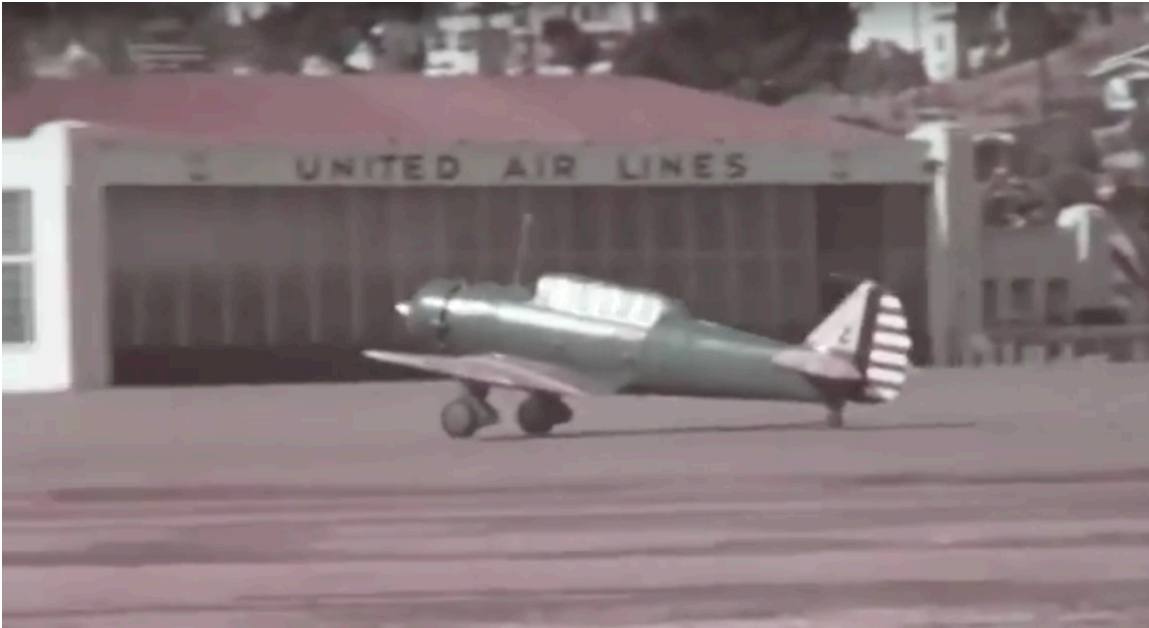
**Plate 6.4–13: Circa 1931 to 1941 photograph of the UAHT building showing the terminal attached to the right side.**  
*(Photograph courtesy of the San Diego Air and Space Museum)*

Before it was removed, the terminal was attached to what is currently the west façade of the UAHT building (Plate 6.4–13). The attached terminal building was rectangular, clad in stucco, with a flat, parapeted roof and casement-style windows. The two eastern corners of the attached terminal exhibited square, stepped pillars that matched those on the four corners of the hangar. The wall separating the hangar from the terminal was solid brick, except for a large doorway near the northern end and a smaller doorway toward the center of what is currently the west façade of the UAHT building (Plate 6.4–14).

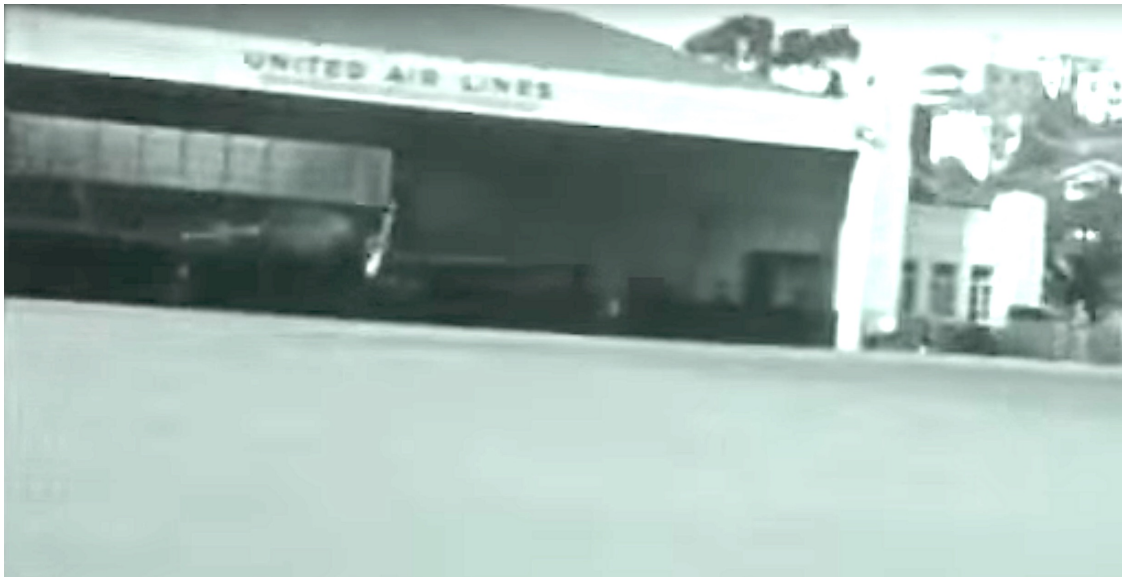
**Plate 6.4–14: Circa 1931 to 1941 photograph of the interior of the UAHT building showing the attached terminal and two entrance doors on the right side.**  
*(Photograph courtesy of the San Diego Air and Space Museum)*

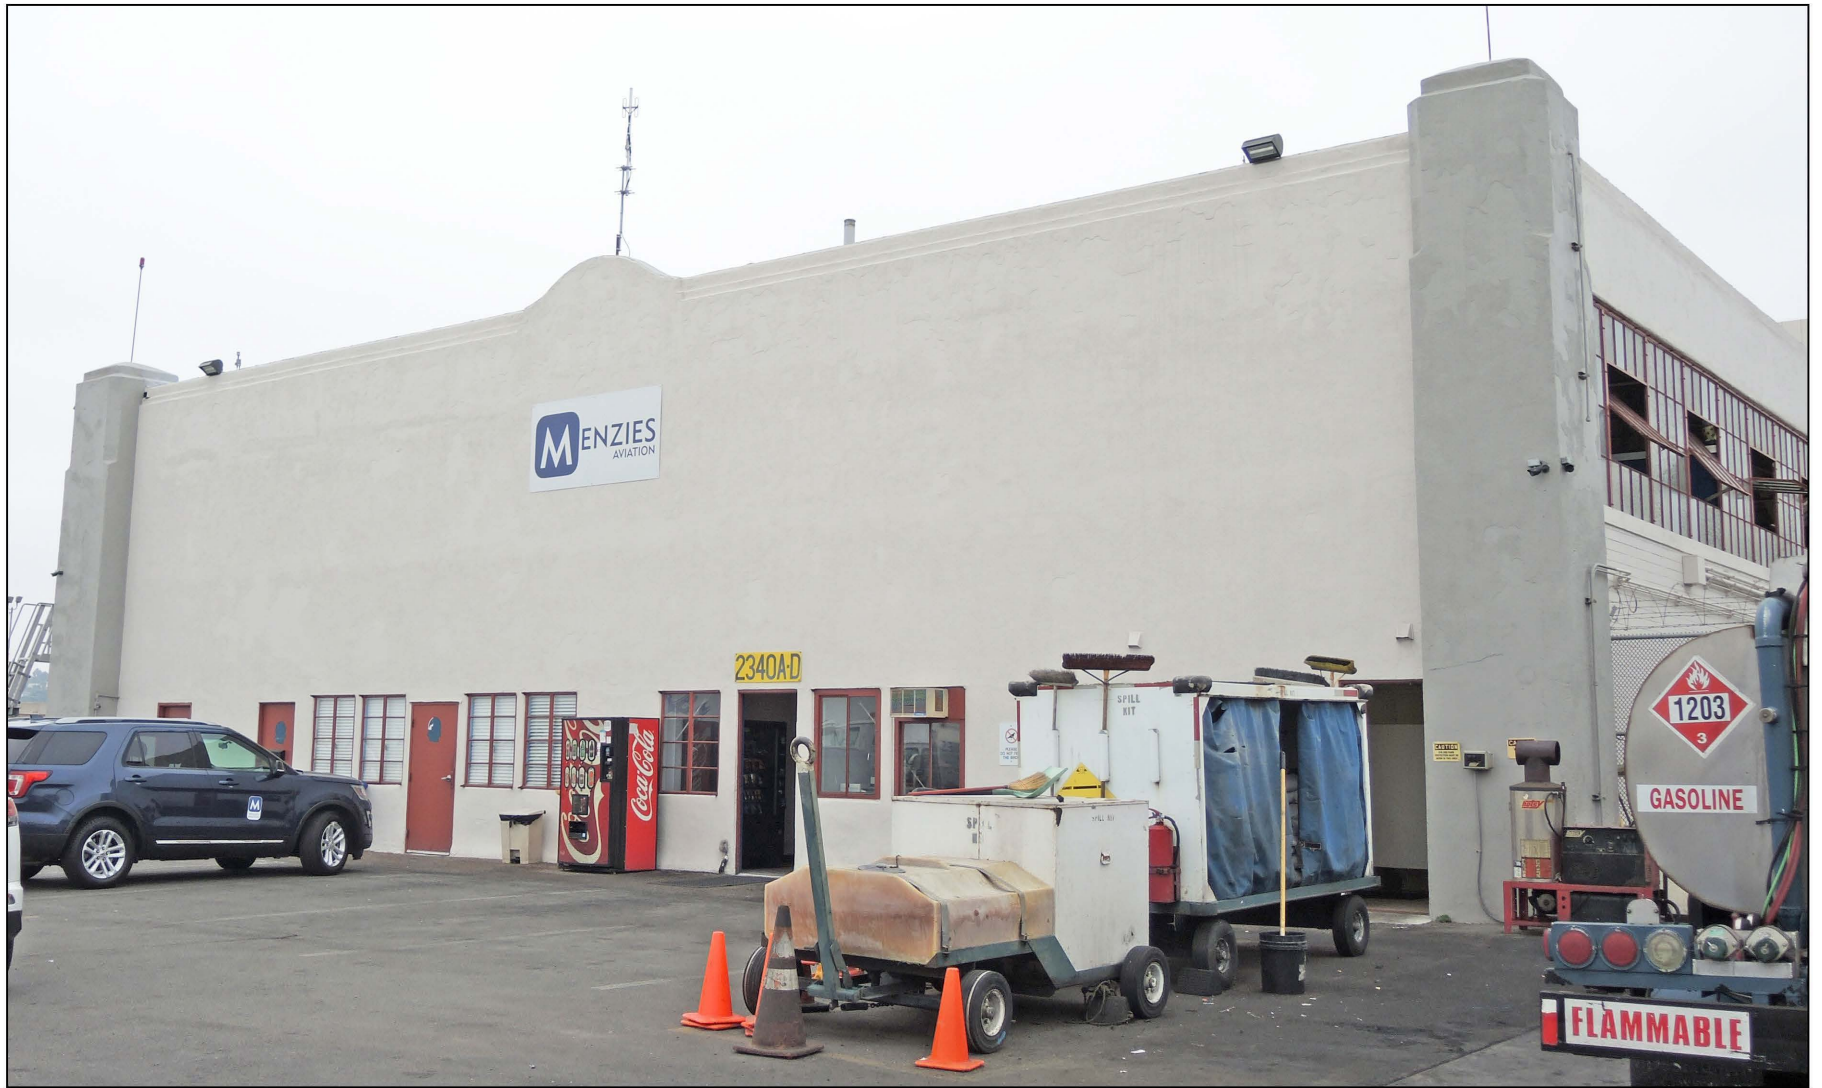
**Plate 6.4-15**  
**View of the West Façade of the UAHT Building, Facing East**  
The SAN Airfield Improvements and Terminal 1 Replacement Project

As stated previously, the UAHT building was constructed in 1931 in a mixture of Spanish Revival and Modernistic architectural styles. The Spanish Revival style was common between 1915 and 1940, predominantly in the southwestern states and particularly in California. Spanish Revival-style buildings use decorative details that are broadly borrowed from historic Spanish architecture. The style was introduced at the Panama-California Exposition held in San Diego in 1915 (McAlester 2015). Prior to its relocation in 1952, the UAHT building possessed several Spanish Revival-style elements, including: the arcaded wing wall on the passenger corridor; the flat, parapeted roof on the attached terminal; the casement windows on the terminal; the carved moulding above the door on what is currently the east façade; and the shed-style roof on the passenger corridor. However, all of these elements were removed when the building was relocated in 1952.

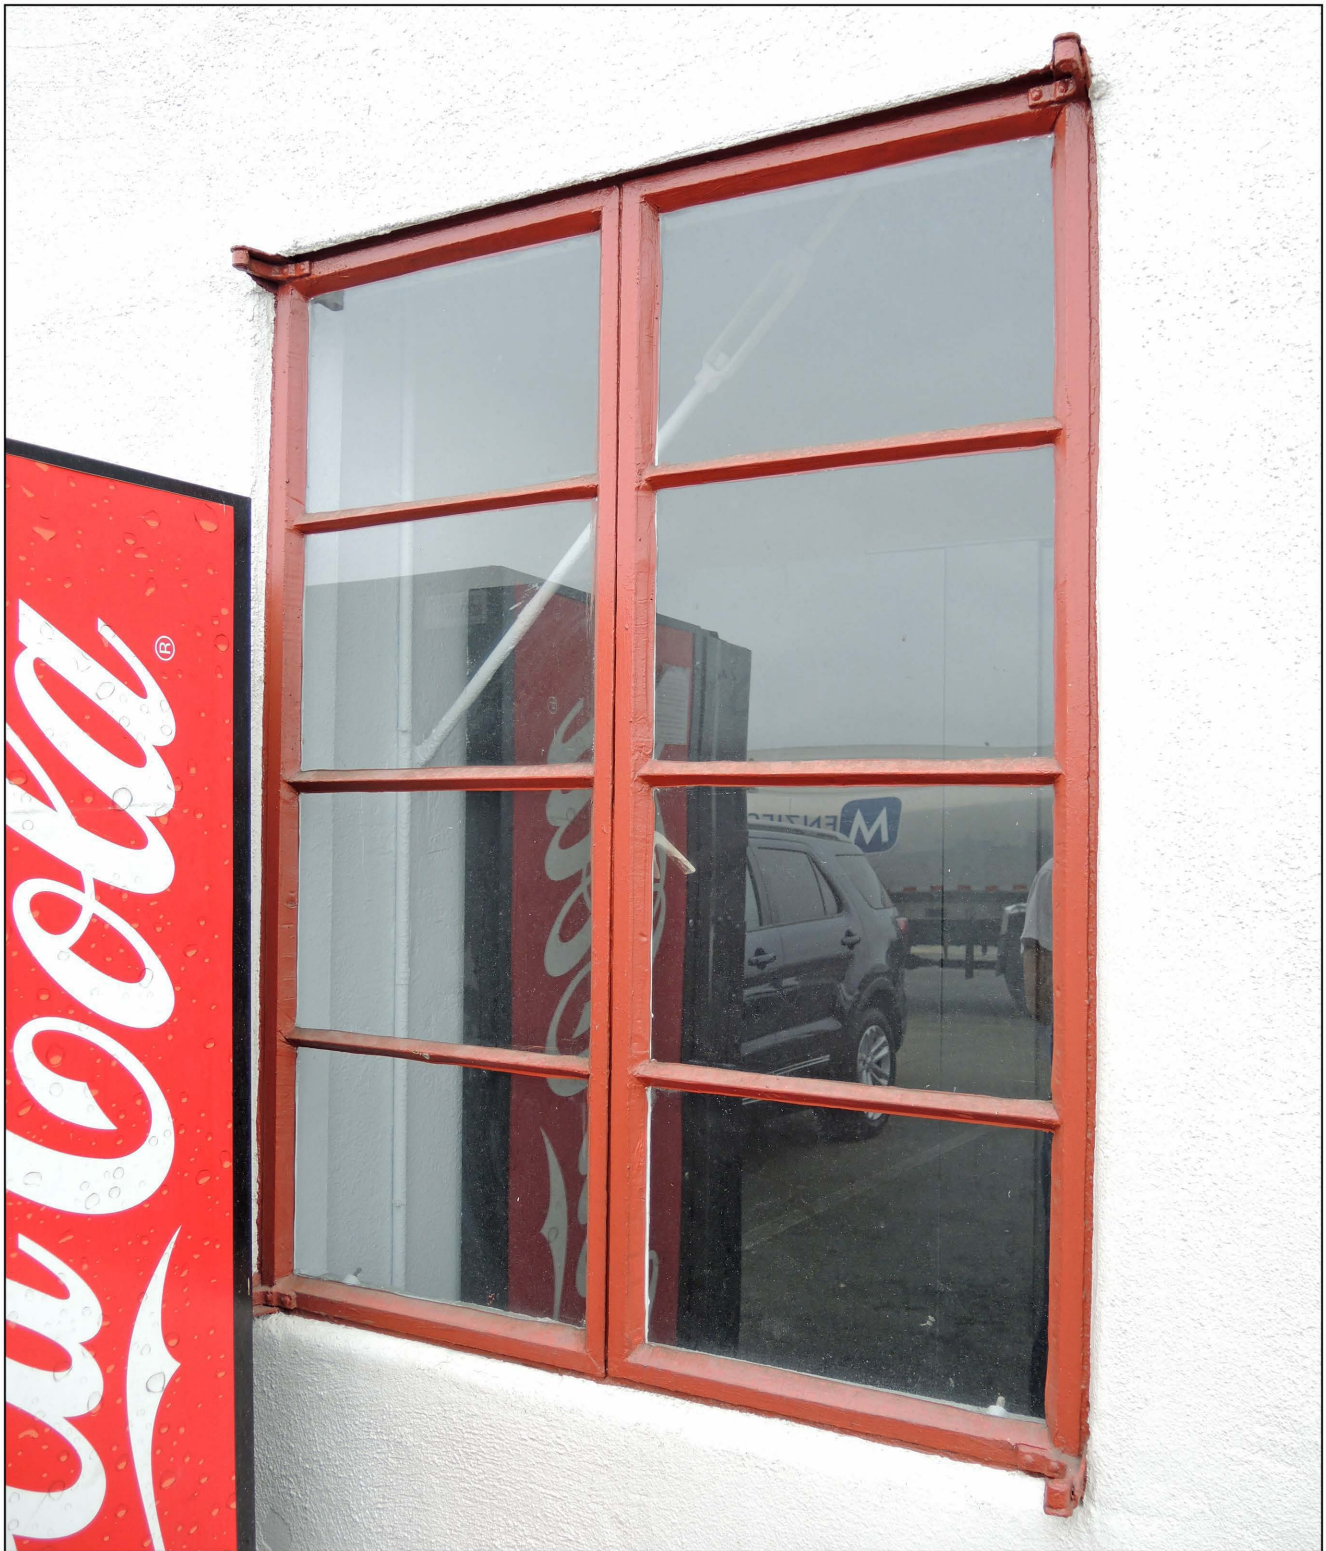
**Plate 6.4–16**

**View of a Metal-Framed, Casement-Style Window on  
the West Façade of the UAHT Building, Facing East**

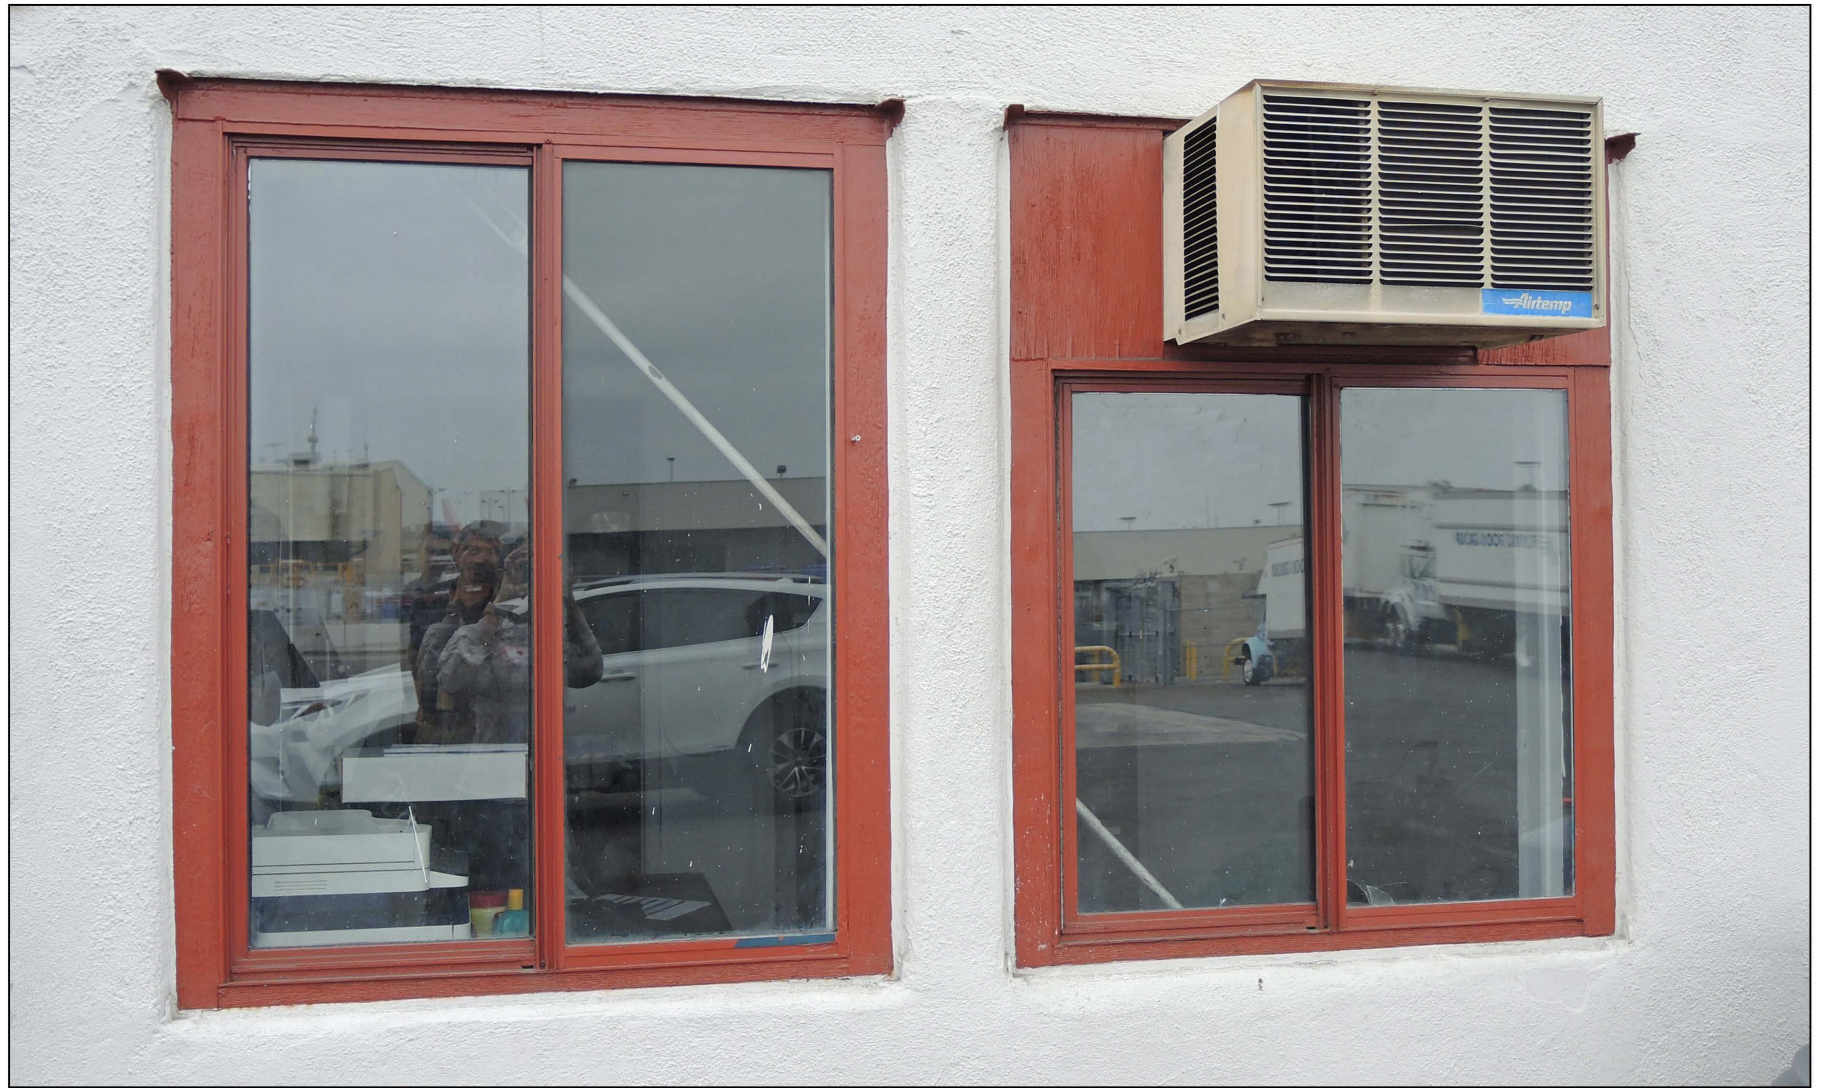
**View of the Two Aluminum-Framed Sliding Windows  
on the West Façade of the UAHT Building, Facing East**  
The SAN Airfield Improvements and Terminal 1 Replacement Project

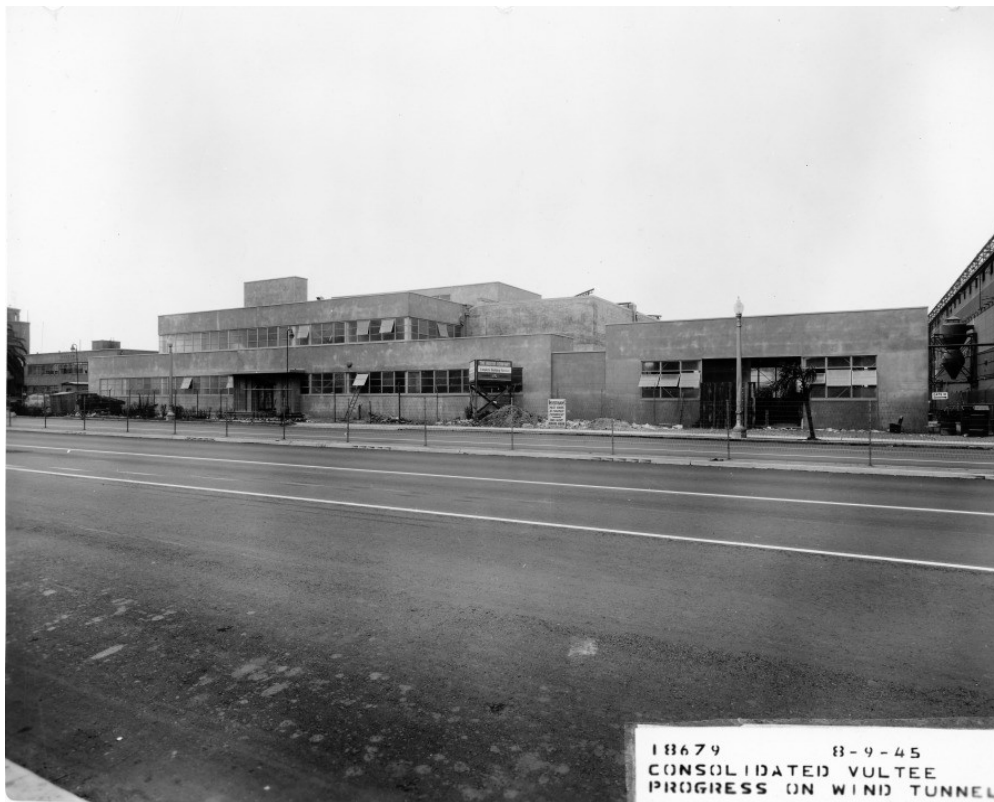
**Plate 6.5–1: View of the CWT building under construction in 1945.**  
*(Photograph courtesy of the San Diego Air and Space Museum)*

In 1944, Convair (Consolidated Vultee Aircraft Corporation, previously Consolidated Aircraft Corporation) acquired the land at 3050 Pacific Highway, where Claude Ryan had constructed the RSA airplane hangar in 1932 (see Plate 5.5–2). In October of 1944, the RSA hangar building was relocated to the southeastern portion of Lindbergh Field, adjacent to the Ryan Aeronautical Company Complex, in order to make way for the construction of a wind tunnel building (*San Diego Union* 1944). Although visible on the 1946 Sanborn Map (Figure 6.5–1), construction of the \$600,000 CWT building was ongoing for nearly three years (Plate 6.5–1) (*San Diego Union* 1946) before completion in 1947. Convair began testing operations at the facility in mid-1947, and in 1948, “Convair Wind Tunnel” was painted over the entrance to the building (*San Diego Union* 1947; *San Diego Union* 1948) (Plate 6.5–2).

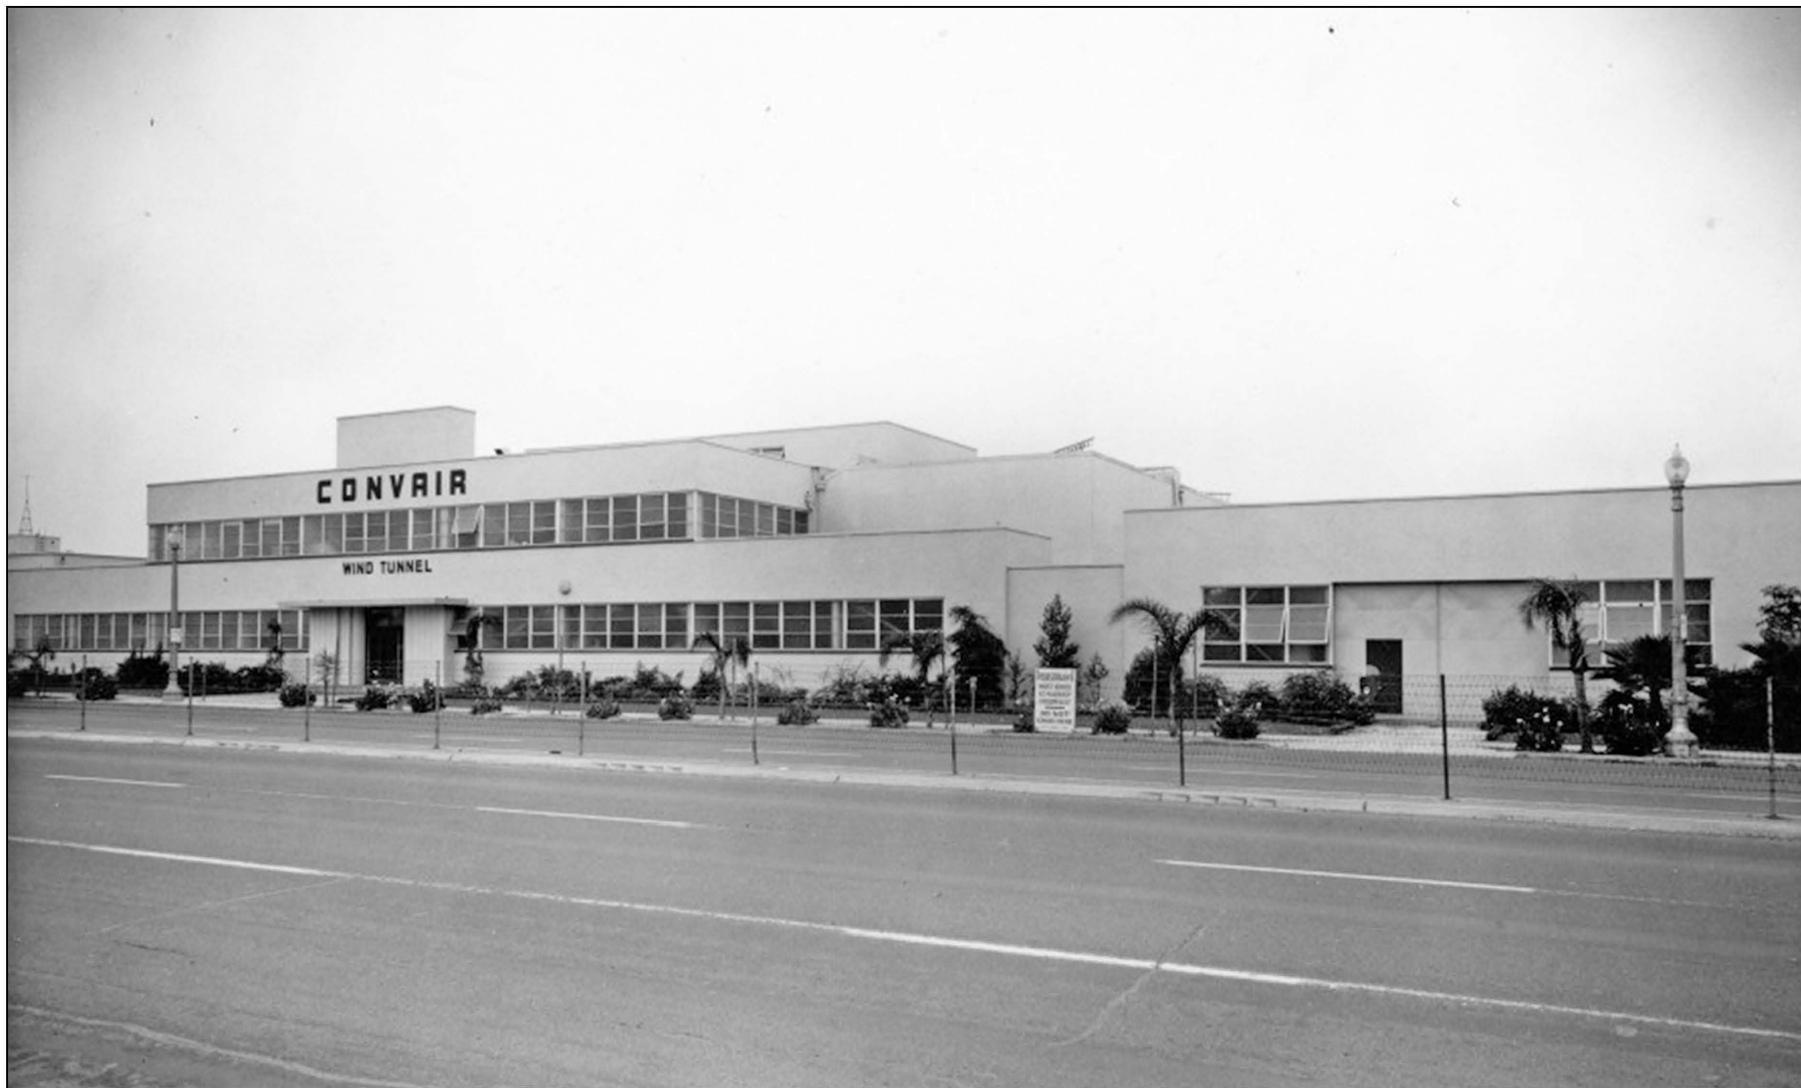
## Plate 6.5-2

### Post-1948 View of the CWT Building

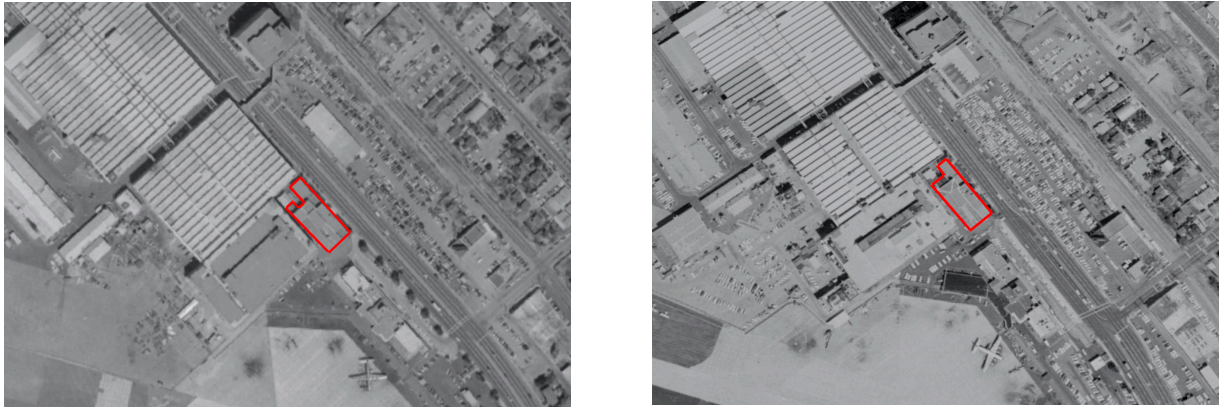
**Plates 6.5–3 and 6.5–4: 1953 (left) and 1964 (right) aerial photographs of the CWT building (outlined in red). (Photographs courtesy of NETROnline)**

A site plan has been provided in Figure 6.5–2 that color-codes the original and modified portions of the building. When completed in 1947, the CWT building could be best described as displaying characteristics of the International architectural style. Between 1953 (Plate 6.5–3) and 1964 (Plate 6.5–4), a three-story, corrugated metal addition was built on the northwest façade of the CWT building, southwest of the power house and transistors required to operate the facility. No other modifications appear to have been made to the exterior of the building.
