**Section 106 Assessment for the San Diego International Airport Airfield  
Improvements and Terminal 1 Replacement Project**

**SECTION 106 ASSESSMENT FOR THE  
SAN DIEGO INTERNATIONAL AIRPORT  
AIRFIELD IMPROVEMENTS AND  
TERMINAL 1 REPLACEMENT PROJECT**

**CITY OF SAN DIEGO, CALIFORNIA**

***November 10, 2020; Revised January 8, 2021; Revised February 19, 2021;  
Revised March 12, 2021; Revised April 27, 2021; Revised May 7, 2021***

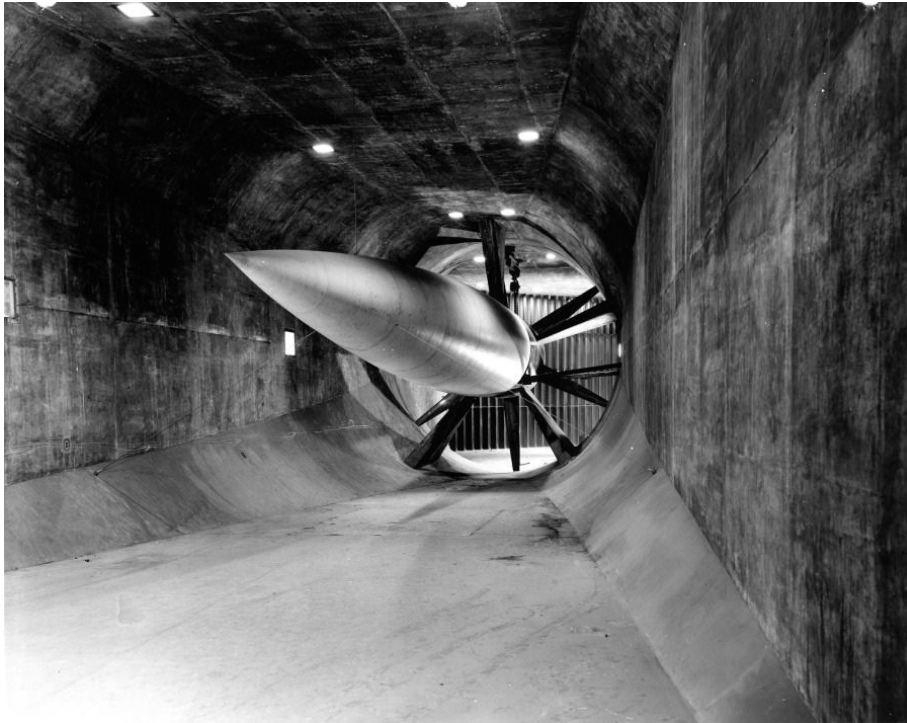
**Plate 6.5–6: CWT building wind propellers at an unknown date.**  
*(Photograph courtesy of the San Diego Air and Space Museum)*

The CWT building is still currently being used as a testing facility, which involves producing complete scale models of aircraft or various aircraft parts that are placed inside the tunnel (Plate 6.5–5). Air is then passed over the scale models so aspects of lift and drag can be measured. Called a “low speed wind tunnel,” the CWT building was, and still is, capable of generating a maximum wind speed of 270 miles per hour. During testing, this “low speed” air current is propelled (Plate 6.5–6) through a wall of boards called turning vanes (Plate 6.5–7). The air is pushed into a triangular room before being blasted through a honeycomb wall into an eight-foot-tall, 12-foot-wide, 15-foot-long room. The small room has large windows on either side that allow engineers to view the testing from the adjacent control room (Plate 6.5–8). Currently, video camera feeds of the testing sessions are displayed in the control room. The CWT building has been used to test Boeing jetliners, fighter jets, and the Space Shuttle, as well as other various structures and items such as Qualcomm Stadium, camping tents, and cell towers. In 2006, the CWT building was purchased by the San Diego Air and Space Museum and is now known as the San Diego Air and Space Technology Center (Masunaga 2017).

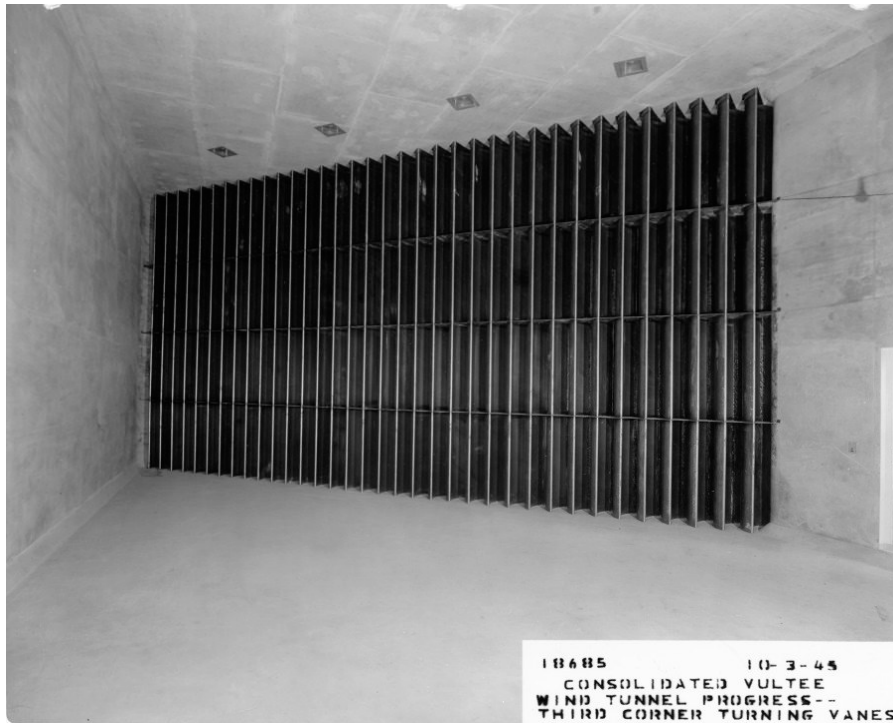
**Plate 6.5-7: CWT building turning vanes in 1945.**  
*(Photograph courtesy of the San Diego Air and Space Museum)*

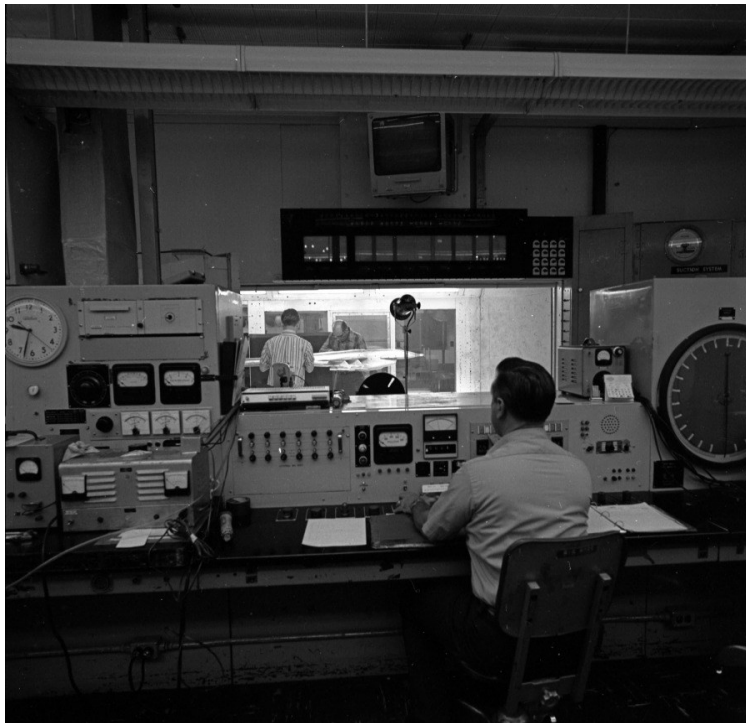
**Plate 6.5-8: The CWT building control room in 1972.**  
*(Photograph courtesy of the San Diego Air and Space Museum)*

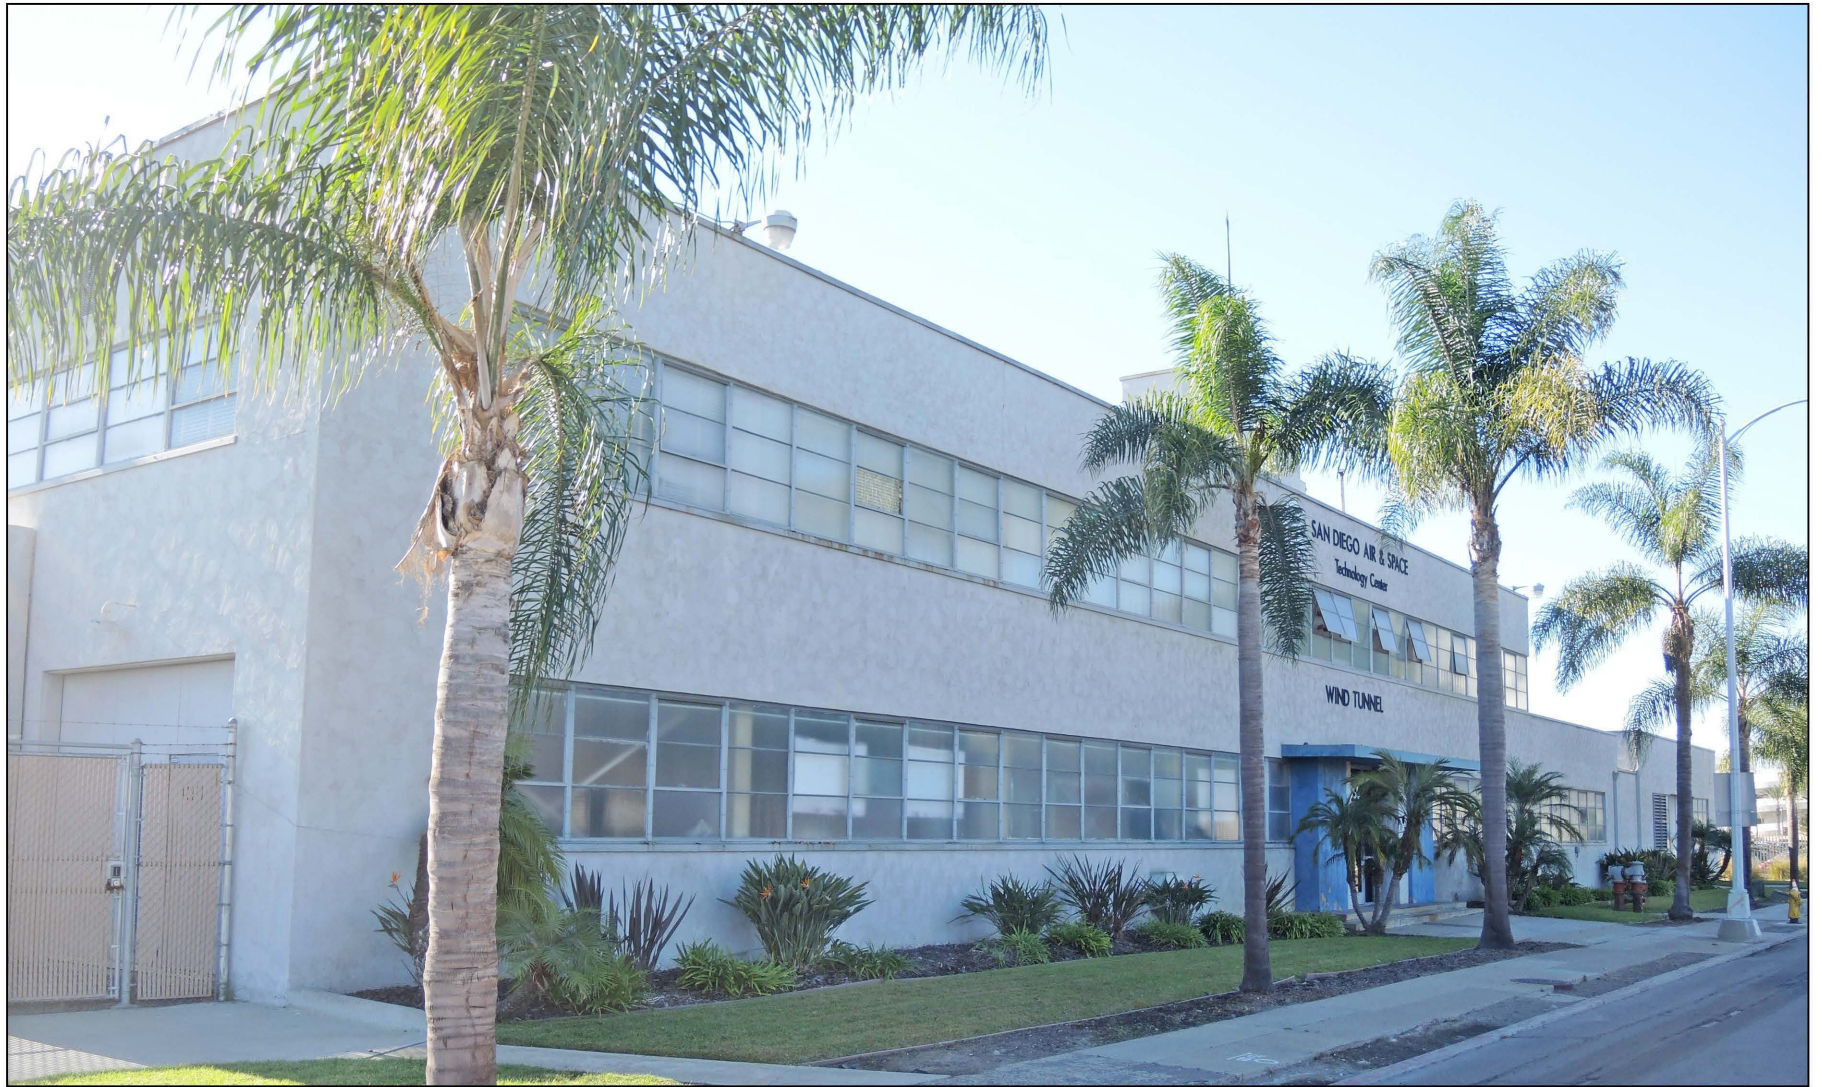
**Plate 6.5-9**

**View of the North Façade of the CWT Building  
Showing Two Rows of Horizontal Windows, Facing West  
The SAN Airfield Improvements and Terminal 1 Replacement Project**

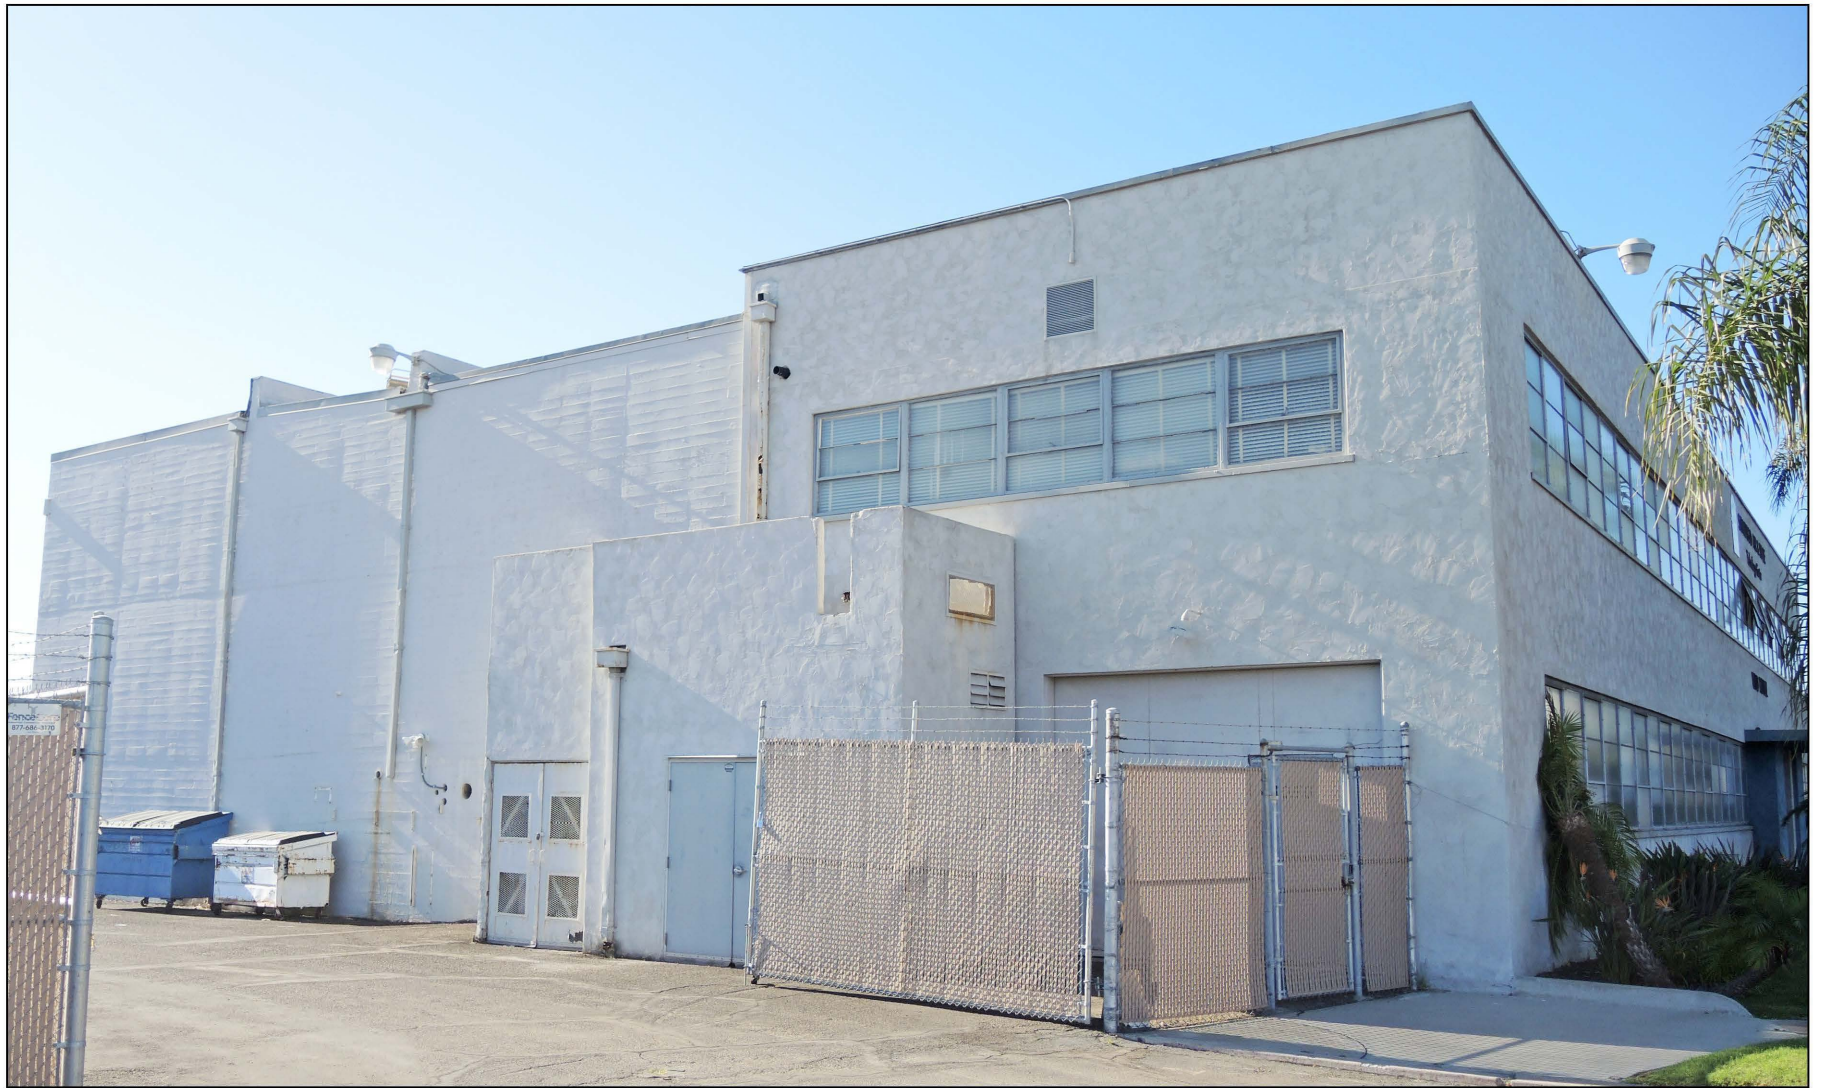
**Plate 6.5-10**  
**View of the East Façade of the CWT Building, Facing Northwest**  
The SAN Airfield Improvements and Terminal 1 Replacement Project

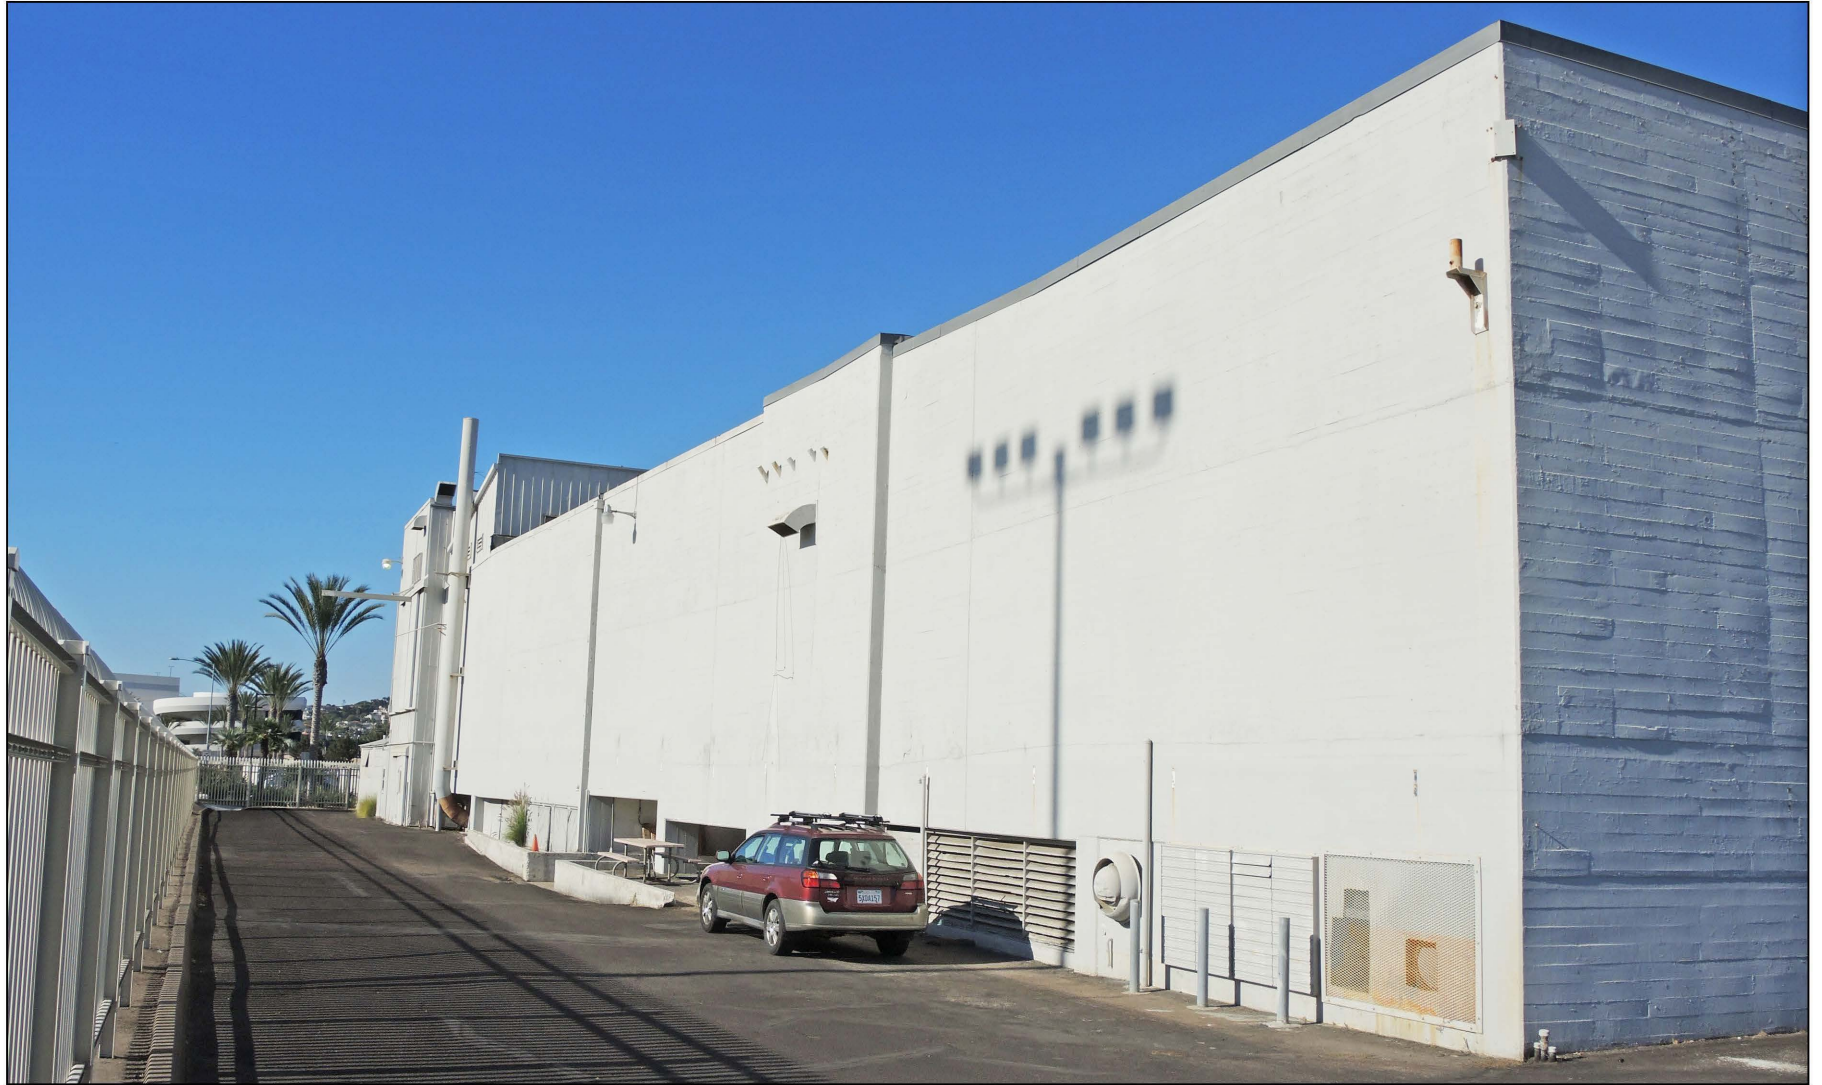
**Plate 6.5-11**  
**View of the South Façade of the CWT Building, Facing North**  
The SAN Airfield Improvements and Terminal 1 Replacement Project

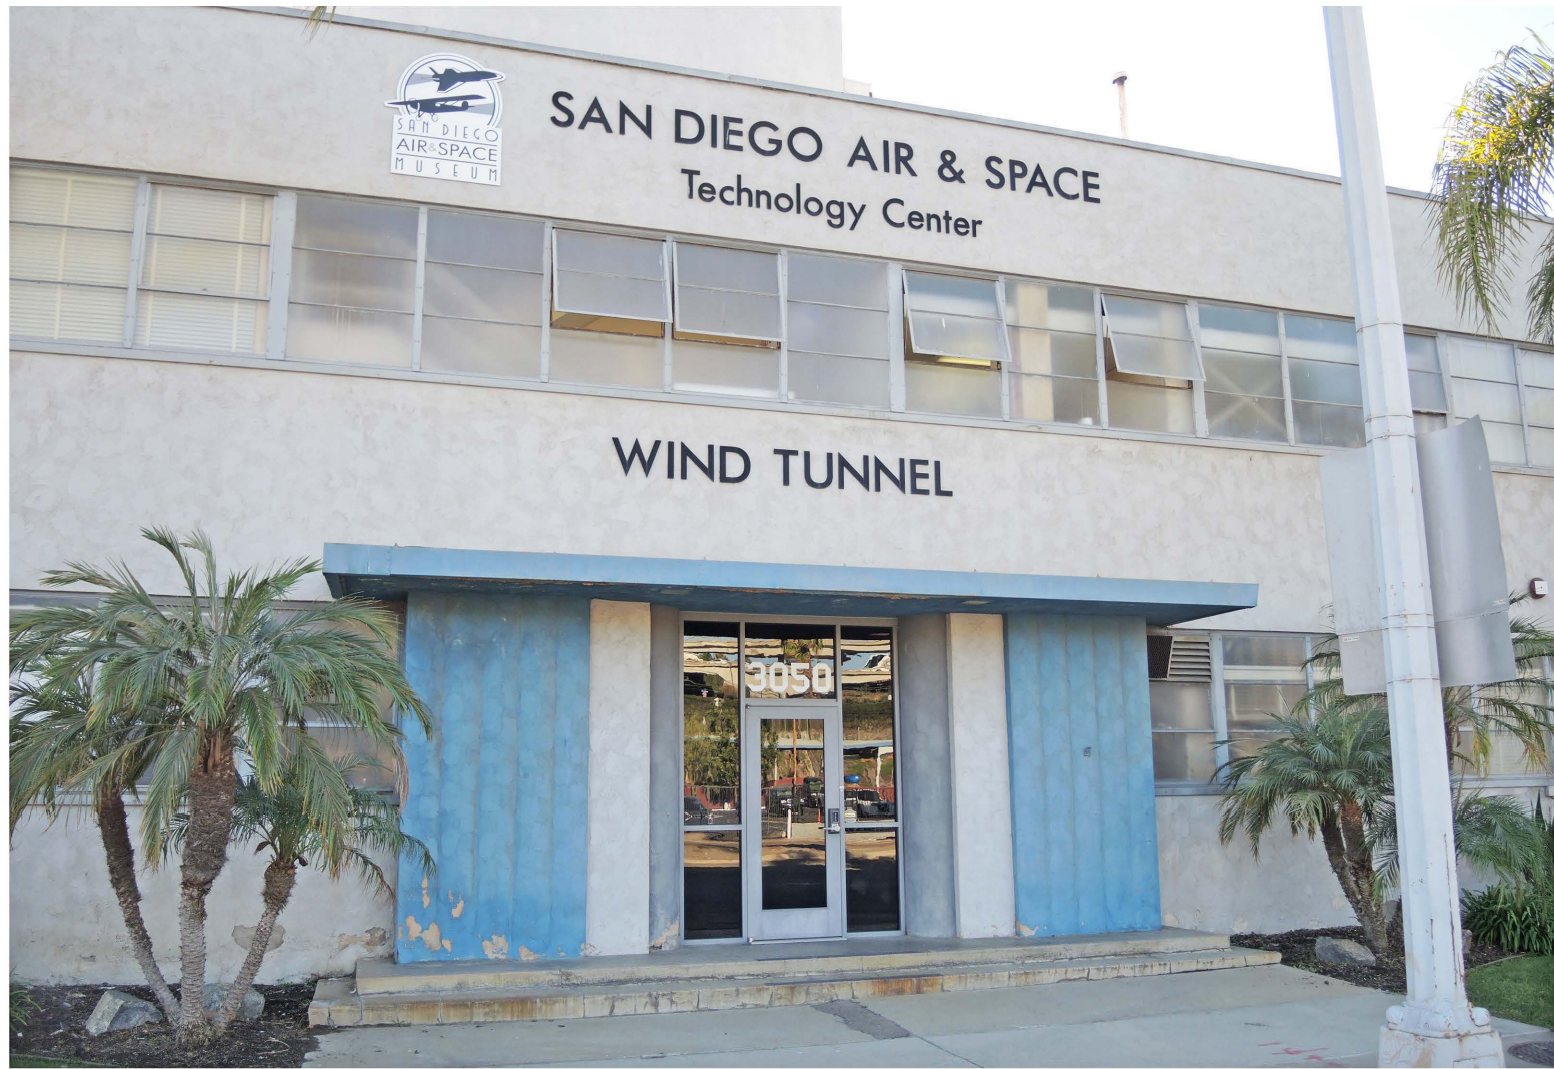
**Plate 6.5-12**

**View of the Main Entrance to the CWT Building on the North Façade, Facing West**

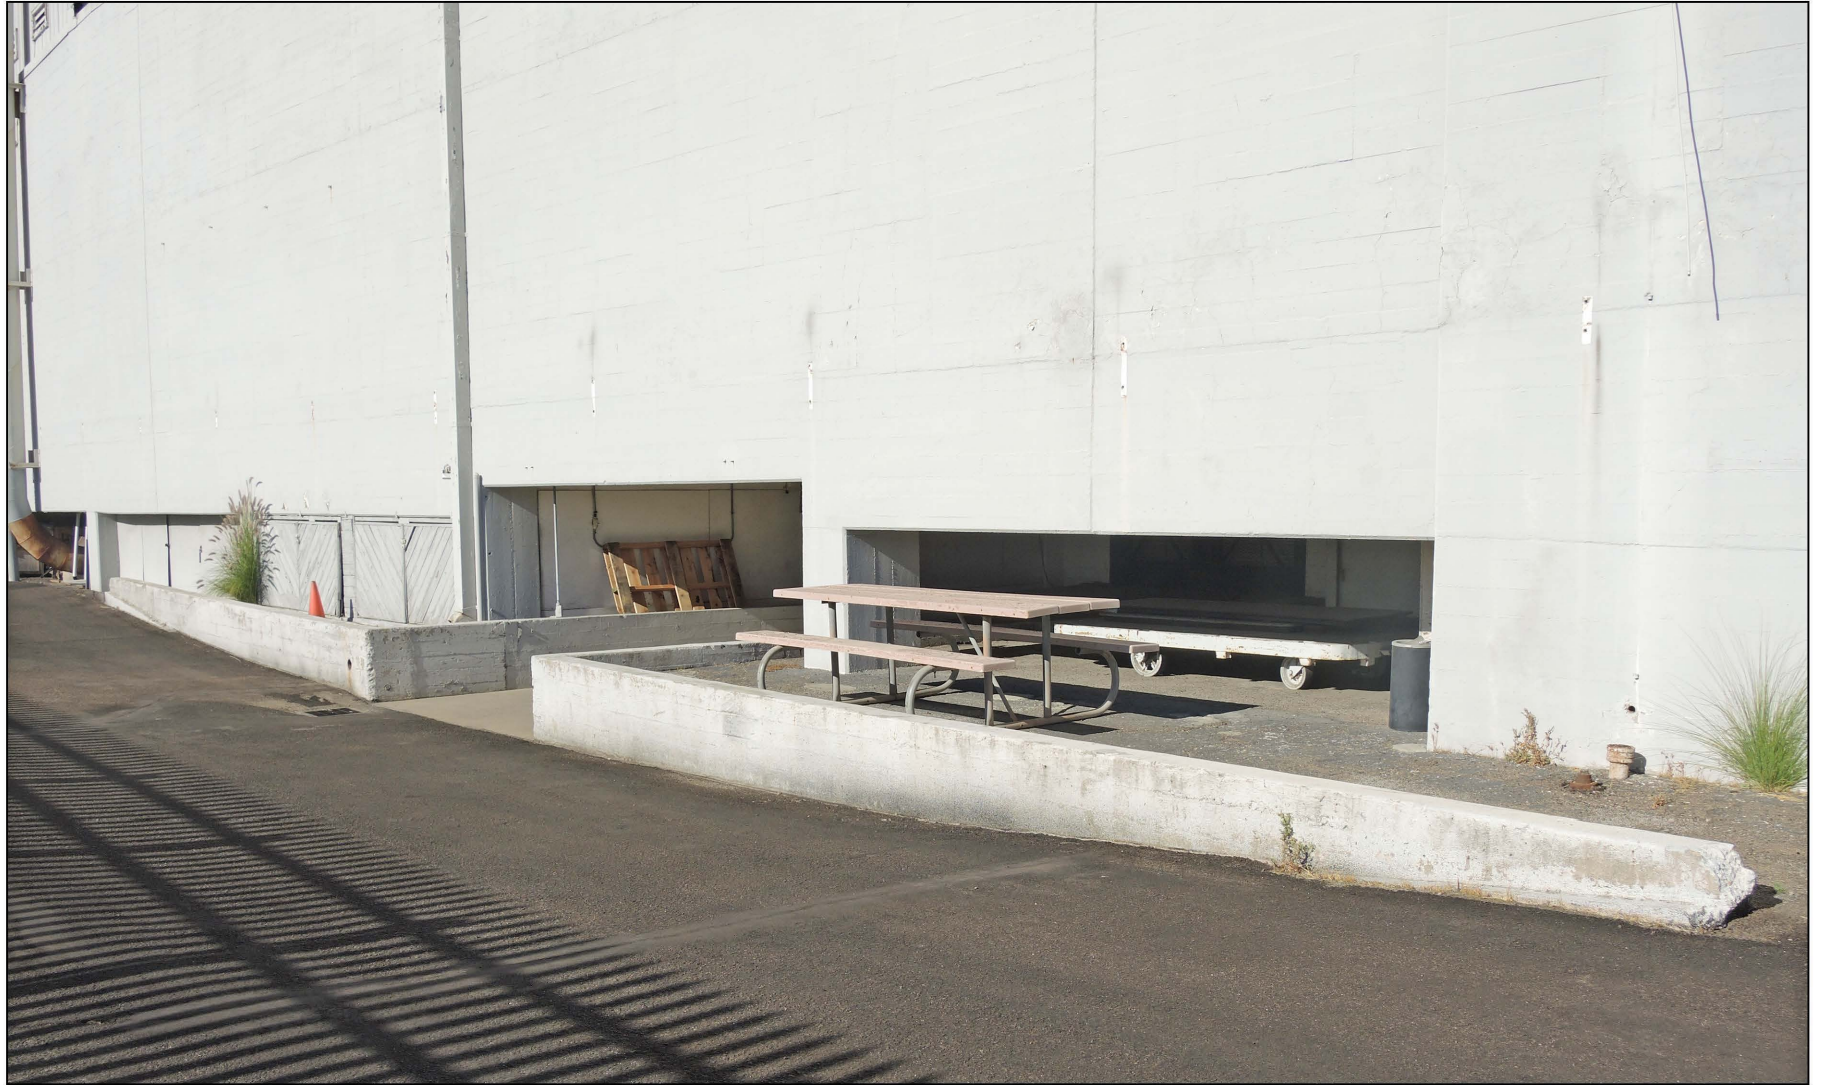
**Plate 6.5-13**

**View of the Basement-Level Vehicle Entrance on the  
South Façade of the CWT Building, Facing Northeast**

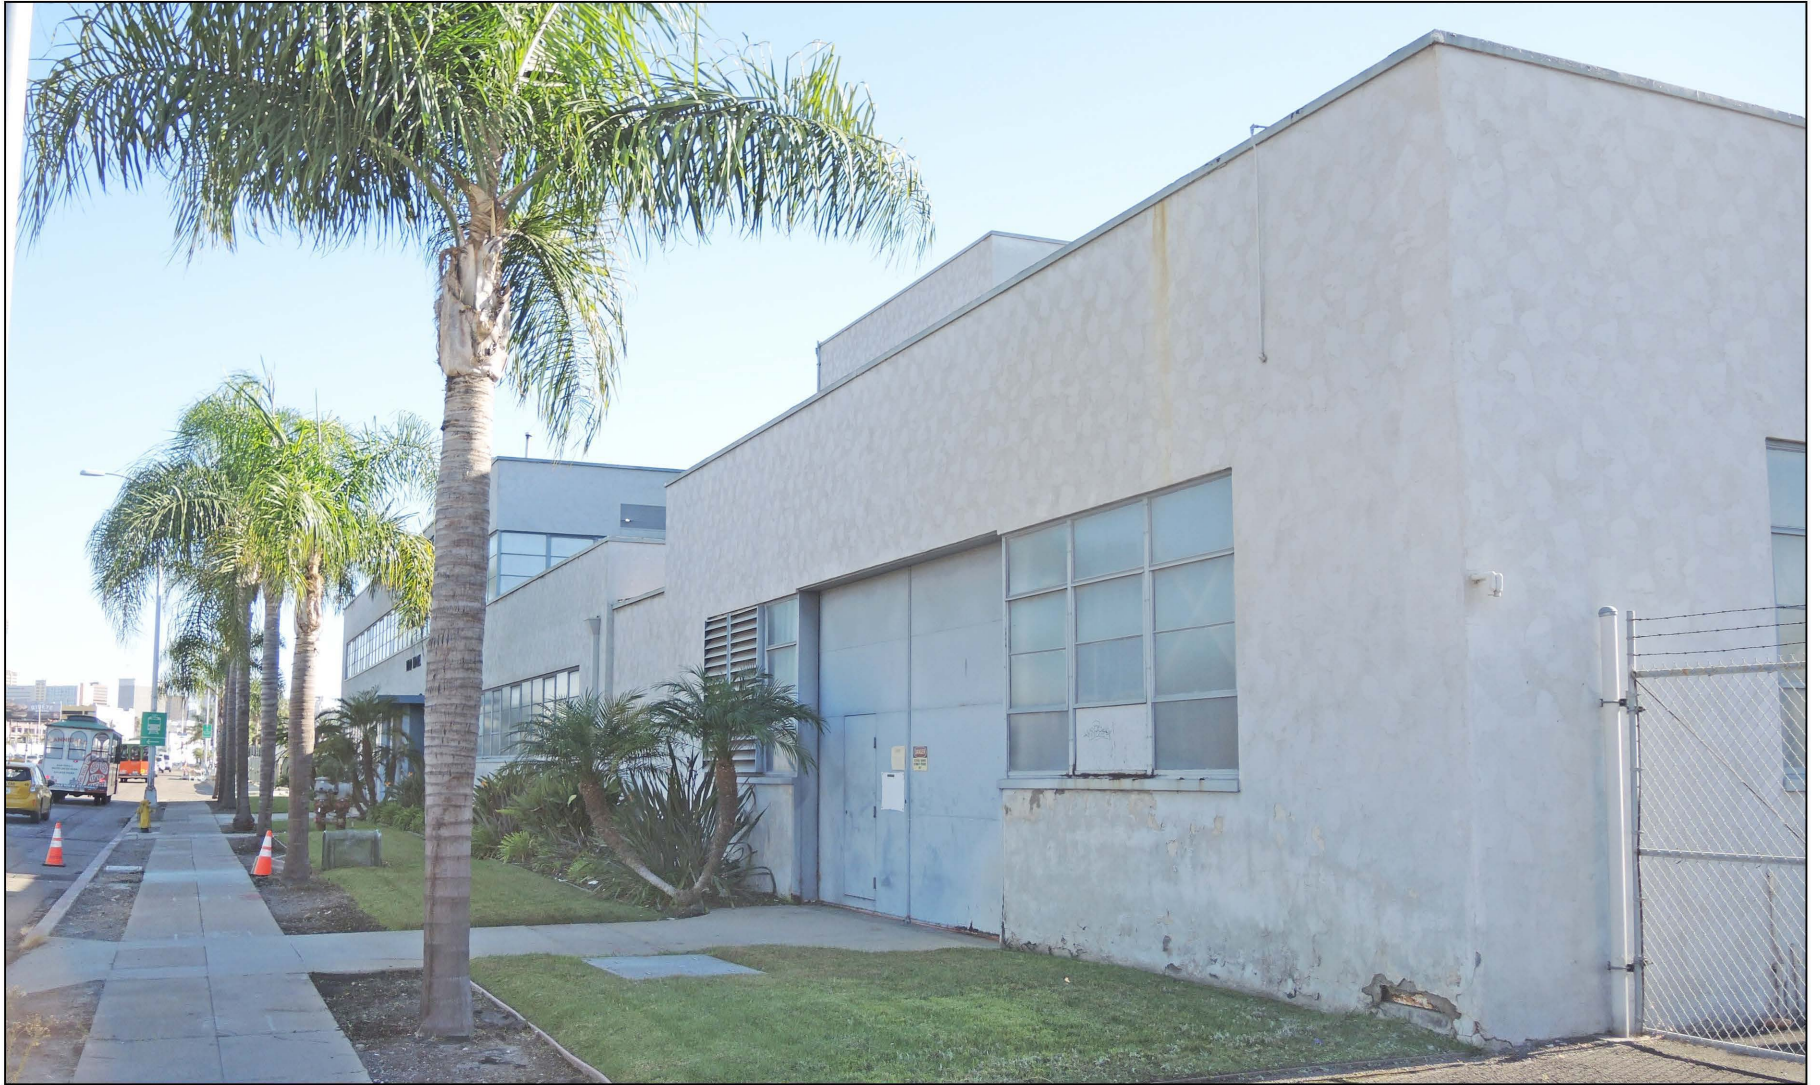
**Plate 6.5-14**

**View of the North Façade of the CWT Building Power House, Facing South**

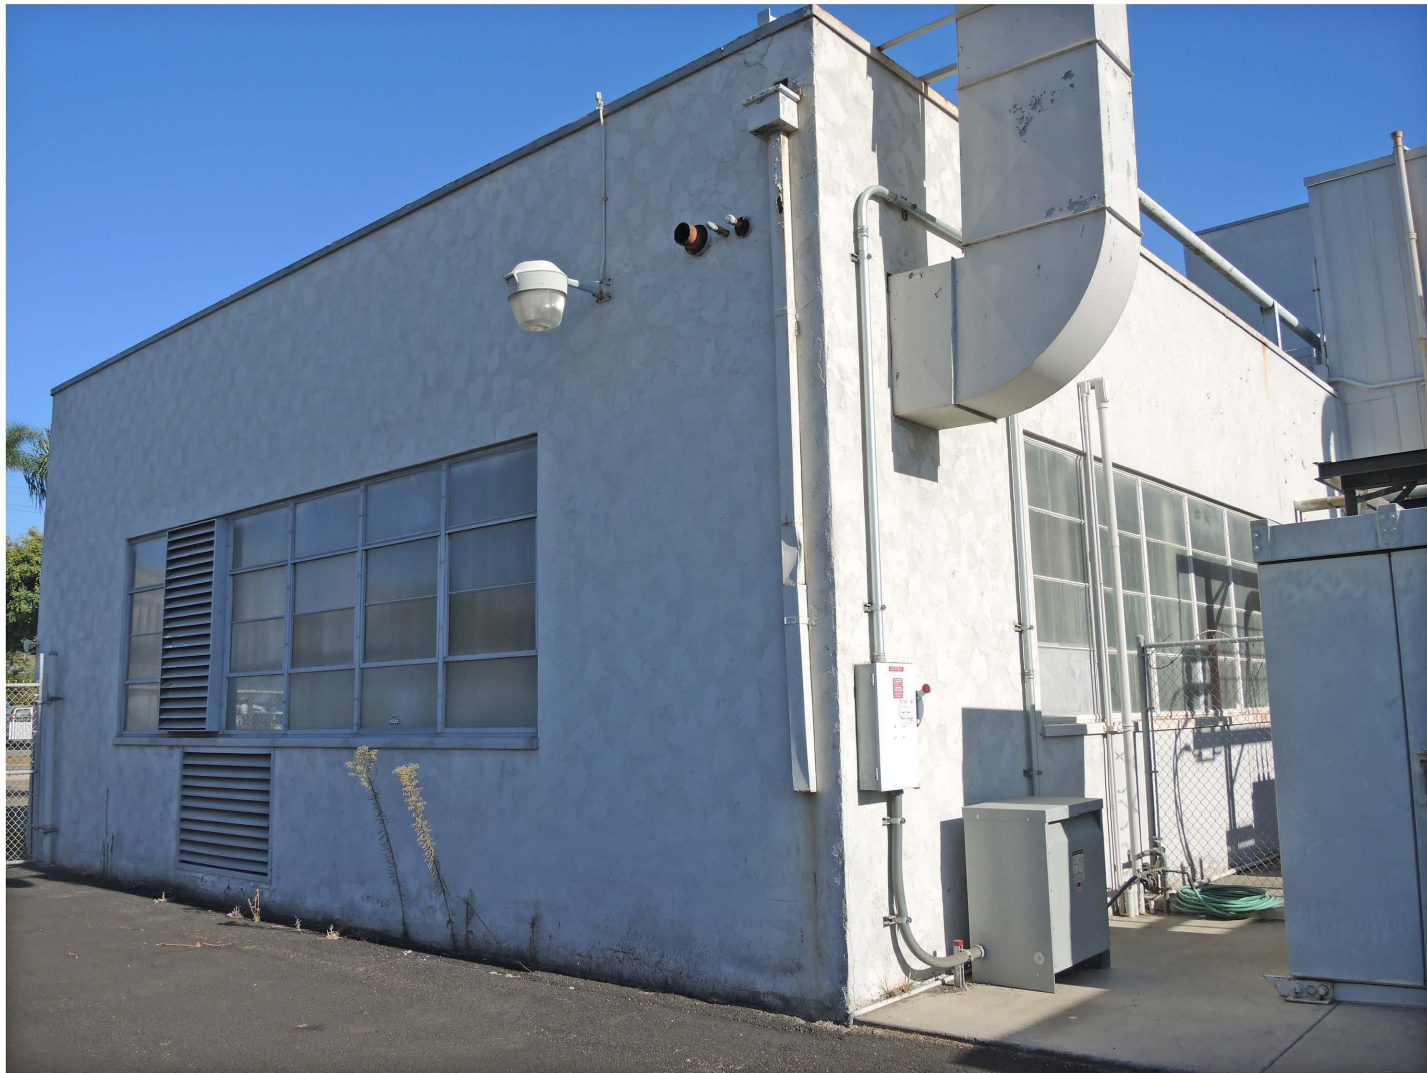
**Plate 6.5-15**

**View of the West and South Façades of the CWT Building Power House, Facing East**

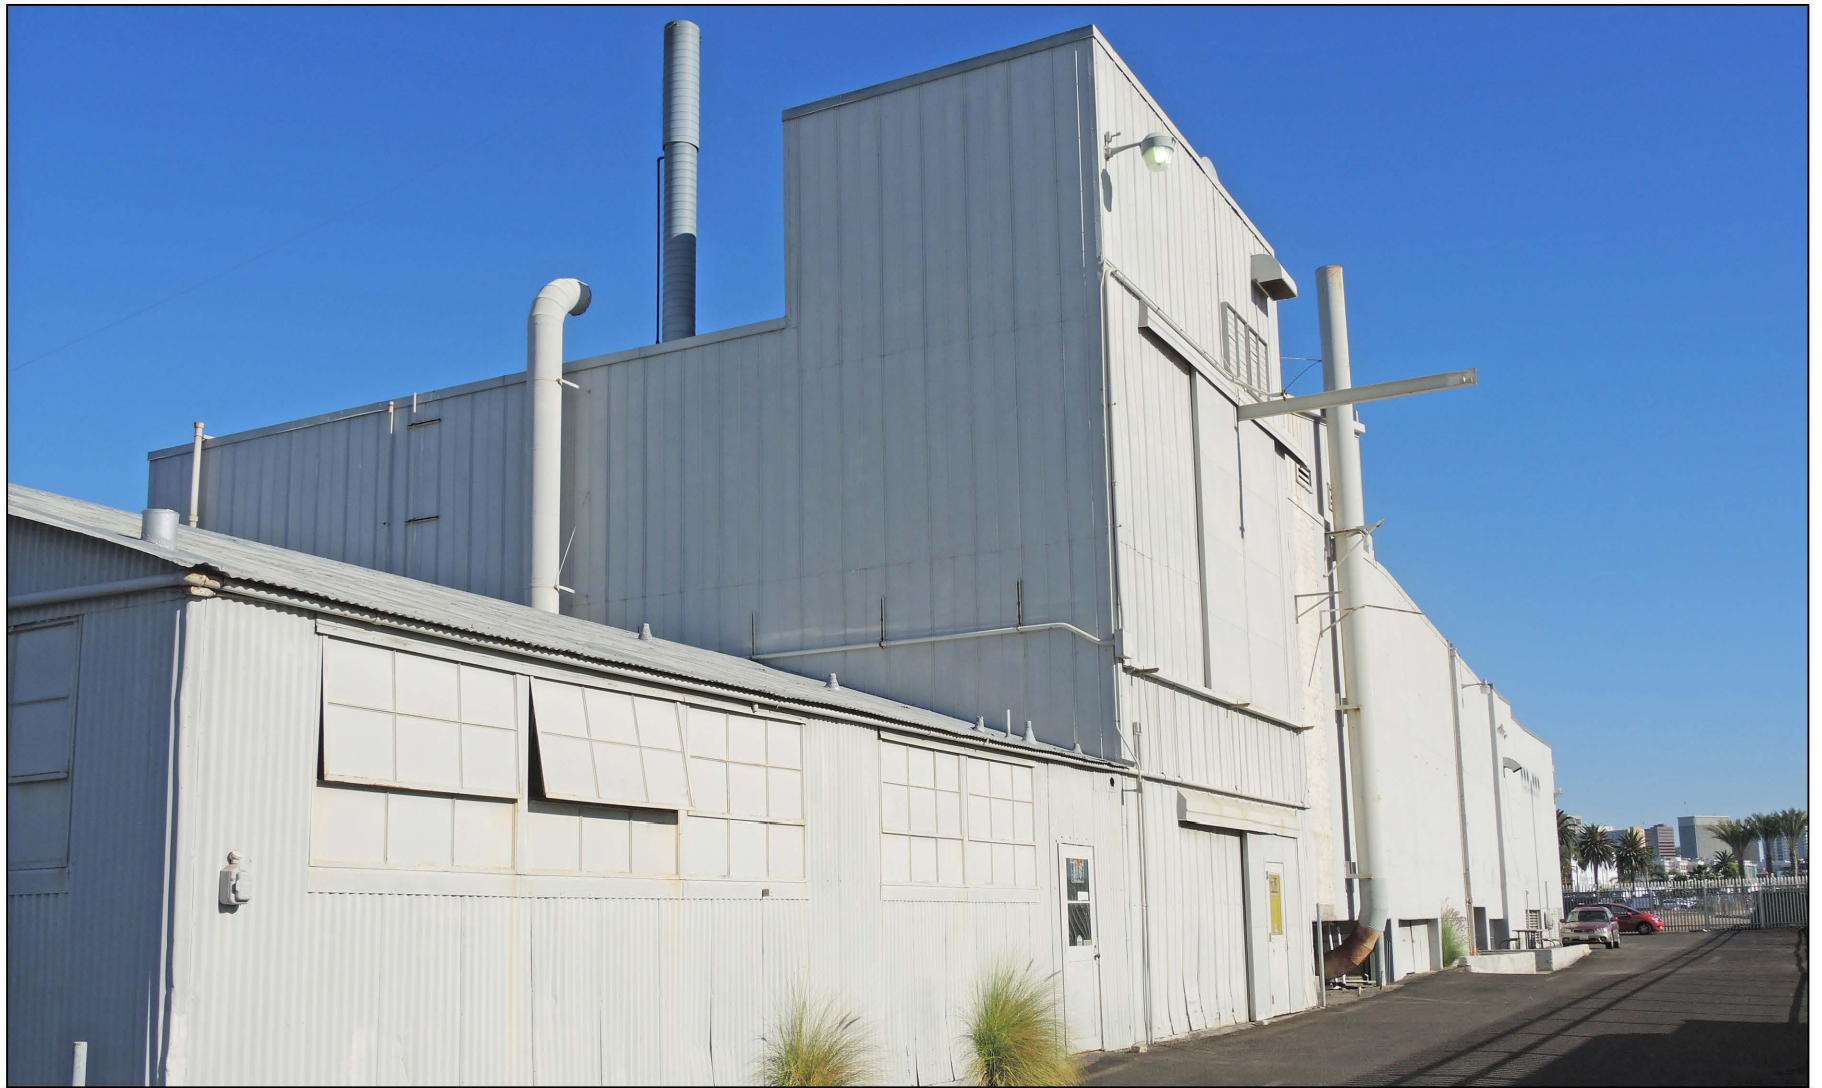
**Plate 6.5-16**

**View of the Three-Story Addition on the South  
Façade of the CWT Building, Facing Northeast**

A site plan has been provided in Figure 6.5–2 that color-codes the original and modified portions of the building. When completed in 1947, the CWT building could be best described as displaying characteristics of the International architectural style. Between 1953 (Plate 6.5–3) and 1964 (Plate 6.5–4), a three-story, corrugated metal addition was built on the northwest façade of the CWT building, southwest of the power house and transistors required to operate the facility. No other modifications appear to have been made to the exterior of the building.
