2021 Asbestos Reinspections

San Diego County Regional Airport Authority
Environmental Affairs
P.O. Box 82776
San Diego, CA 92138

TETRA TECH, INC.
1230 Columbia Street, Suite 1000
San Diego, California 92101
ph. (619) 525-7188

April 1, 2021

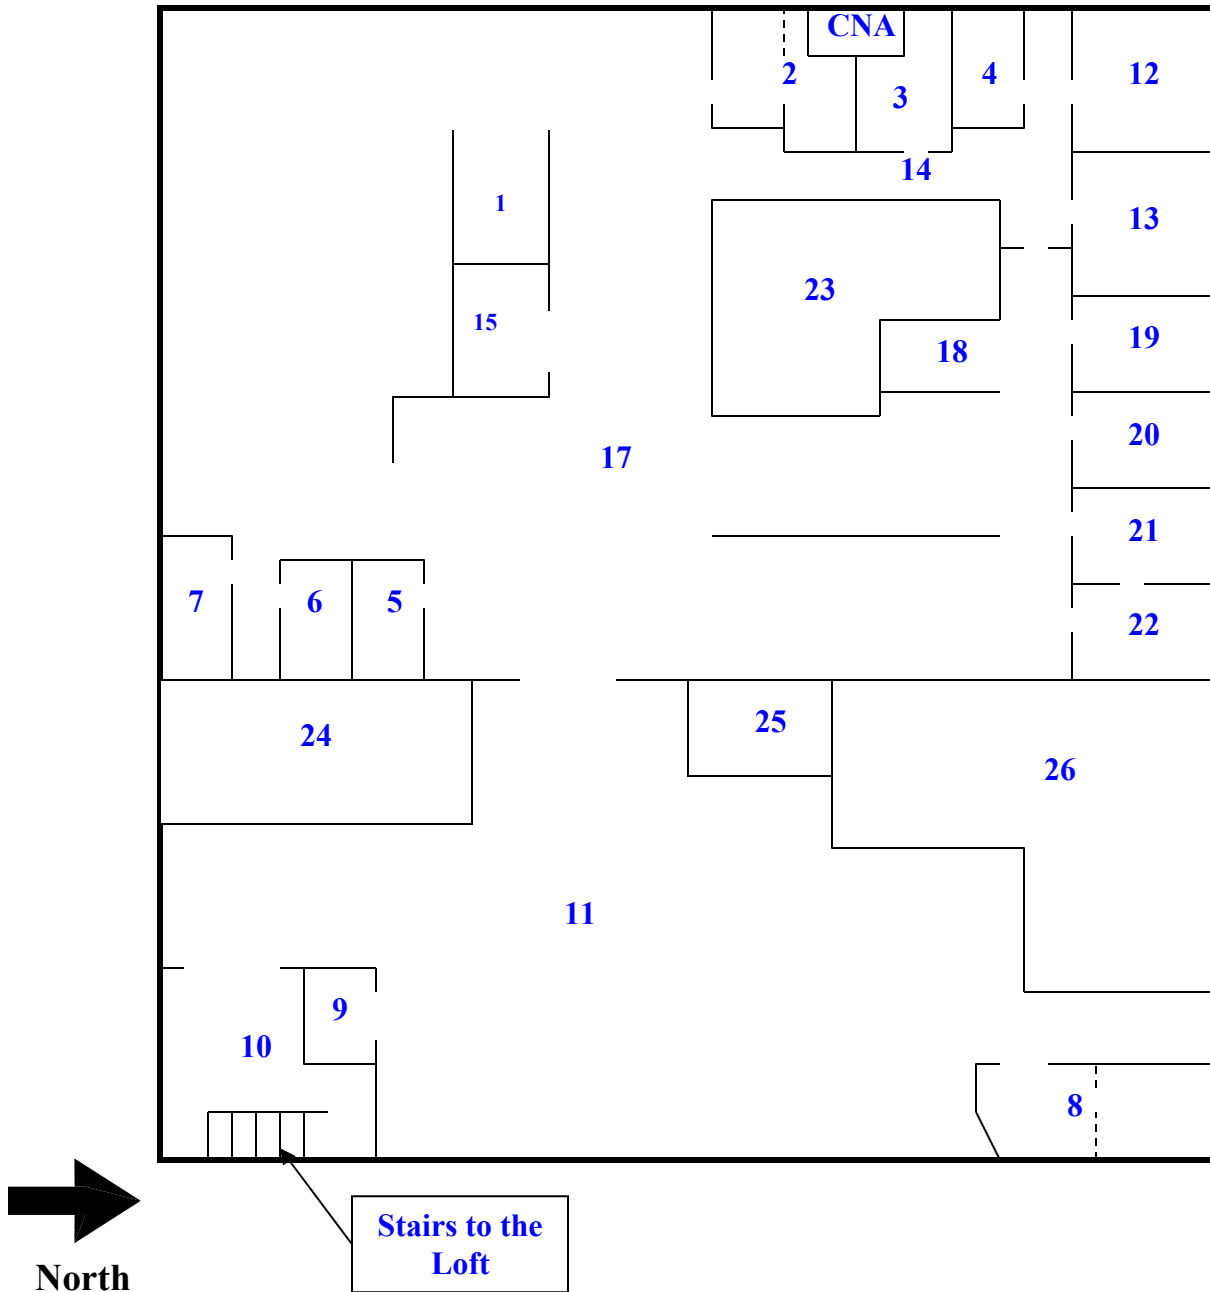
2417 Winship Lane
1st Floor
Not to Scale

As noted in the 2009 assessment report, the interior structure has changed but the rooms with ACMs remain the same

Room #	Room Description
1	Storage Room
2	Dispatch Offices
3	Office
4	Office
5	Storage Room
6	Storage Room
7	Tank Room
8	Office
9	Storage Room
10	Boiler Room
11	Warehouse
12	Men's Bathroom/ Locker Room
13	Women's Bathroom/ Locker Room
14	Hallway to Bathrooms
15	Utility Closet
16	Sanitation Area
17	Production Area
18	Sink Area
19	Cooler
20	Cooler
21	Cooler
22	Cooler
23	Cooler
24	Cooler
25	Cooler
26	Cooler

Room #	Material Description	Material Location	Approximate Quantity ¹	Friable Y/N	Condition ²	Comments
Offices	Vinyl Floor Tile and Associated Mastic	Under carpet and a layer of non-asbestos floor tile	1,000 SF	N	G ³	Offices 2-4, VFT and mastic multiple layers. Entire building has been vacated in preparation for demolition
19-26	Grey sealant	Penetrations and holes in coolers	200 SF	N	G	Material added to inventory March 2 Entire building has been vacated in preparation for demolition

Roof	Penetration Mastic	Scattered around the roof	20 SF	N	G	Not confirmed as asbestos-containing. May remove from inventory. Entire building has been vacated in preparation for demolition.
Exterior	Stucco	All 4 walls of the building	5,000 SF	N	G	Stucco is ACM according to Sample 181208 ASB-075. Minor staining and cracks observed.
1-26	White window caulk	Interior of large original steel-framed windows, all 4 sides of building.	1,000 LF	Y	D	Sample 181208 ASB-081. Material is damaged and friable. Can be seen readily at top of stairs in loft area.
11	Plaster	Warehouse, north wall	5,000 SF	N	D	Remnant plaster observed and tested on north wall of warehouse, near offices.
