UPS

Facility Description and Activities

SAN DIEGO INTERNATIONAL AIRPORT

**UPS
Operating Areas**

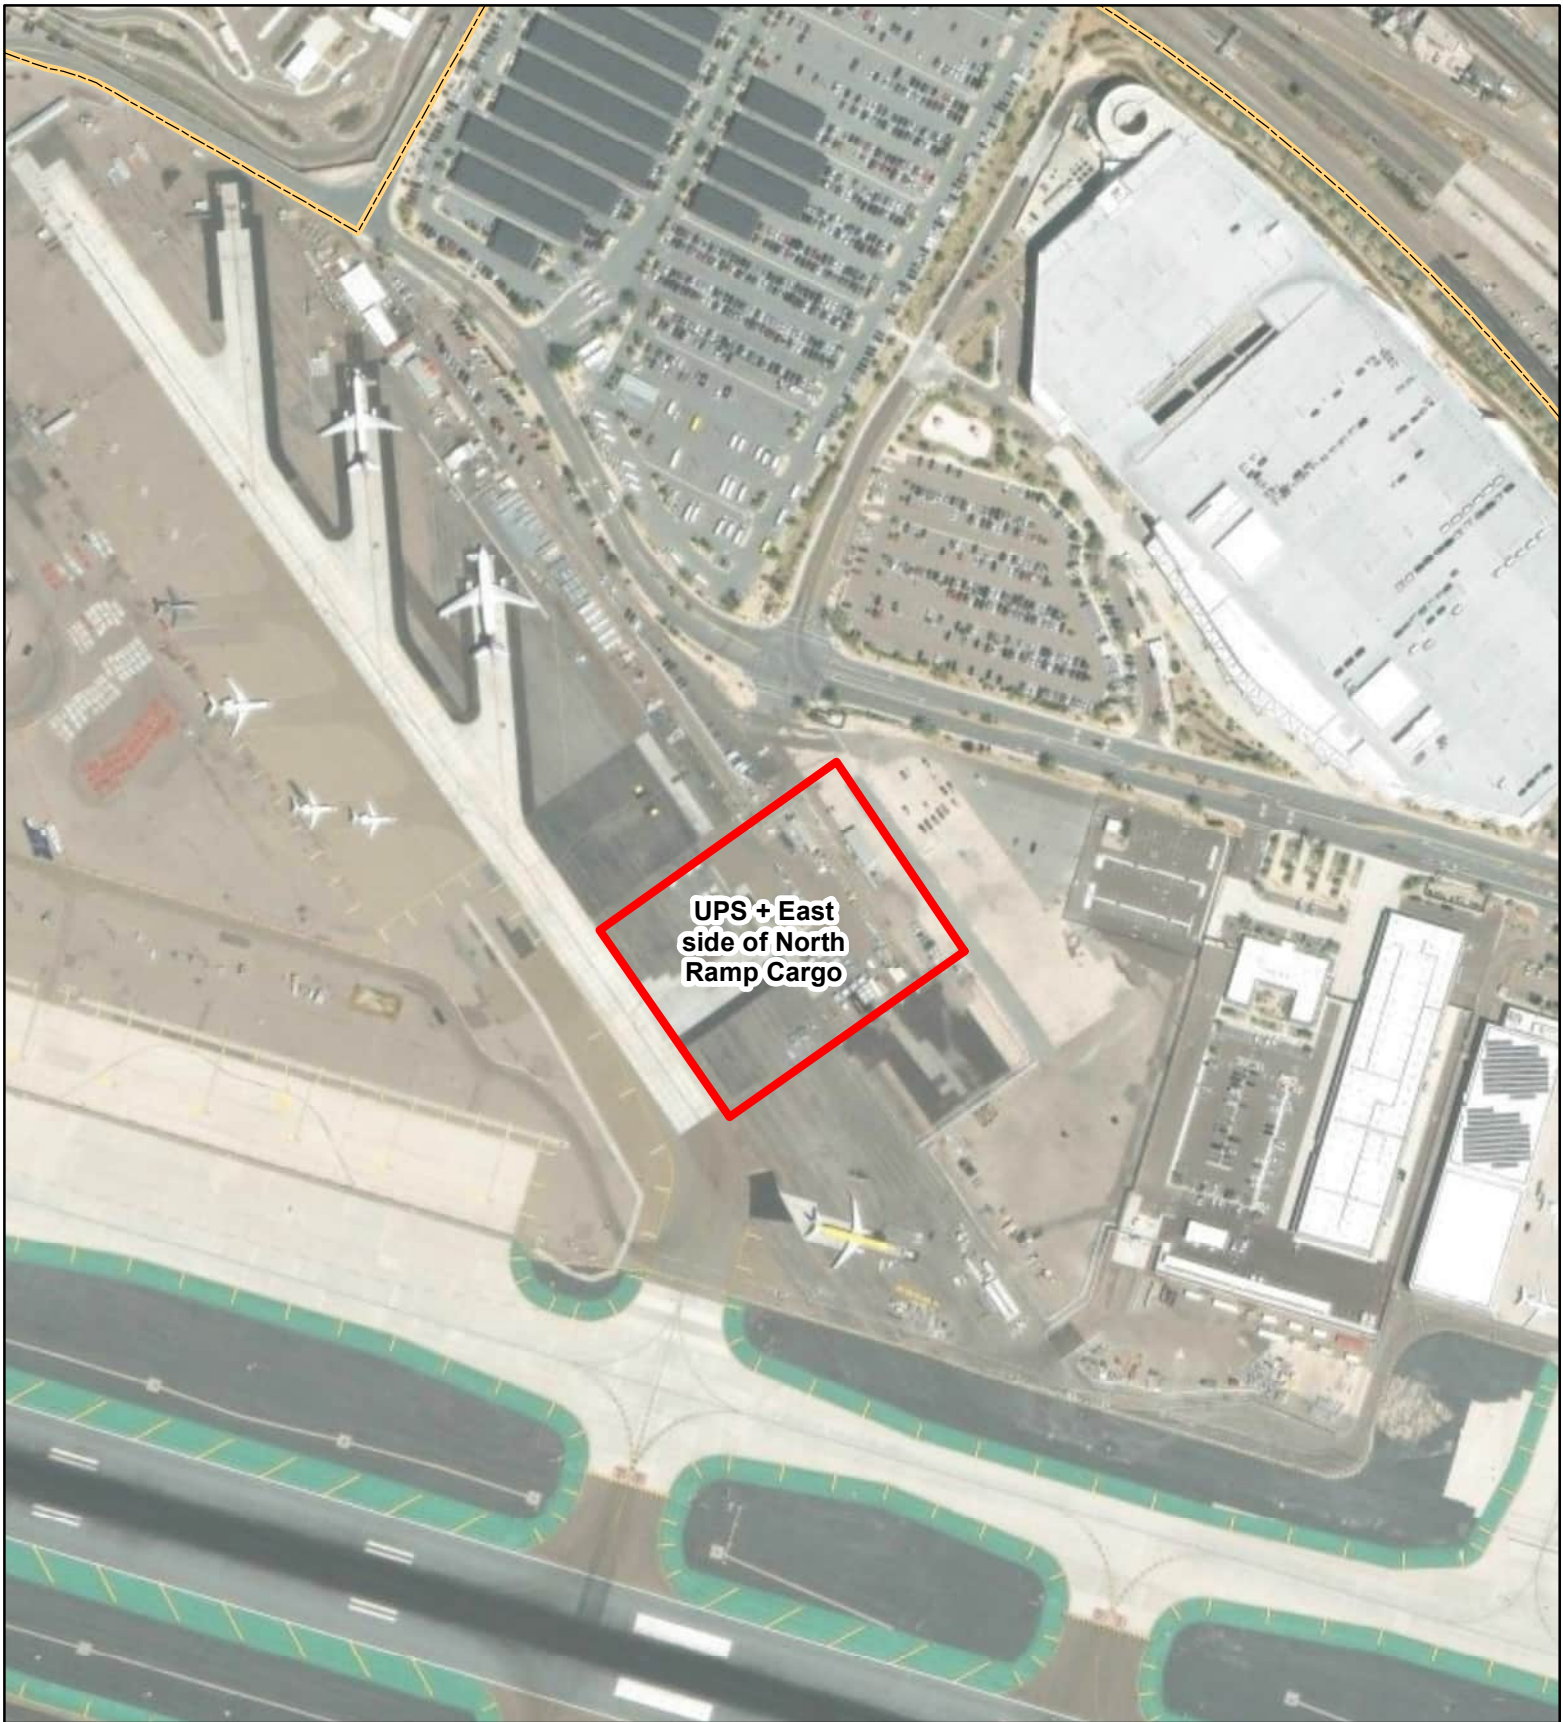
E-37

UPS + East
side of North
Ramp Cargo
